**APPENDIX 3C – SURFACE WATER  
MONITORING DATA**

## **Creek Stability Monitoring Reports**

Prepared for  
**Wilpinjong Coal Pty Ltd**

21 March 2018

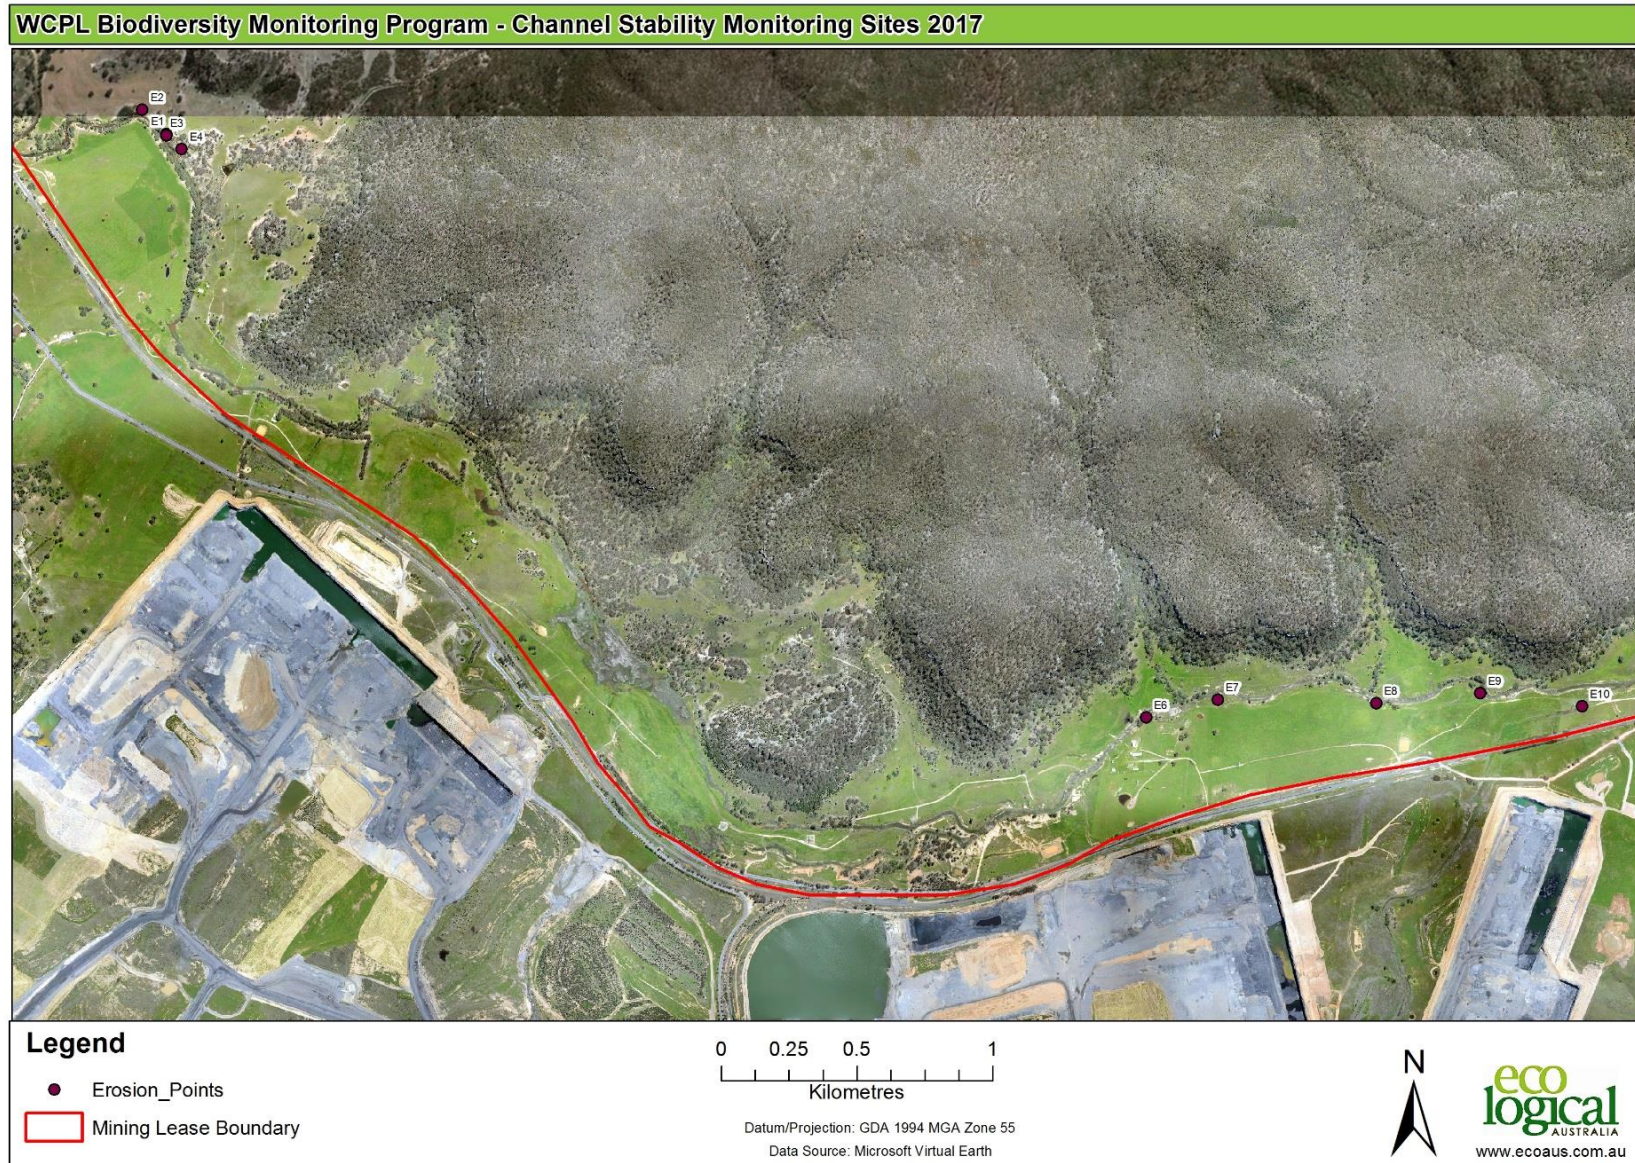
Figure 3-1: Active erosion points assessed in 2017

Active erosion points were observed along the creek, displaying lateral erosion caused primarily by cleared adjacent paddocks (**Figure 3-1**). There were no signs of ongoing downstream erosion. Bank instability along Wilpinjong Creek appeared to be related to cattle accessing the riparian zone. Photos of each erosion point and suggested remediation actions are included in **Table 4-3**.
