**APPENDIX 3C – SURFACE WATER
MONITORING DATA**

Wilpinjong Coal Mine

2018 Channel Stability Monitoring Report

Prepared for
Wilpinjong Coal Pty Ltd

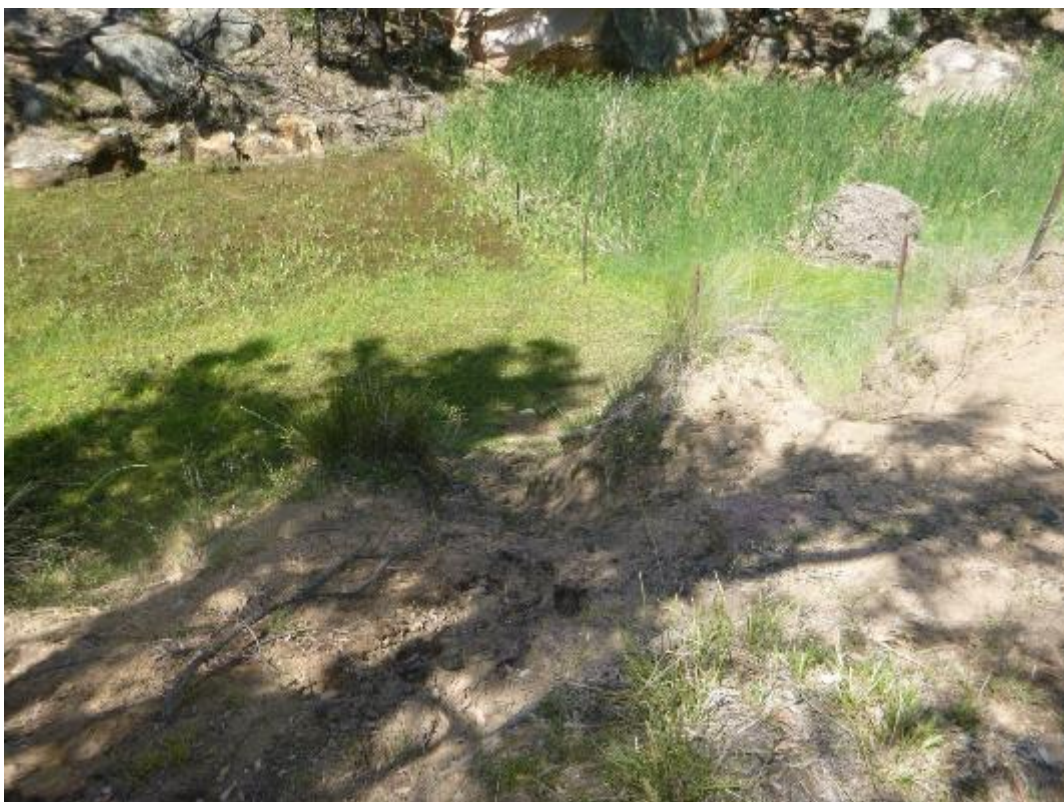
Figure 4-1: Effects of stock access in the riparian zone (left-hand side of the fence line), contrasted with the results of stock exclusion (right-hand side of the fence line)

Livestock (cattle) access to the riparian zone continues to impact on the overall stability and health along sections of both Wilpinjong and Cumbo Creeks. By contrast, sections where stock are excluded show natural regeneration and improved channel stability. **Figure 4-1** below clearly demonstrates the impacts that cattle continue to exert on sections of Wilpinjong Creek. As evidenced by the photograph, the left-hand side of the fence line has significantly lower macrophyte biomass, high turbidity and large patches of bare soil on the right bank (foreground of photograph) resulting from cattle accessing the creek.

Stock have been observed within the eastern section of Wilpinjong Creek (incorporating sites Wck36 to Wck45), as well as the far-western section (incorporating sites Wck1 to Wck8). Excluding stock from the riparian zone through the installation of fencing is recommended. This is likely to provide additional benefits to natural regeneration through reducing grazing pressure from native herbivores.

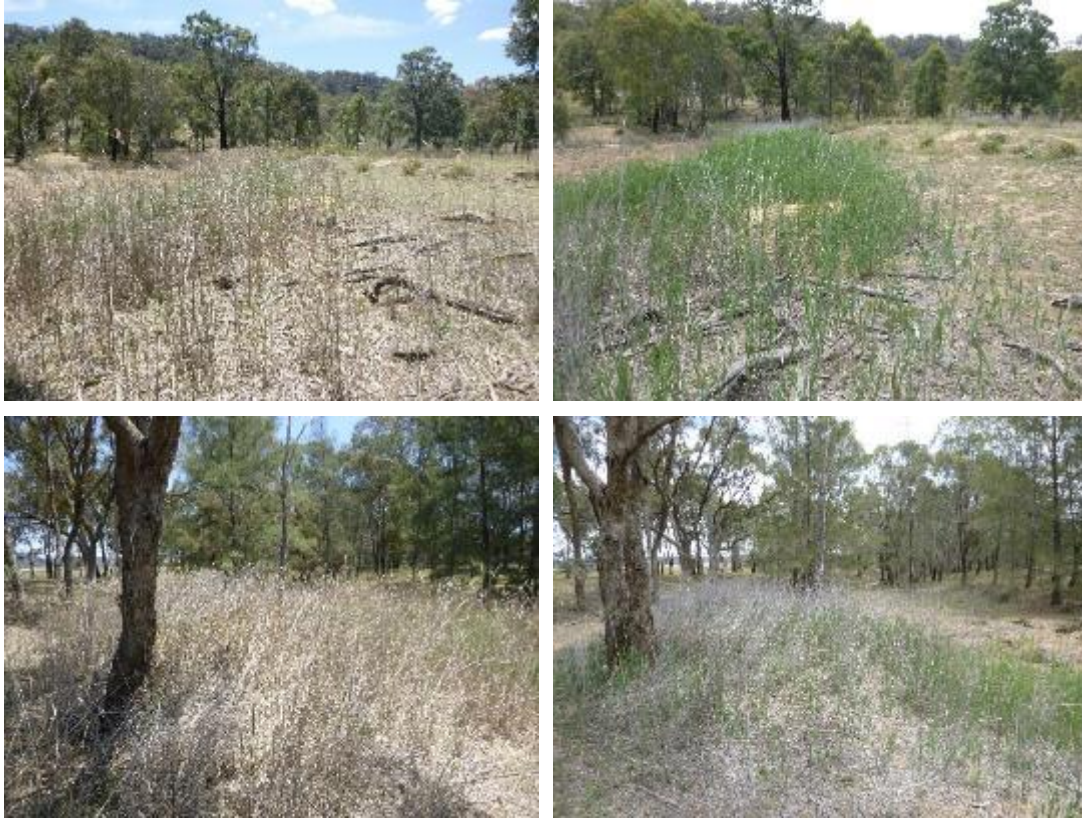
Figure B- 11: WcK11 site photos clockwise from top left: 2017 upstream, 2018 upstream. 2018 downstream, 2017 downstream

Site	Upstream	Downstream
WCK11	<ul style="list-style-type: none"> - Increased Wombat activity on bench of right bank compared to 2017 - Generally good vegetation cover in channel bed - Good litter cover in channel bed 	<ul style="list-style-type: none"> - Reasonably well-vegetated - Wombat burrows on right bank bench
WCK12	<ul style="list-style-type: none"> - Good vegetation cover on banks - Some minor <i>Casuarina cunninghamiana</i> (River Sheoak) regrowth on left bank - Wombat holes on left-hand bank - Blackberry noted along left-hand bank 	<ul style="list-style-type: none"> - Good vegetation cover on right bank, moderate vegetation cover on left bank - LWD, litter and wombat burrows on right-hand bank bench
WCK13	<ul style="list-style-type: none"> - Wombat burrows noted on left bank - Some bare exposed areas on left bank in steep sections - Blackberry present 	<ul style="list-style-type: none"> - Some undercutting on left bank downstream of reach - Left bank steep and bare - Sand and gravel in channel bed - Pig digging evident on left bank

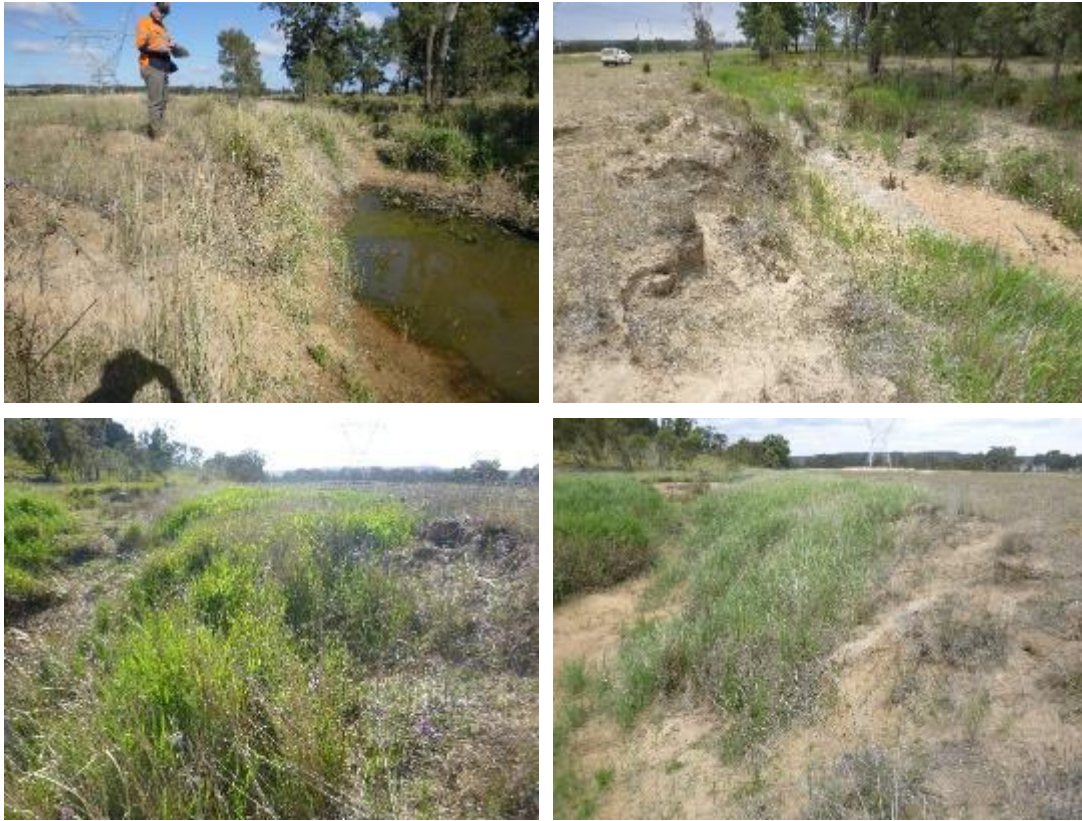
Figure B- 17: WcK17 site photos clockwise from top left: 2017 upstream, 2018 upstream. 2018 downstream, 2017 downstream

Site	Upstream	Downstream
WCK17	<ul style="list-style-type: none"> - Well vegetated banks and channel bed with <i>Phragmites australis</i> - Sand/gravel accumulations in channel with some iron staining - Animal tracks present - Wombat burrows in both banks 	<ul style="list-style-type: none"> - Thick covering of <i>Phragmites australis</i> in channel bed and on bank - Animal tracks crossing the creek - Sand/gravel substrate in channel
WCK18	<ul style="list-style-type: none"> - Wombat burrows in both banks - Reasonably good vegetation cover of grasses/ruches in channel and on banks - Animal tracks across channel beds 	<ul style="list-style-type: none"> - Wombat burrows in both banks - Current erosion on right - Good vegetation cover inn channel bed, with thick <i>Phragmites australis</i> - Sand and gravel substrate in channel
WCK19	<ul style="list-style-type: none"> - Good vegetation cover of grasses/rushes in channel bed and banks - Some animal tracks on left bank - Wombat holes on right bank 	<ul style="list-style-type: none"> - Good vegetation cover in channel and on right-hand bank - Some mass wasting on top of left-hand bank

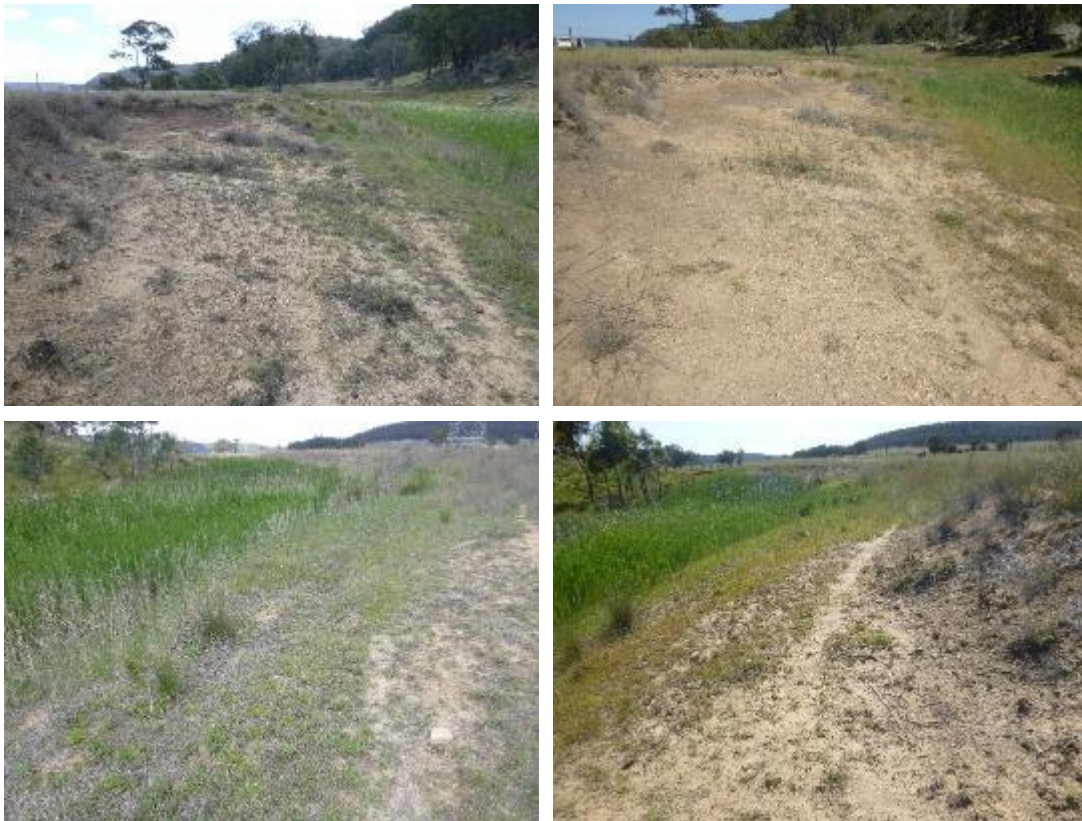
Figure B- 34: WcK34 site photos clockwise from top left: 2017 upstream, 2018 upstream. 2018 downstream, 2017 downstream

Site	Upstream	Downstream
WCK34	<ul style="list-style-type: none"> - In channel vegetation cover remains high - Right bank stable but some wombat burrows - Active erosion on face of left bank and right bank 	<ul style="list-style-type: none"> - Right-hand bank actively eroding and several bare animal tracks - Good vegetation cover on left bank - Blackberry at top of right bank
WCK35	<ul style="list-style-type: none"> - Instream vegetation cover remains high - Lower section of left bank remains stable and well vegetated, however some block failure is evident on top of left bank - Right bank active erosion and bare soil predominant 	<ul style="list-style-type: none"> - Right-hand bank has improved in vegetation cover - Regeneration downslope of reach on left bank
WCK36	<ul style="list-style-type: none"> - Right bank largely consistent, signs of grazing remain evident - Some bare dirt from stock tracks and erosion - Left bank remains steeply sloped and concave - Top of left bank still steep, showing signs of erosion - Good grass cover in channel and lower banks 	<ul style="list-style-type: none"> - Slumping still occurring on right bank - Some undercutting and exposed bare soil at downstream end of left bank - Good grass cover in channel and lower banks

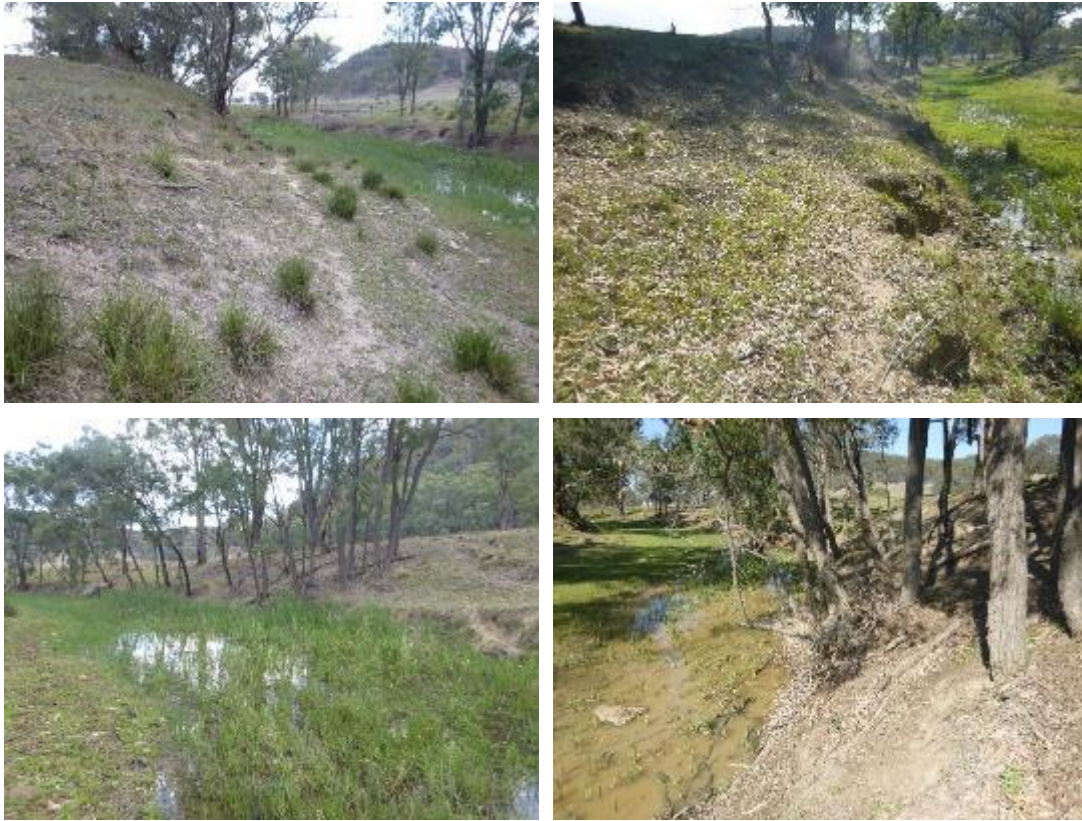
Figure B- 37: WcK37 site photos clockwise from top left: 2017 upstream, 2018 upstream. 2018 downstream, 2017 downstream

WCK37	<ul style="list-style-type: none"> - Left bank remains well vegetated (grazed) with some lateral erosion - Some Wombat burrows in left bank - Right bank bare, with very little vegetation cover - Stock tracks causing bare areas and erosion on right bank 	<ul style="list-style-type: none"> - Wombat burrows on left-hand bank - Right bank groundcover appears to have deteriorated with increased bare soil compared to 2017 - Stock tracks evident on right-hand bank - Moderate vegetation cover on left bank, with some lateral erosion
WCK38	<ul style="list-style-type: none"> - Instream vegetation remains similar, continues to be grazed by cattle - Wombat burrows on left bank - Stock tracks causing localised erosion on both banks - Right bank has reasonable vegetation cover though grazed - Left bank active erosion, is steep and bare 	<ul style="list-style-type: none"> - Stock access causing localised erosion - Good vegetation cover in channel and on banks, however it is being actively grazed

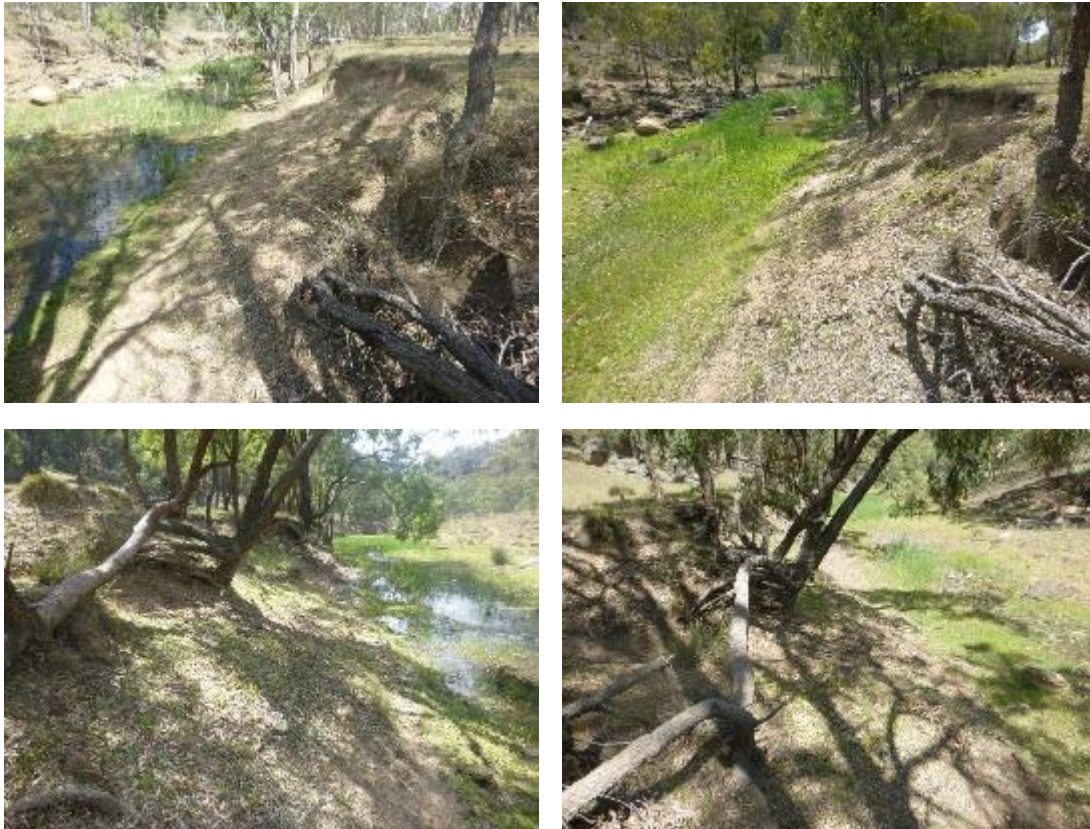
Figure B- 47: WcK47 site photos clockwise from top left: 2017 upstream, 2018 upstream. 2018 downstream, 2017 downstream

WCK47	<ul style="list-style-type: none"> - Instream vegetation cover remains good, though some impact of grazing noted below fence - Steep erosion around fence on right bank - Right bank bare where animal tracks are 	<ul style="list-style-type: none"> - Stock causing localised erosion on banks - Good vegetation cover in channel - Good level of debris and litter in stream and on lower banks
WCK48	<ul style="list-style-type: none"> - Good vegetation cover in channel - Some steep erosion points and bare soil on left bank - Right bank stabilised by rock cover - Good leaf litter and native and exotic grasses and herbs vegetation cover on right bank 	<ul style="list-style-type: none"> - Stock and macropod access on left bank instigating lateral erosion - Abundant exposed <i>Angophora floribunda</i> roots on left bank - Good debris in channel
WCK49	<ul style="list-style-type: none"> - Good cover of grasses on channel and on right bank - Left bank showing signs of stock tracks and localised erosion - Vegetation has been heavily grazed 	<ul style="list-style-type: none"> - Vegetation cover good in channel and right-hand bank - Left bank steep but presently stable - Localised erosion caused by stock access - Wombat burrows on right bank

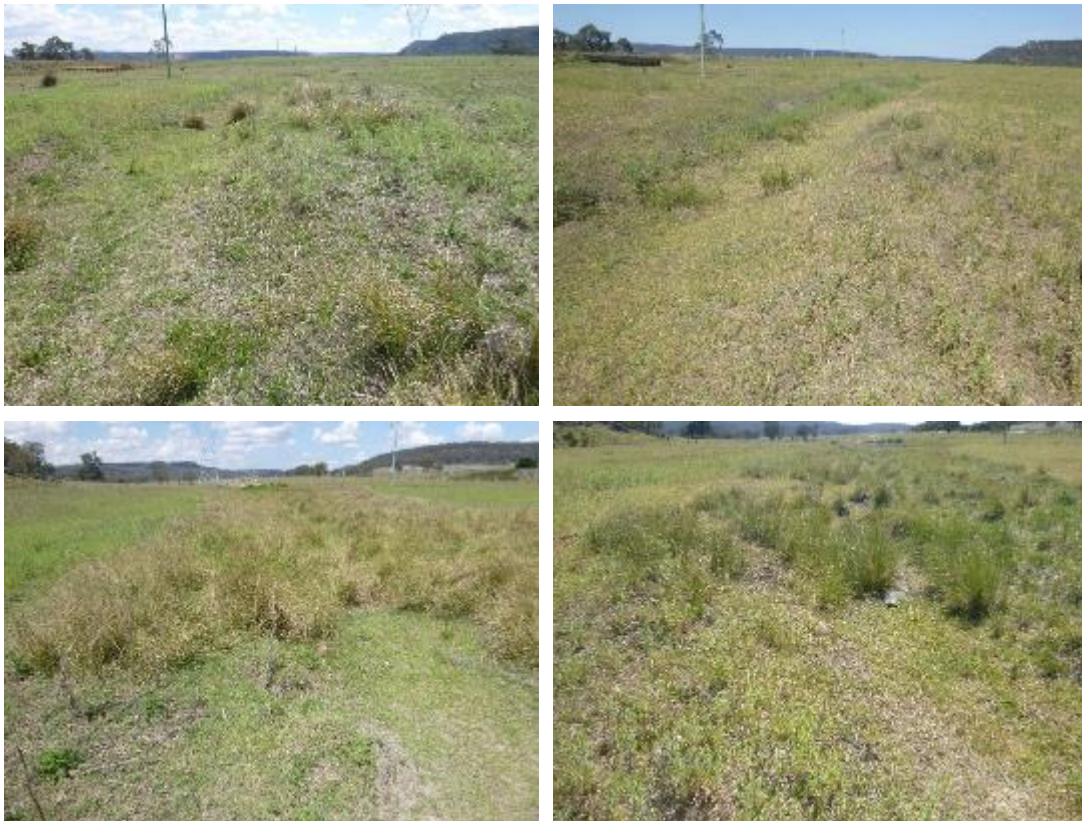
Figure B- 56: CCK8 site photos clockwise from top left: 2017 upstream, 2018 upstream. 2018 downstream, 2017 downstream

Site	Upstream	Downstream
CCK8	<ul style="list-style-type: none"> - Good vegetation cover in channel and on both banks - Very limited riparian zone apart from groundcover 	<ul style="list-style-type: none"> - Site remains stable with good vegetation cover
CCK9	<ul style="list-style-type: none"> - Some minor lateral erosion on top right bank - Site remains well vegetated - Saffron Thistle prevalent on both banks 	<ul style="list-style-type: none"> - Some minor lateral erosion, exposing soil on both banks - Animal track across creek
CCK10	<ul style="list-style-type: none"> - Site remains well vegetated in channel and on both banks - Very limited riparian zone apart from groundcover 	<ul style="list-style-type: none"> - Site remains stable with good vegetation cover - Lateral erosion on left bank - Strong exotic cover
