METROPOLITAN COAL LONGWALLS 311-316

HERITAGE MANAGEMENT PLAN

N	Metropolitan Coal – Heritage Management Pl	an
Revision No. HMP-R01-C		Page 1
Document ID: Heritage Management Plan

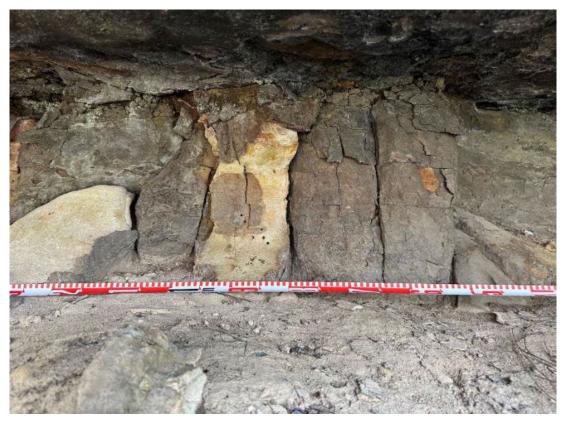
Plate 3: Example of vertical cracking in back wall (example of entire back wall) – Woronora Reservoir Northern Trail 3.

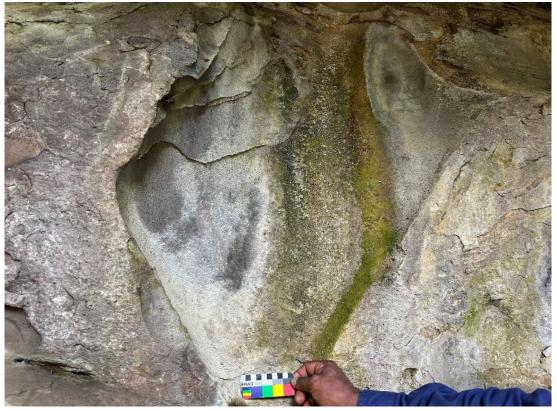
Plate 40: Art Panel #2, motif #7, showing water wash damage, no distinct lines – Woronora Reservoir Northern Trail 5.

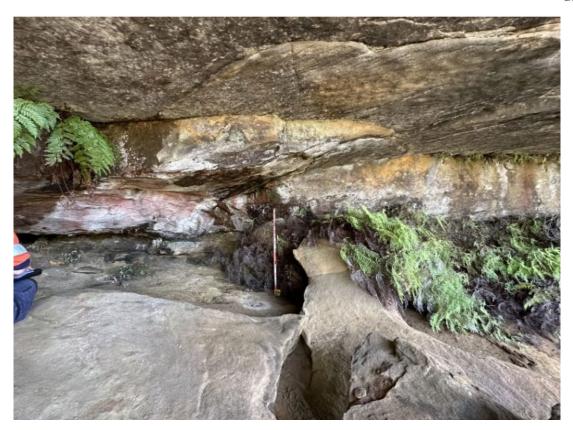
Plate 114: Seepage (#4) and back wall crack at 15 m - 16 m - Woronora Reservoir Northern Trail 9

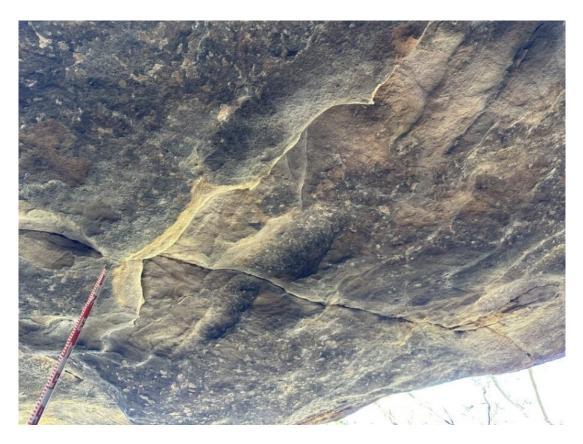
Plate 115: Roof crack (monitoring point #5) – Woronora Reservoir Northern Trail 9

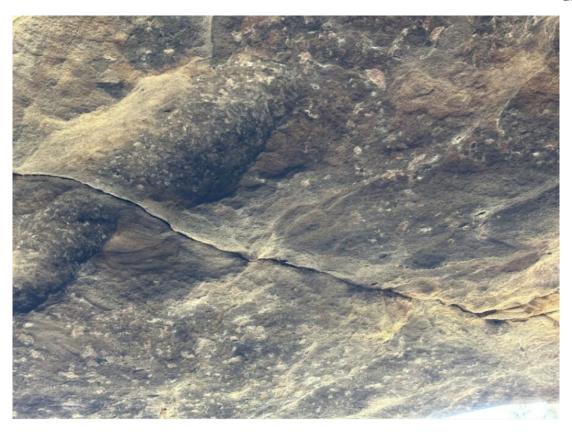
Plate 116: Roof crack (monitoring point #5) – Woronora Reservoir Northern Trail 9

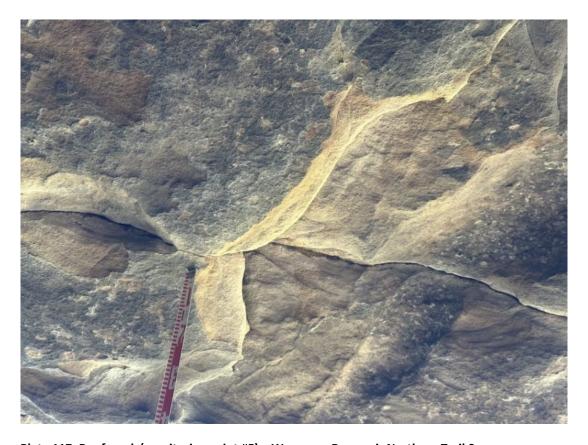
Plate 117: Roof crack (monitoring point #5) – Woronora Reservoir Northern Trail 9

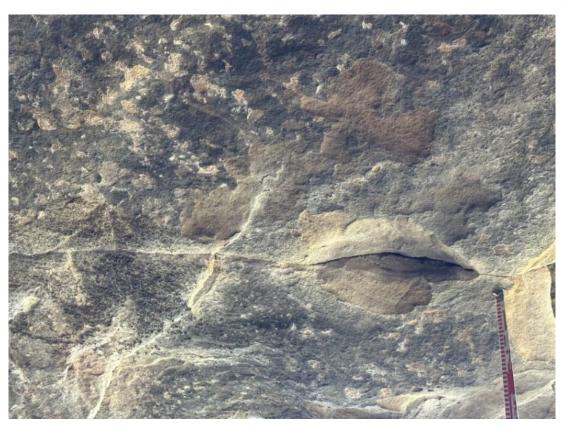
Plate 118: Roof crack (monitoring point #5) – Woronora Reservoir Northern Trail 9

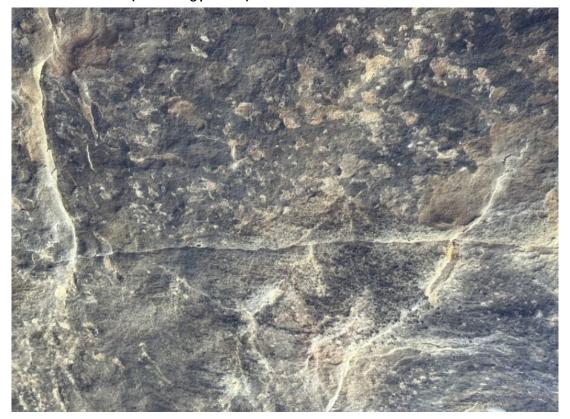
Plate 119: Roof crack (monitoring point #5) – Woronora Reservoir Northern Trail 9

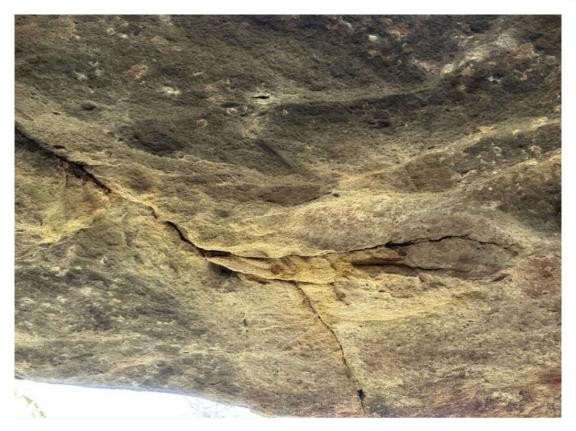
Plate 120: Roof crack (monitoring point #5) – Woronora Reservoir Northern Trail 9

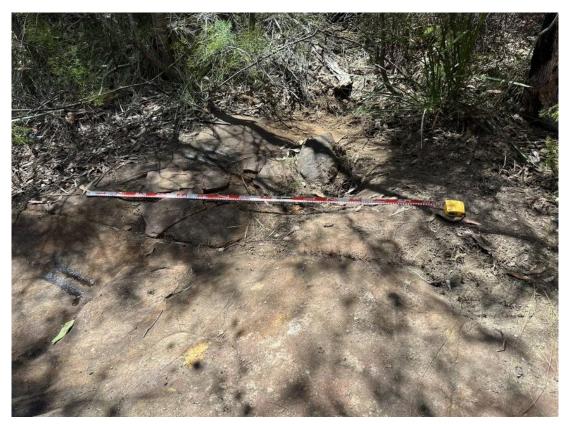
Plate 145: Example evidence of damaged grooves (rock popping).

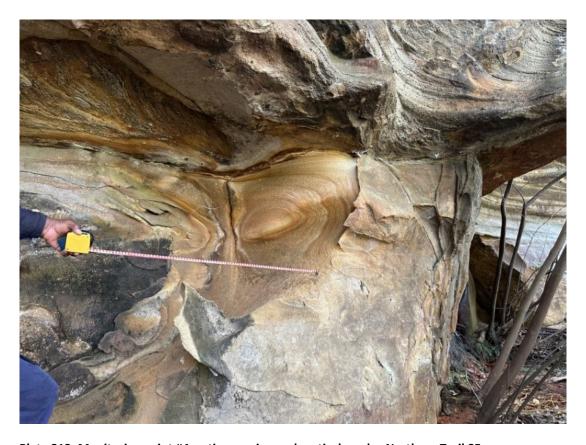
Plate 312: Monitoring point #4, active erosion and vertical crack – Northern Trail 85.

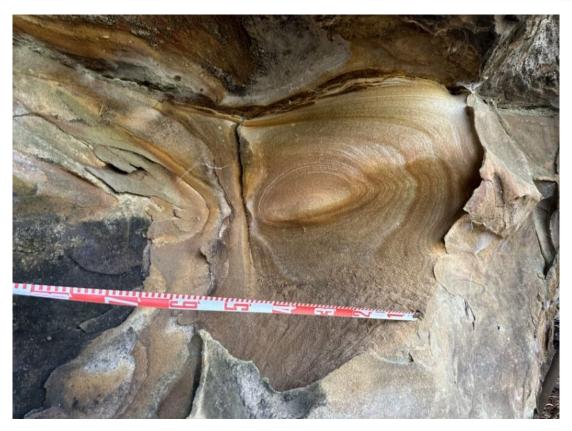
Plate 313: Monitoring point #4, active erosion and vertical crack – Northern Trail 85.

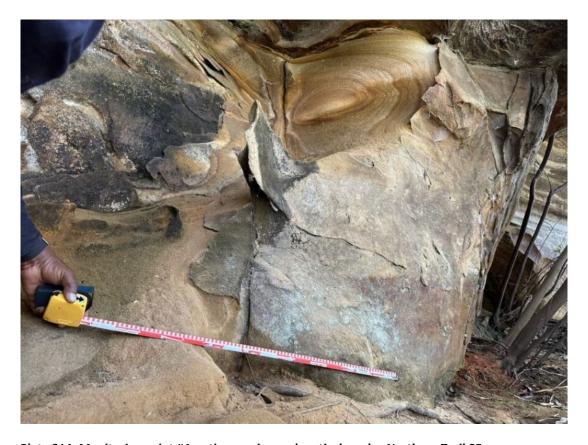
Plate 314: Monitoring point #4, active erosion and vertical crack – Northern Trail 85.

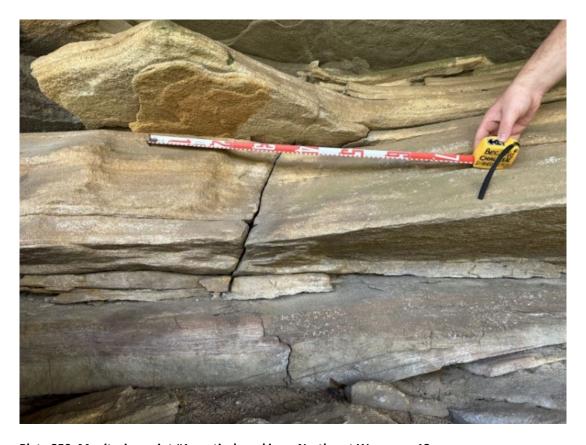
Plate 350: Monitoring point #1, vertical cracking – Northeast Woronora 12.

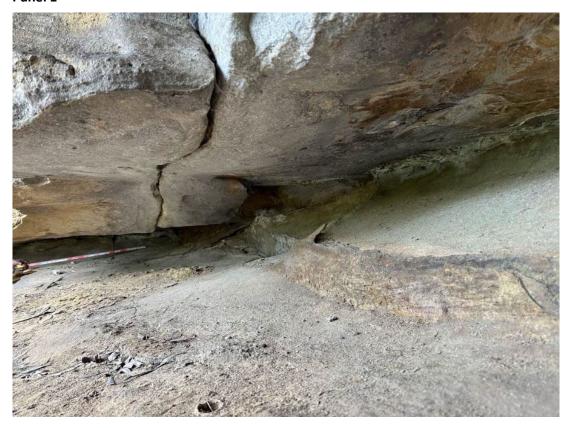
Plate 374: Monitoring Point #1 Vertical Crack – Northeast Woronora 19.

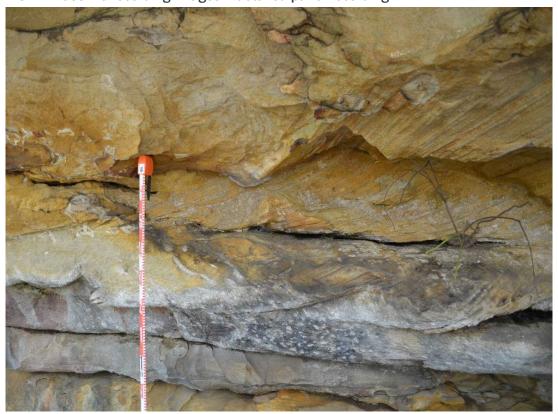
Plate 390: Northeast Woronora 21 monitoring point #1 - crack running along shelf with vegetation.

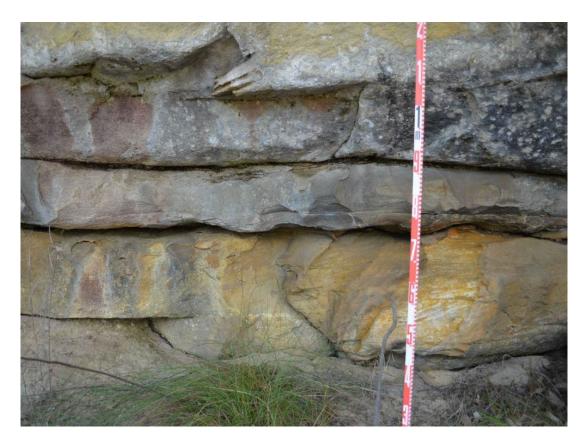
Plate 391: Northeast Woronora 21 monitoring point #2 - vertical fissure under shelf adjoining point #1.

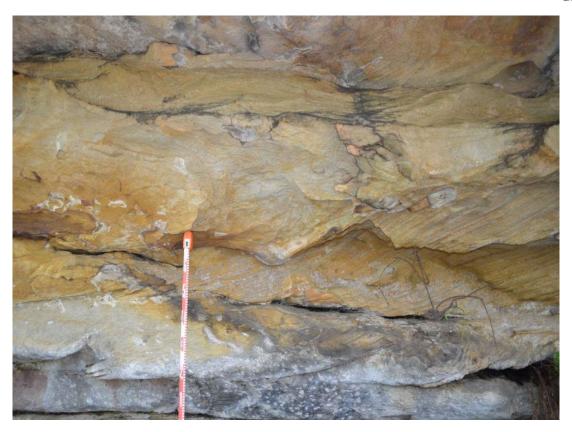
Plate 392: Northeast Woronora 21 monitoring point #3 - water wash and vertical fissuring above art panel.

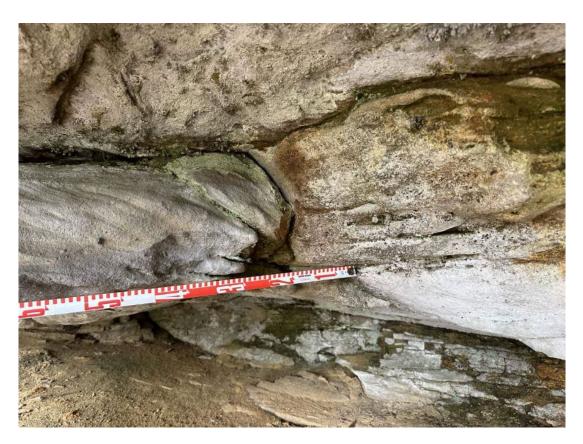
Plate 404: Vertical crack, monitoring point #1 – Northeast Woronora 23.

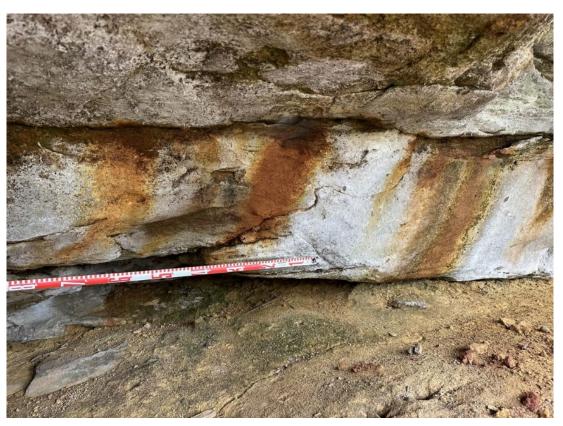
Plate 405: Vertical crack at art panel, monitoring #2 – Northeast Woronora 23.

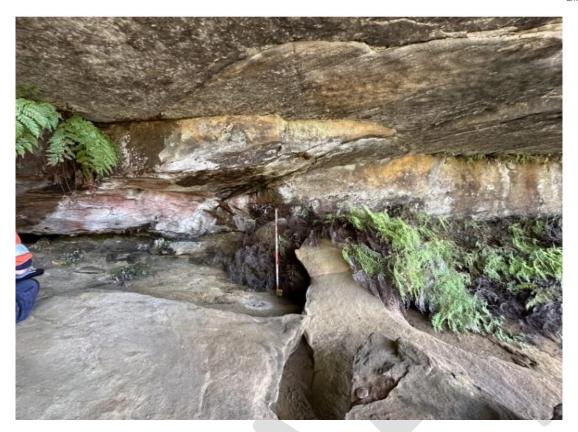
Plate 114: Seepage (#4) and back wall crack at 15 m - 16 m - Woronora Reservoir Northern Trail 9

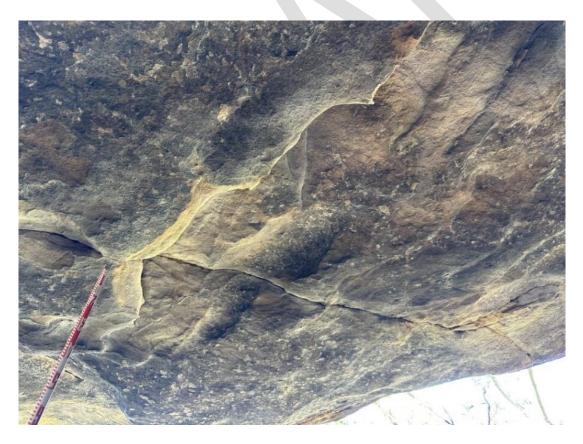
Plate 115: Roof crack (monitoring point #5) – Woronora Reservoir Northern Trail 9

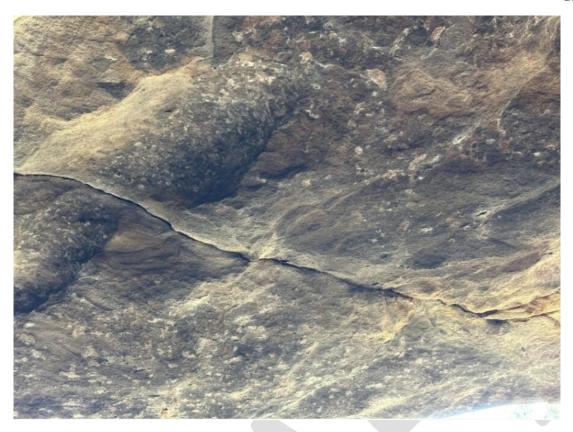
Plate 116: Roof crack (monitoring point #5) – Woronora Reservoir Northern Trail 9

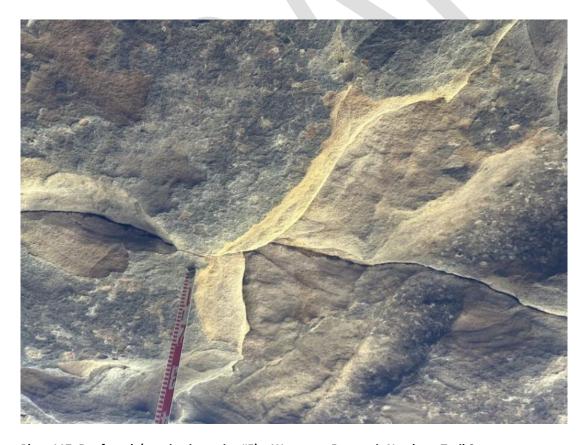
Plate 117: Roof crack (monitoring point #5) – Woronora Reservoir Northern Trail 9

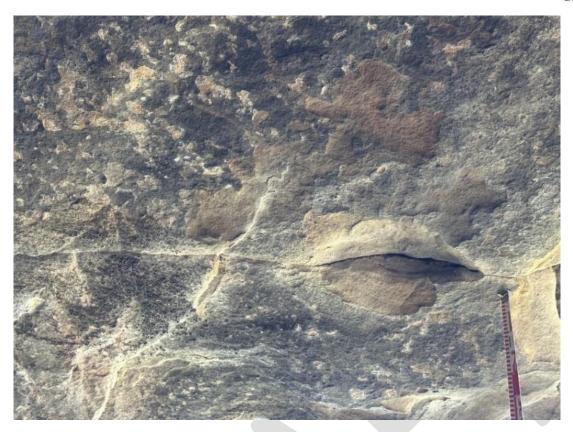
Plate 118: Roof crack (monitoring point #5) – Woronora Reservoir Northern Trail 9

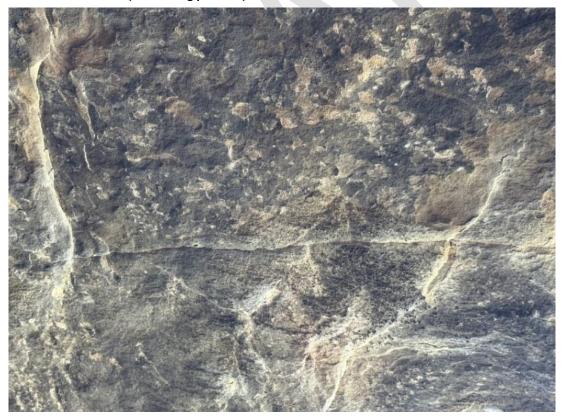
Plate 119: Roof crack (monitoring point #5) – Woronora Reservoir Northern Trail 9

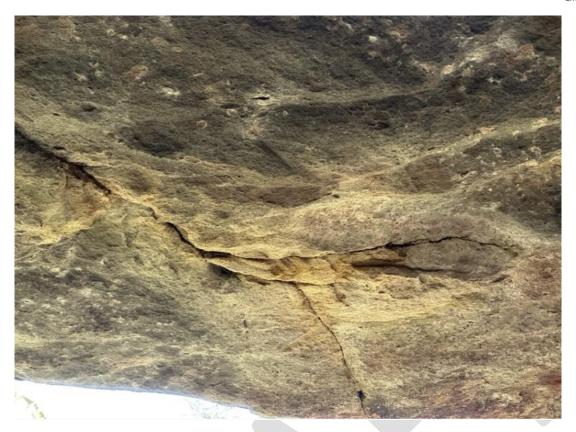
Plate 120: Roof crack (monitoring point #5) – Woronora Reservoir Northern Trail 9
