**WILPINJONG COAL PTY LTD**

**Environment Protection Licence (EPL) 12425**

**LICENCE MONITORING DATA  
MONTHLY SUMMARY REPORT**

**1 October 2022 to 31 October 2022**

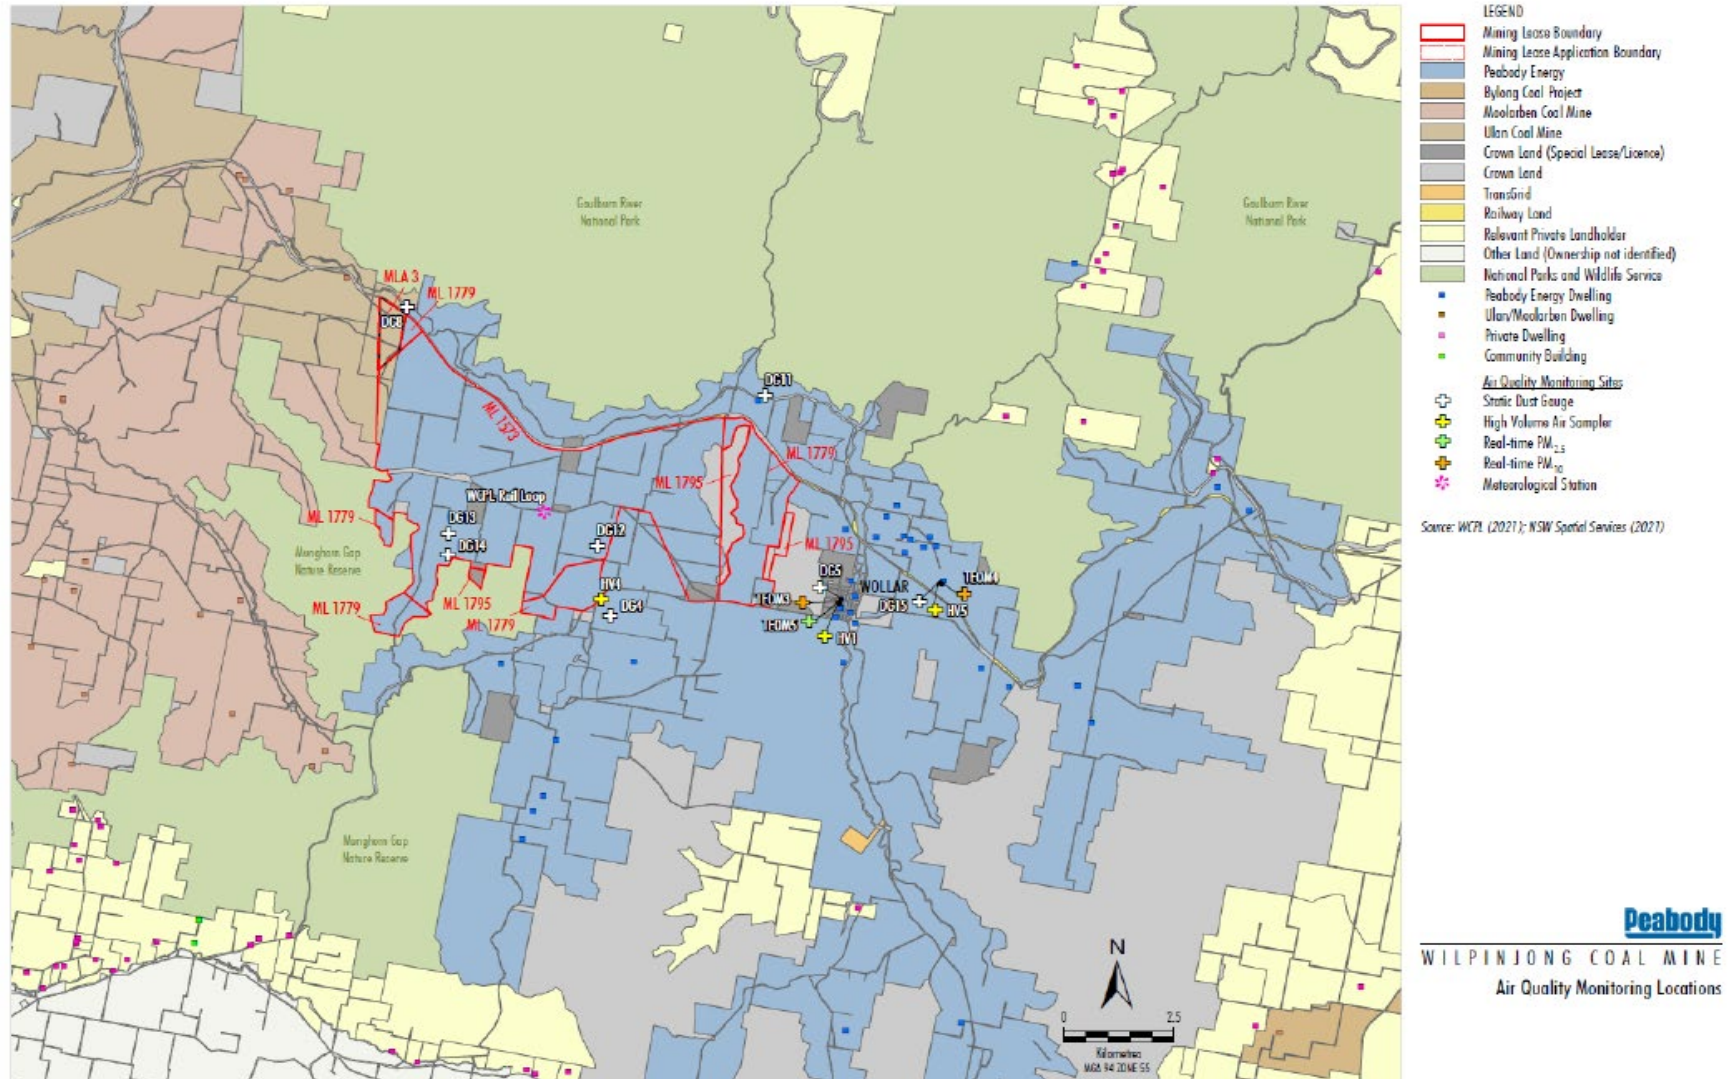
Figure 6 – Air (Dust) Monitoring Locations

The location of the above monitoring equipment in relation to Wilpinjong Coal Mine is shown in **Figures 6** and **8**.

Continuous weather monitoring occurs onsite at the location shown on Figures 5 and 6 (**Meteorological Station**). The Meteorological Station continuously monitors for: rainfall; relative humidity; temperature (i.e. at 2m, 10m & 60m), barometric pressure, wind speed, wind direction and temperature lapse rate.
