# METROPOLITAN COAL

## 2018 ANNUAL REVIEW

Project No. MET-19-16  
Document No. 00964839

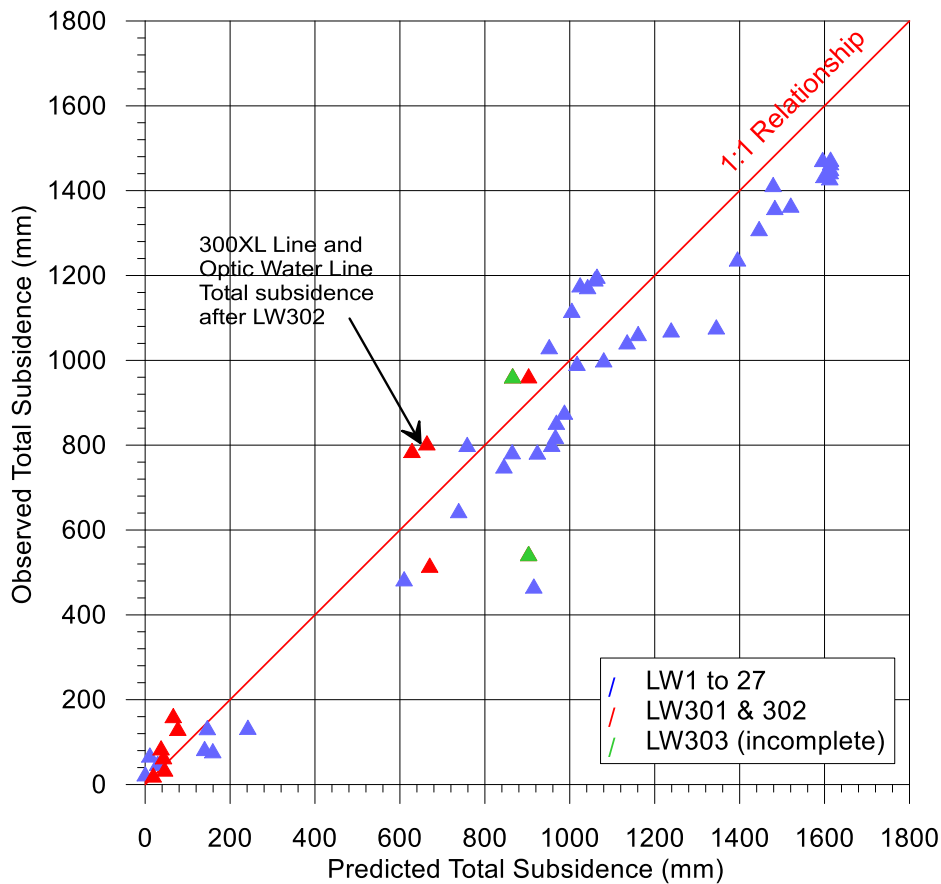
**Chart 1 Comparison Between the Maximum Observed and Maximum Predicted Total Conventional Subsidence for Longwalls 3 to 27, Longwalls 301 to 302 and Partial Extraction of Longwall 303 at Metropolitan Colliery**

A comparison of the maximum observed and maximum predicted total conventional subsidence for the Project after each longwall for Longwalls 3 to 27 and Longwalls 301 to 302 and partial extraction of Longwall 303 is shown in Chart 1. The comparison of conventional subsidence effects excludes the valley cross lines which represent non-conventional subsidence movements.

An analysis of the maximum observed versus maximum predicted vertical subsidence was undertaken by MSEC (Appendix A). Based on the results of survey data to date and comparison with predicted conventional subsidence parameters, the profiles of vertical displacement adequately reflect the predictions. The overall subsidence effects of the project do not exceed predictions by more than 15% (Appendix A).

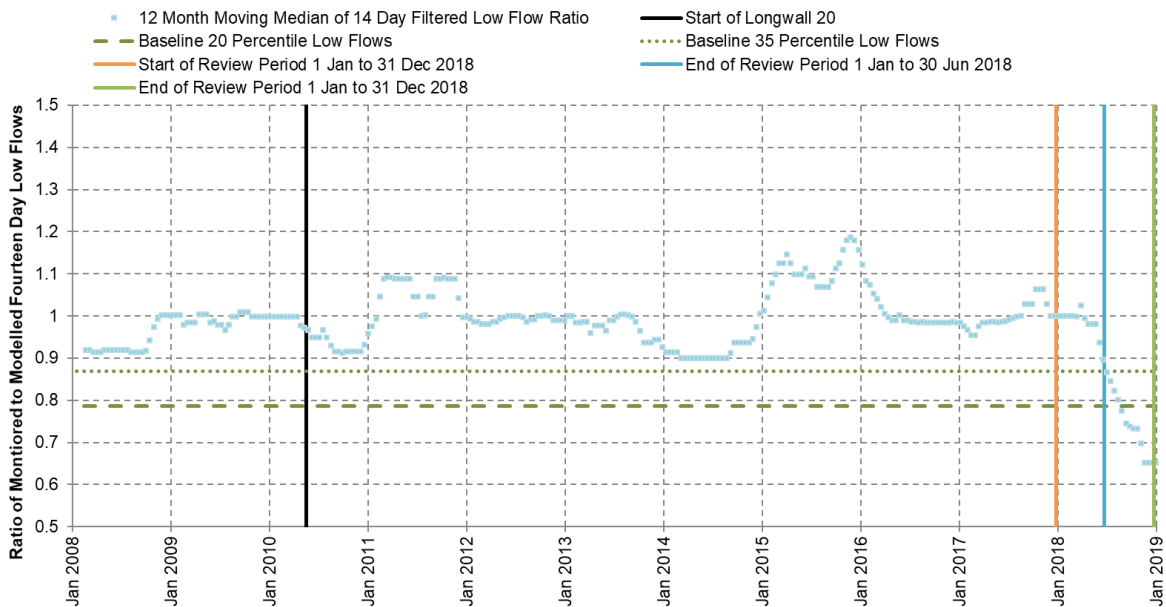
**Chart 2 One Year Sliding Median for the Ratios of the 14 Day Sums of Monitored and Modelled Flow Rates at Waratah Rivulet (GS 2132102)**

The quantity of water entering the Woronora Reservoir is not considered to be significantly different post-mining compared to pre-mining if the median of the ratios (of 14 day sums of monitored flow) for the ‘sliding’ 12 month period does not fall below the 20<sup>th</sup> percentile of the baseline data. The 12 month sliding median is shown on Chart 2.

For the Project EA a comprehensive analysis of stream flow data and data on the yield behaviour of Woronora Reservoir indicated that past mining at Metropolitan Coal had no discernible effect on the inflow to, or yield from, the reservoir. Surface water flow monitoring indicates there has been a negligible reduction in the quantity of water resources reaching the Woronora Reservoir during the review period.

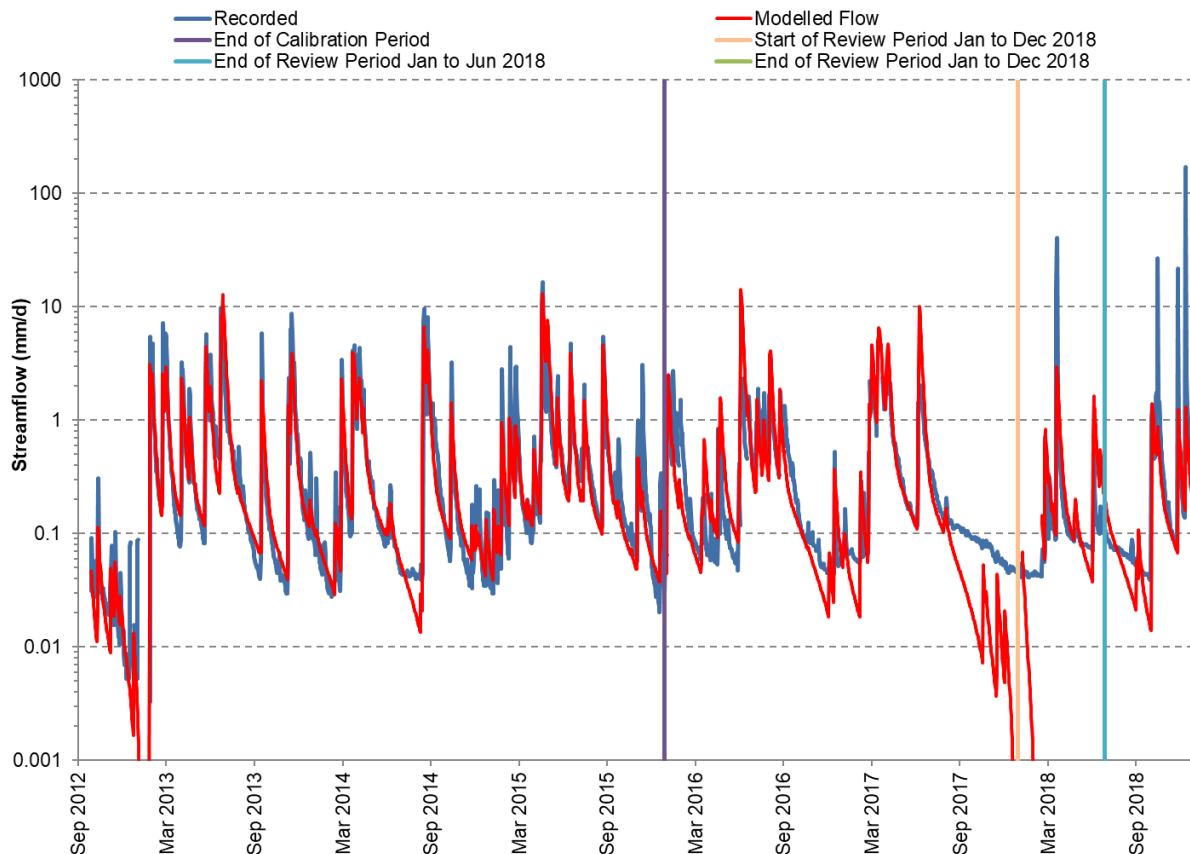
**Chart 3 Monitored and Model Predicted Flows – Eastern Tributary Upstream of Woronora Reservoir**

Chart 3 shows the flow monitoring data that is available since gauging station construction on the Eastern Tributary (GS 300078; Figure 7) in September 2012 compared to model predictions. The results for the reporting period indicate that flow has been continuous at the gauging station and that it has been generally consistent with, or above, model predictions (Chart 3). This indicates that flows reaching the Woronora Reservoir have not been reduced by mining (Appendices B1 and B2).

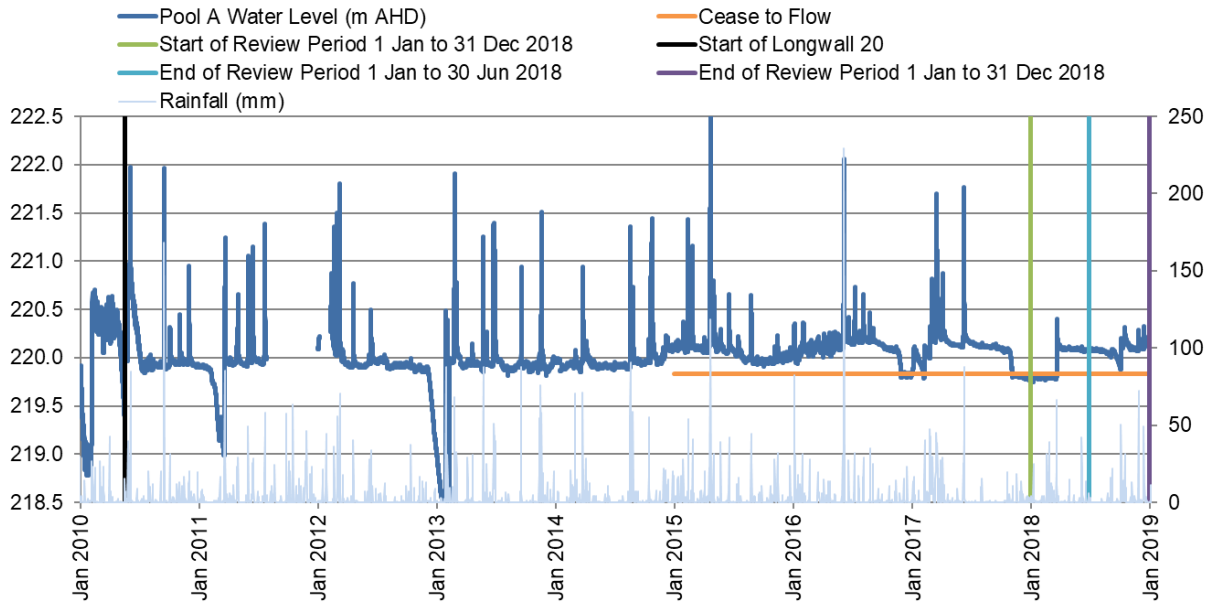
**Chart 4 Pool A Waratah Rivulet**

The water level in a number of pools on the Waratah Rivulet, Eastern Tributary, Tributary B and Woronora River (Figure 7) has been either manually monitored on a daily basis<sup>2</sup> or monitored using a continuous water level sensor and logger.

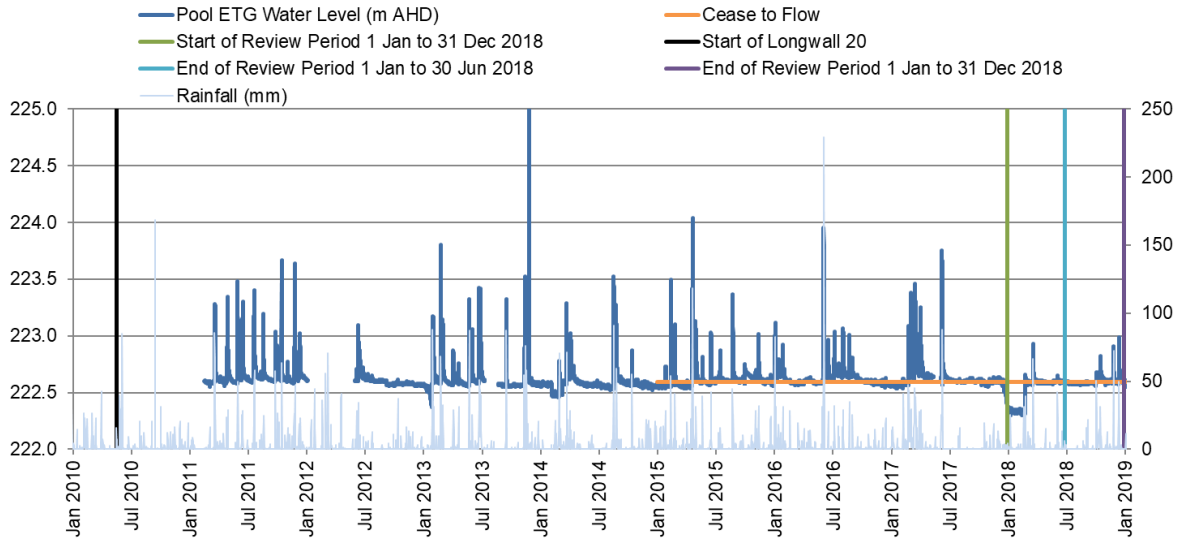
**Chart 19 Pool ETG**

On the Eastern Tributary, water levels in Pools ETG, ETJ, ETM, ETU, ETW, ETAF, ETAG, ETAH, ETAI, ETAQ, ETAS/ETAT<sup>5</sup> and ETAU are monitored using a continuous water level sensor and logger (Figure 7).

As described in Section 6.2.1, the Eastern Tributary pool water level monitoring results for the review period were consistent with the potential subsidence impacts and environmental consequences described in the Project EA, Preferred Project Report and Metropolitan Coal Water Management Plan in that data that is available to MSEC for the Southern Coalfield (including the Waratah Rivulet and Eastern Tributary results) indicates that less than 10% of all pools have experienced the diversion of flow at predicted closure values of less than 200 mm, consistent with previous assessments of potential pool impacts. On their own, the impacts for the Eastern Tributary are outside of the predictions of the empirical based model.

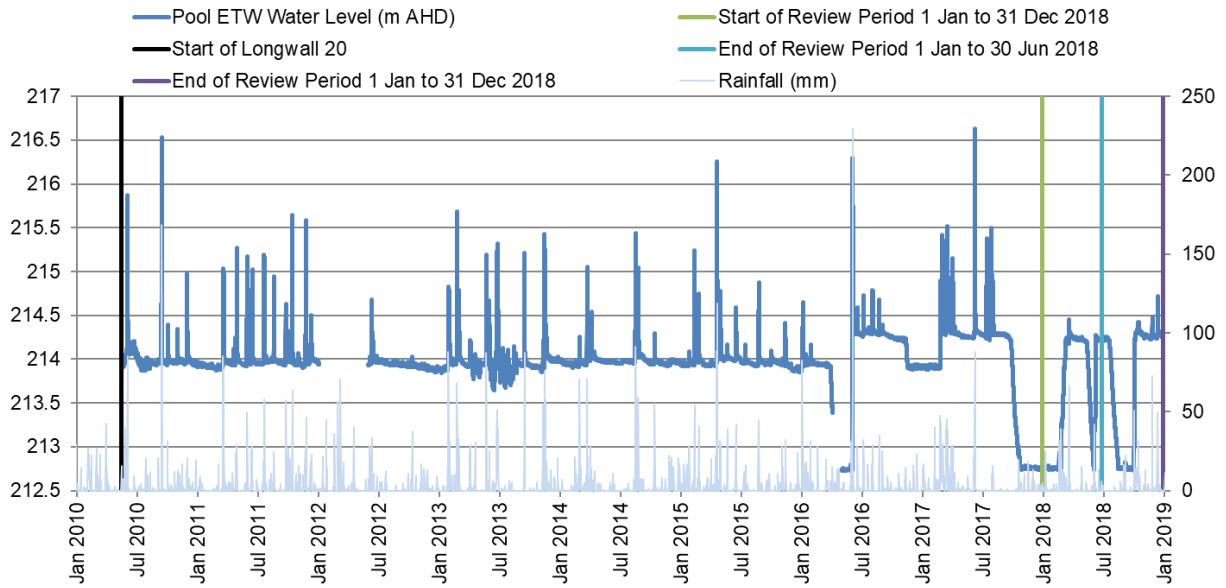
**Chart 23 Pool ETW<sup>6,7</sup>**

<sup>6</sup> Note discrepancies in water levels caused by pool being dry and water level sensor being exposed at time of download.

<sup>7</sup> After heavy rainfalls in early June 2016, the diver stand at Pool ETW became clogged with sediment and the diver was unable to reach the bottom. On 14 July 2016, a new diver was installed at Pool ETW to replace the previous diver. In September 2017, the old diver was cleared of sediment and was able to be used again. The original diver extends deeper into the pool, allowing additional information to be obtained during periods when the pool water level is below the cease to flow level. Data shown after September 2017 is from the original diver.

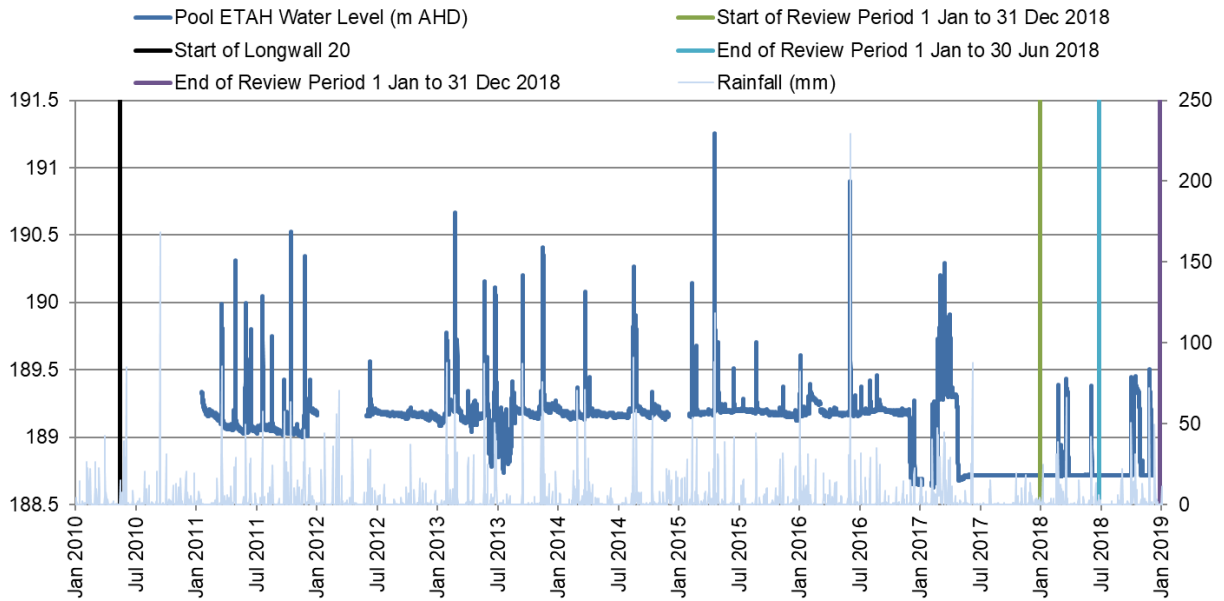
**Chart 26 Pool ETAH<sup>8</sup>**

<sup>8</sup> Water level was below measurable levels for ETAH from the 10/12/18 to the 31/12/18.

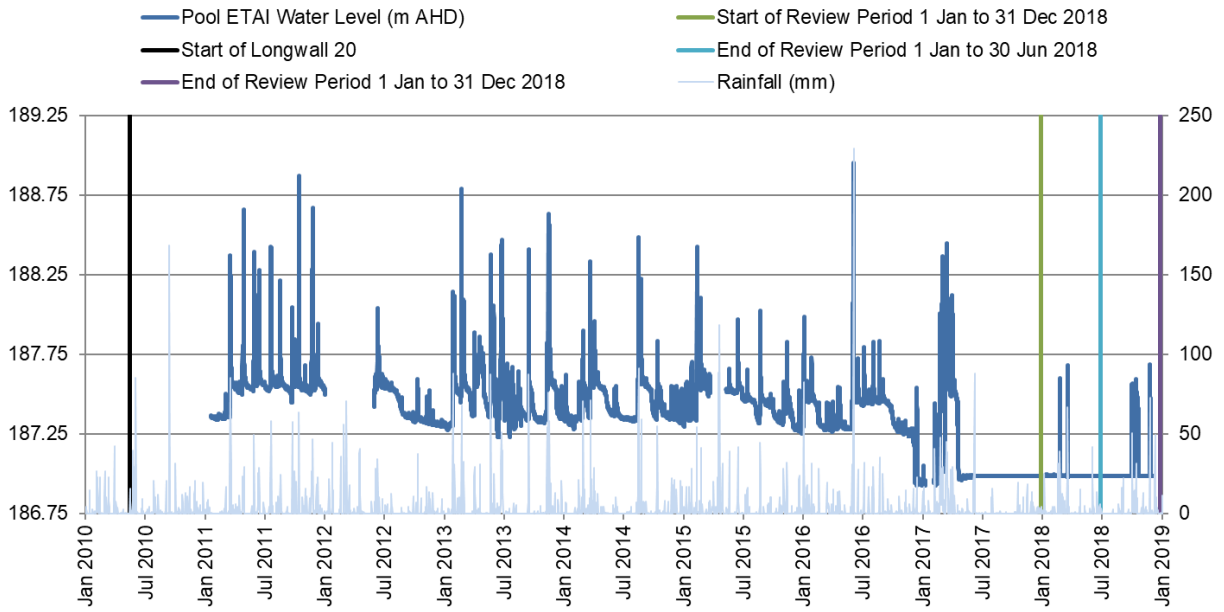
**Chart 27 Pool ETAI<sup>9</sup>**

<sup>9</sup> Water level was below measurable levels for ETAI from the 10/12/18 to the 31/12/18.

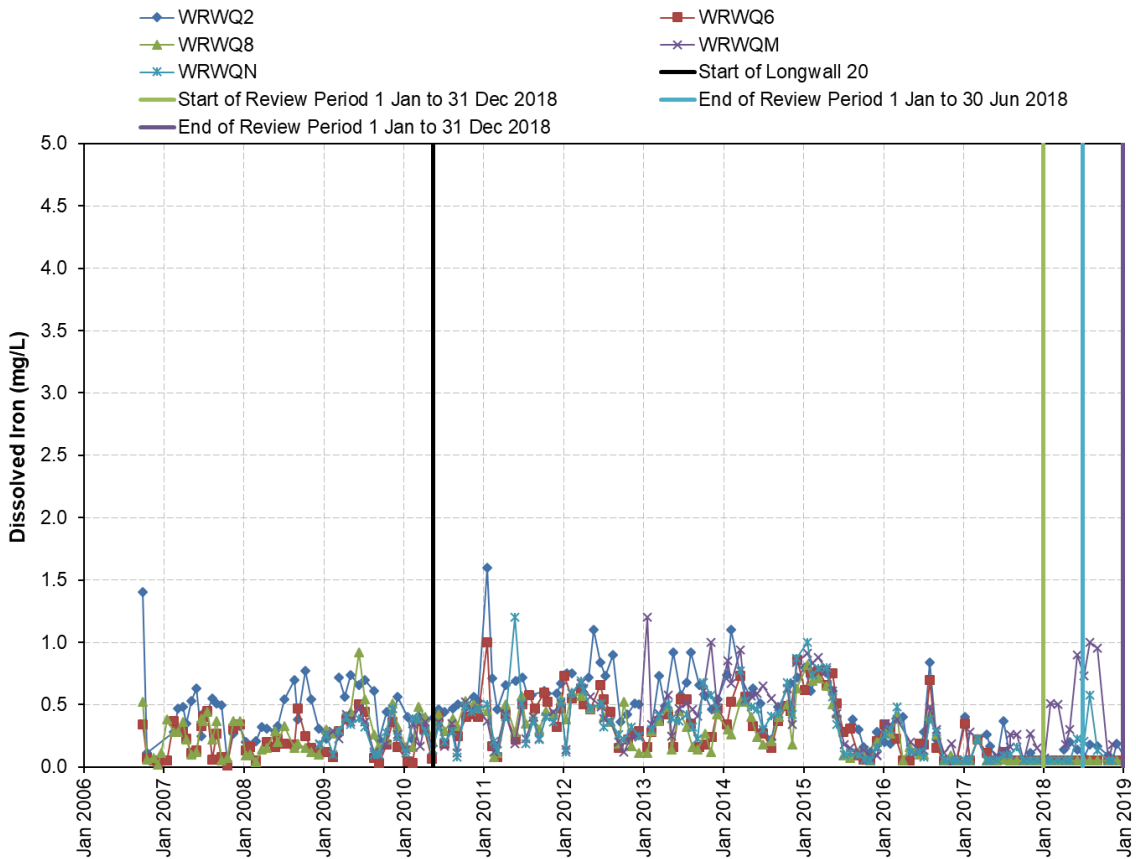
**Chart 33 Dissolved Iron Waratah Rivulet – Upper and Middle Reach Sites**

The cracking and dilation of bedrock and associated diversion of surface flow and leakage of water through rock bars at pools which has occurred on the Eastern Tributary, including at the location of the stream which was the subject of the exceedance of the Eastern Tributary watercourse performance measure (the Eastern Tributary Incident), has resulted in increases in dissolved manganese and iron.

The environmental consequences of subsidence impacts on water quality were predicted by the Project EA, Preferred Project Report and Metropolitan Coal Water Management Plans to be similar to that previously observed at Metropolitan Coal, specifically, transient pulses of iron, manganese and aluminium, which would likely occur following fresh cracking of the stream bed.

Monitoring and analysis of water quality data will continue in accordance with the Longwalls 301-303 Water Management Plan. Metropolitan Coal is committed to the remediation of pools on the Eastern Tributary. It is anticipated that the stream remediation activities will reduce the transfer of iron and manganese from the groundwater to the Eastern Tributary.

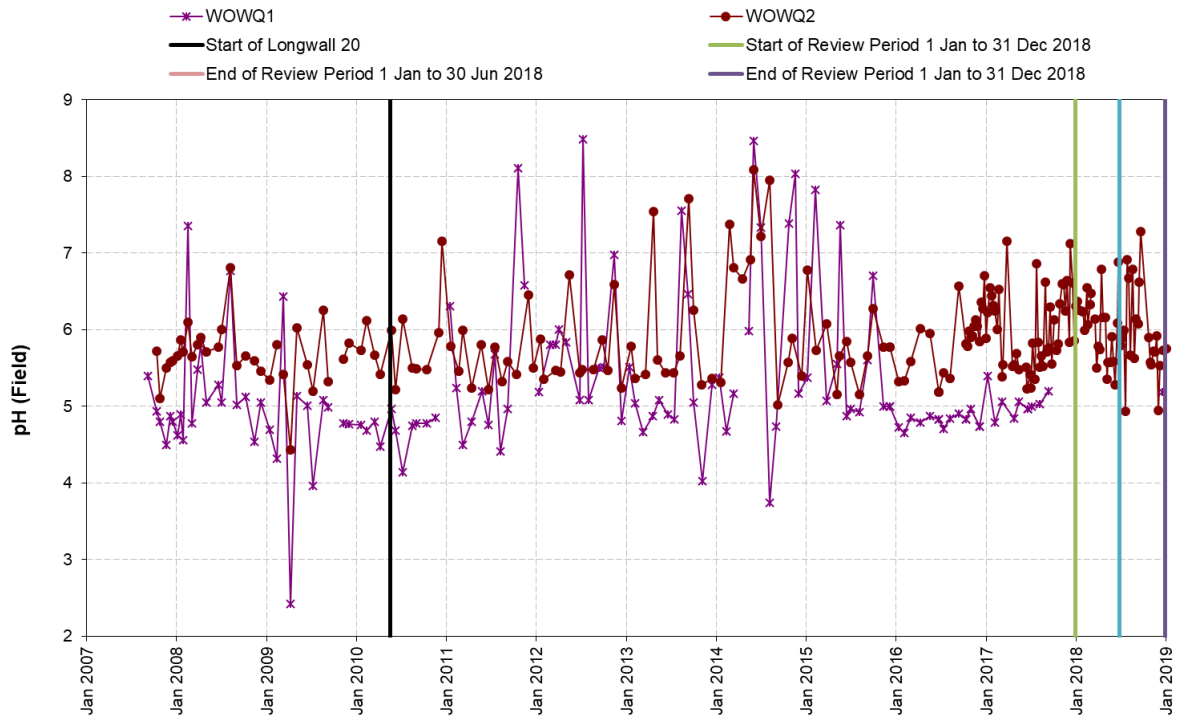
**Chart 39 pH Levels Woronora River<sup>11</sup>**

<sup>11</sup> WOWQ1 was dry between 23/10/17 and 20/12/2018 and hence no water quality samples were collected.

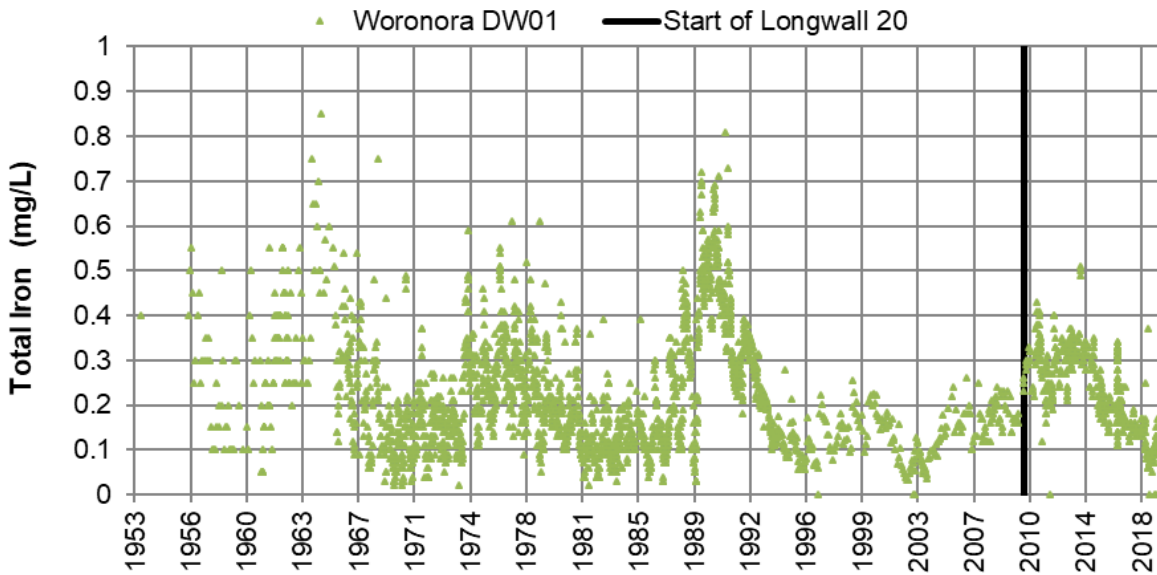
Chart 58 Total Iron Concentration Woronora Reservoir

Metropolitan Coal has sourced water quality data for the Woronora Reservoir from WaterNSW in accordance with a data exchange agreement. Results in relation to total iron, aluminium and manganese at levels from 0 m to 9 m below the reservoir surface for Woronora Reservoir throughout the period of record are presented in Charts 58 to 60.

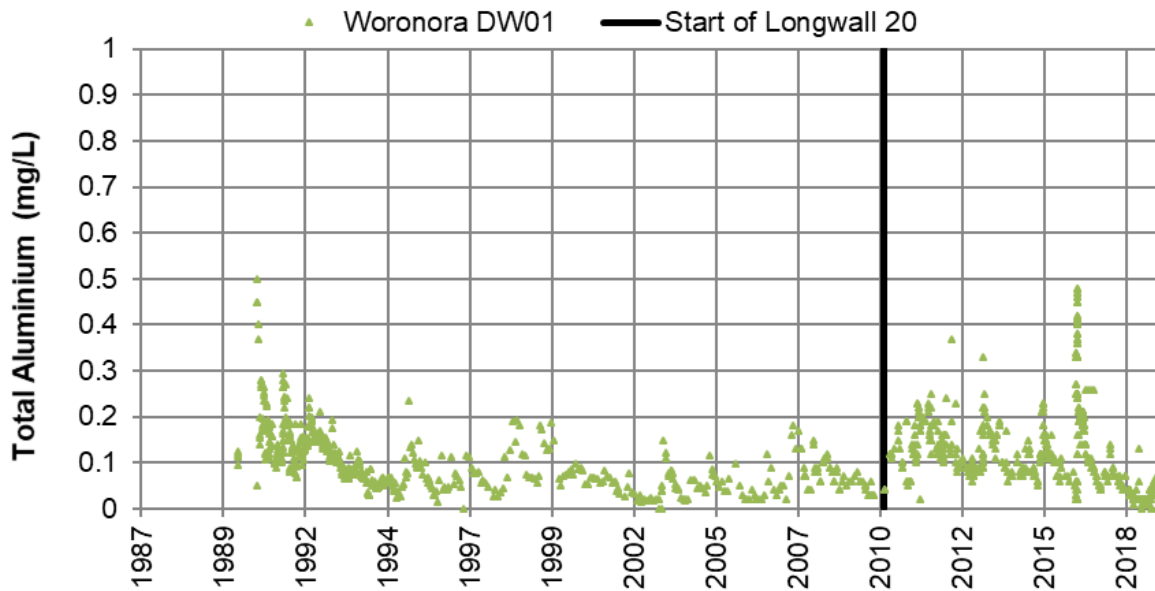
Chart 59 Total Aluminium Concentration Woronora Reservoir

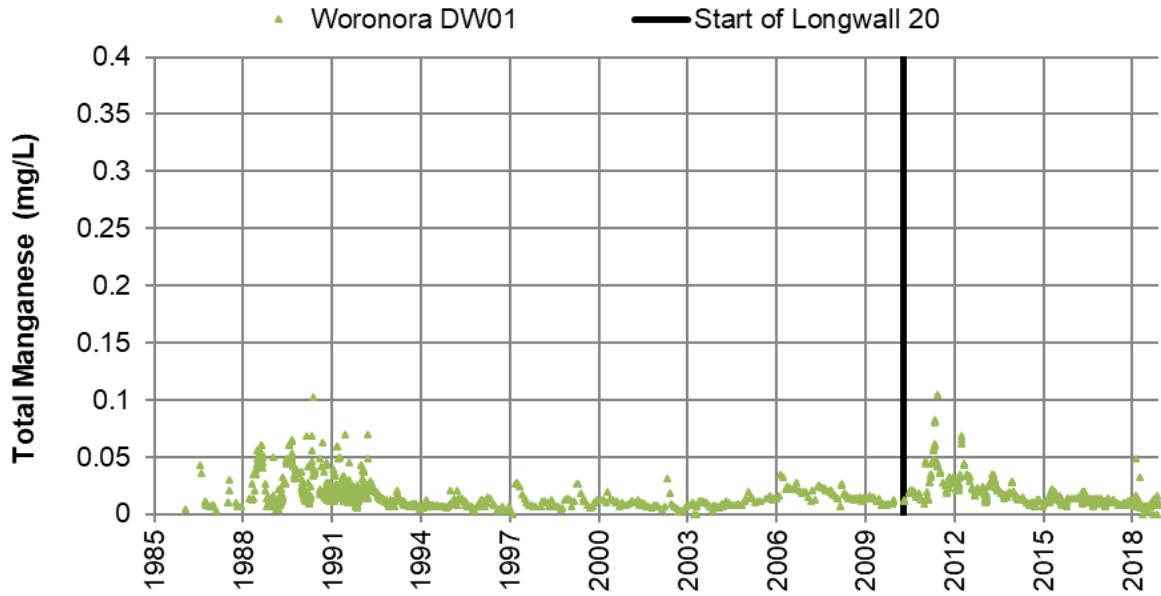
**Chart 60 Total Manganese Concentration Woronora Reservoir**

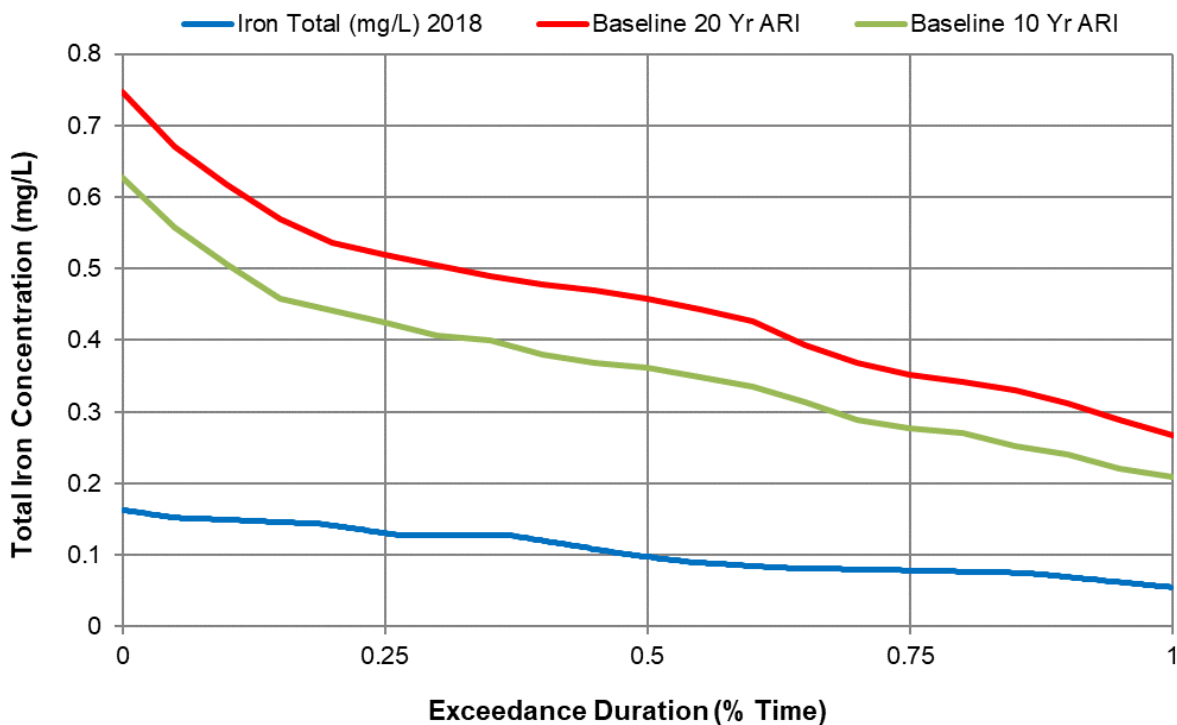
**Chart 61 Total Iron Performance Indicator Woronora Reservoir 2018**

There were no exceedances of the Woronora Reservoir water quality performance indicator (the 20 year ARI exceedance curve) for total iron, total aluminium or total manganese during the review period (Charts 61, 62 and 63, respectively) (Appendix B2). There were also no exceedances of the 10 year ARI exceedance curve for total iron, total aluminium or total manganese (Charts 61, 62 and 63, respectively) (Appendix B2).

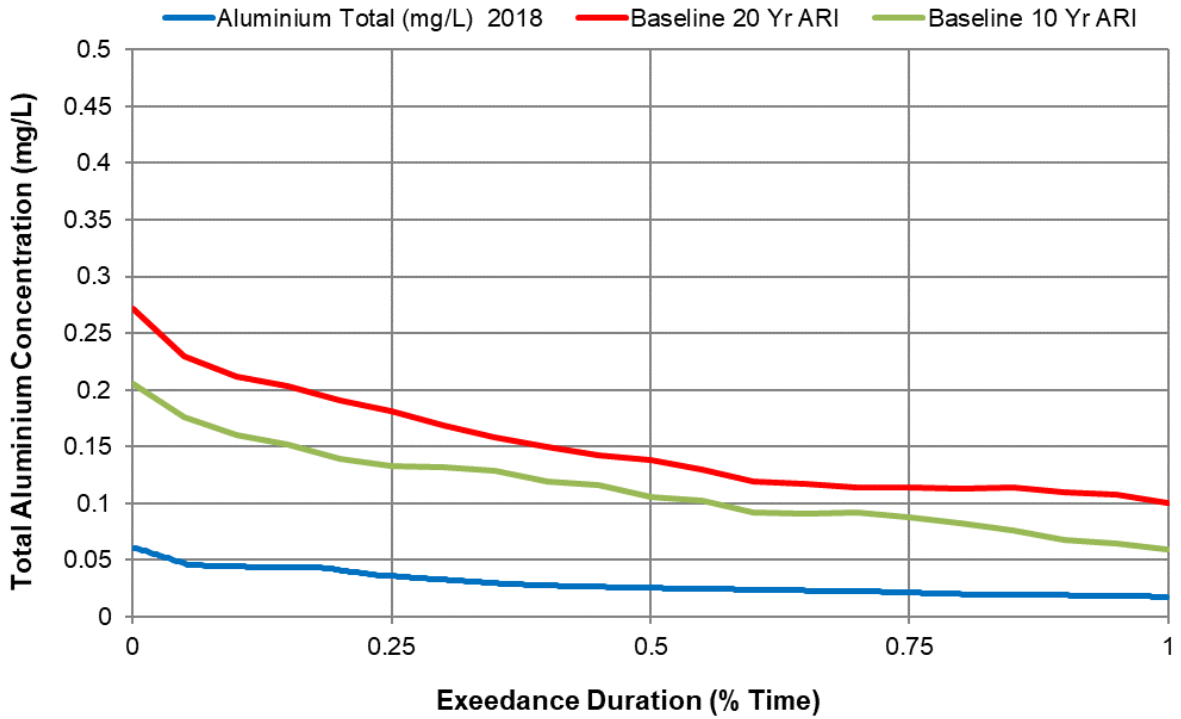
Chart 62 Total Aluminium Performance Indicator Woronora Reservoir 2018

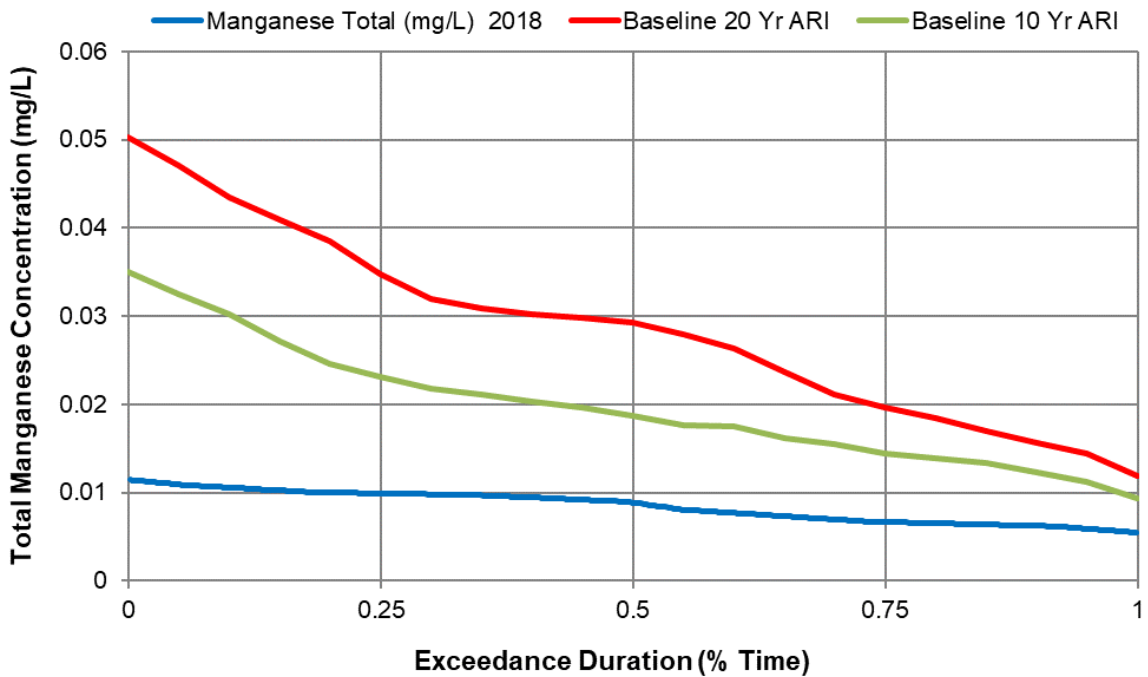
Chart 63 Total Manganese Performance Indicator Woronora Reservoir 2018

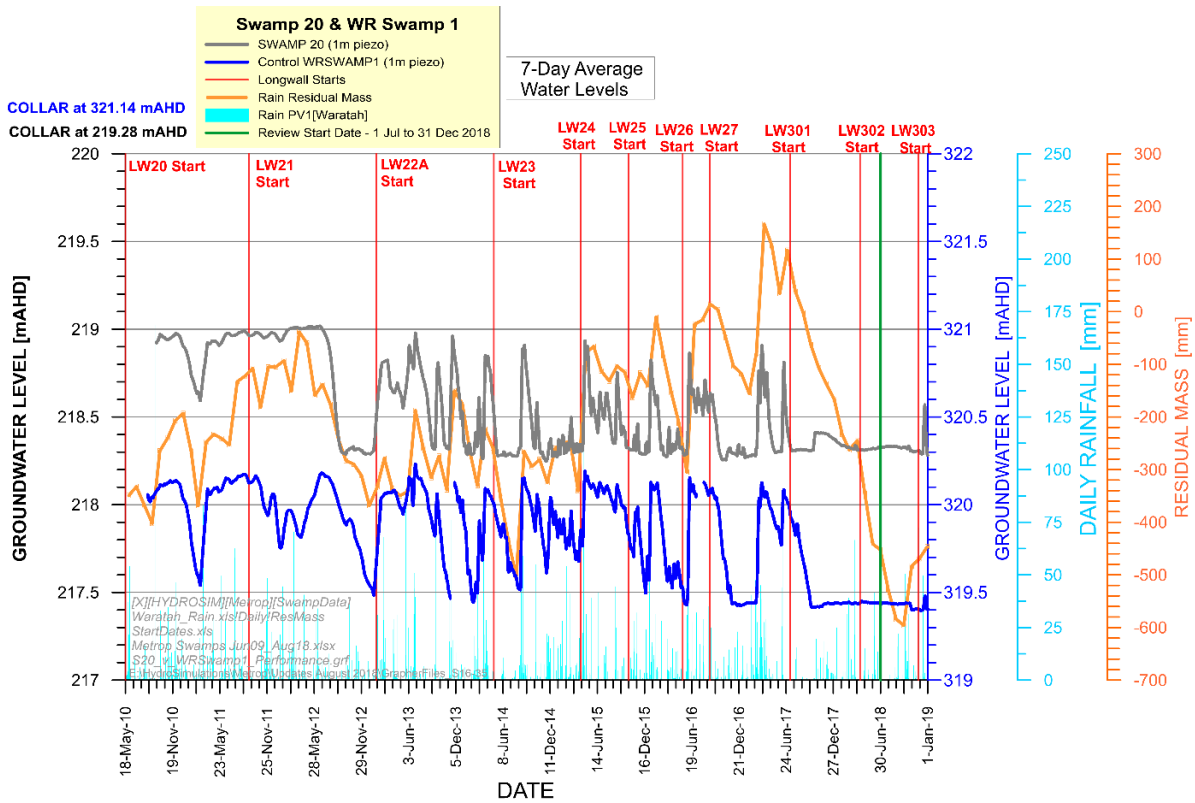
**Chart 64 Comparison of Piezometer Responses at Swamp 20 and Woronora River 1 Control Swamp**

Semi-quantitative comparisons of the swamp substrate water levels of Swamps 25, 30, 33 and 35 with control swamps and rainfall records do not show a definitive mining effect and the dry conditions are regarded as a natural response to reduced rainfall (Appendices C1 and C2).

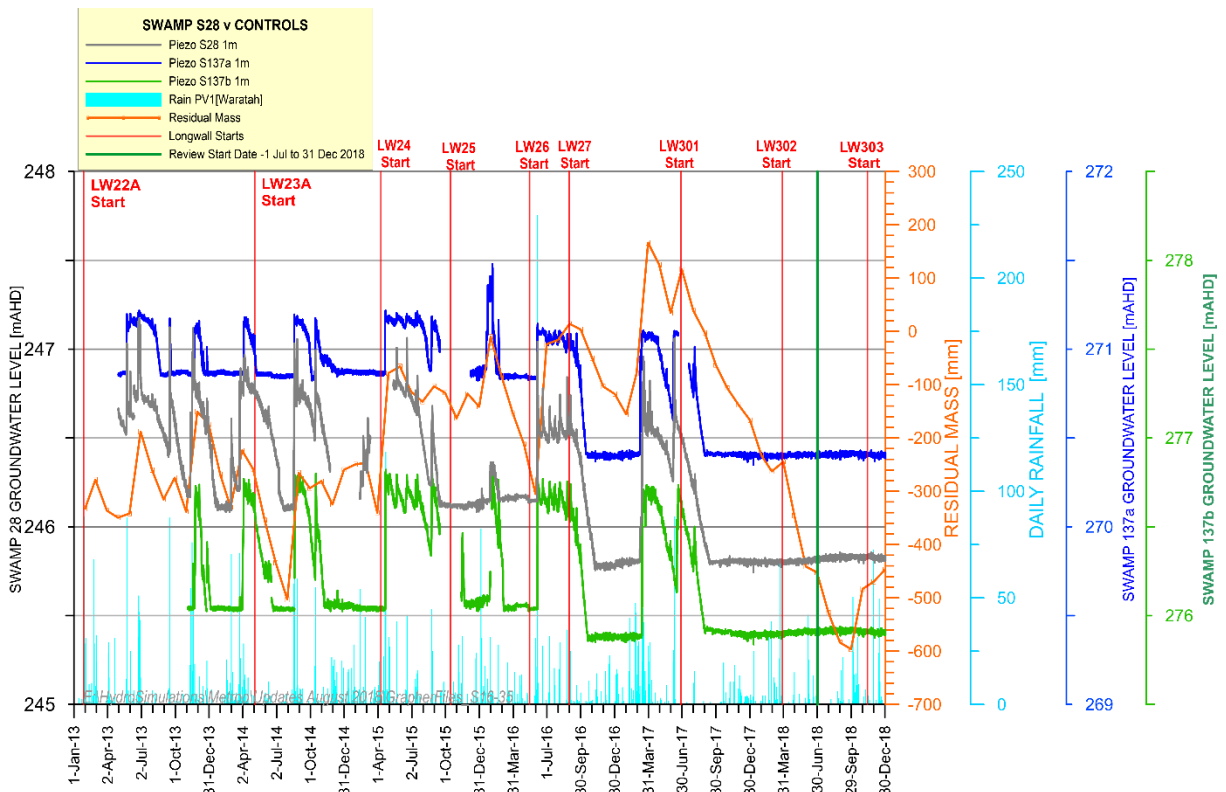
**Chart 65 Groundwater Hydrographs at Swamp 28 and Two Control Swamps (137a and 137b) Swamp Monitoring for Longwalls 301-303**

A mining effect to the substrate water levels of Swamp 28 (overlying Longwall 24) was identified in 2016 based on the incomplete recovery of substrate water levels following rainfall events (Chart 65 and Appendices C1 and C2). Swamp 28 is considered to have an impact from mining of Longwall 25, although no effect on swamp substrate water levels occurred when Longwall 24 passed directly beneath the monitoring site (Appendices C1 and C2). The substrate piezometer at Swamp 28 returned to dry conditions from September 2017, remaining so until the end of this reporting period, as did the two control swamp piezometers (Swamps 137a and 137b; Chart 65).

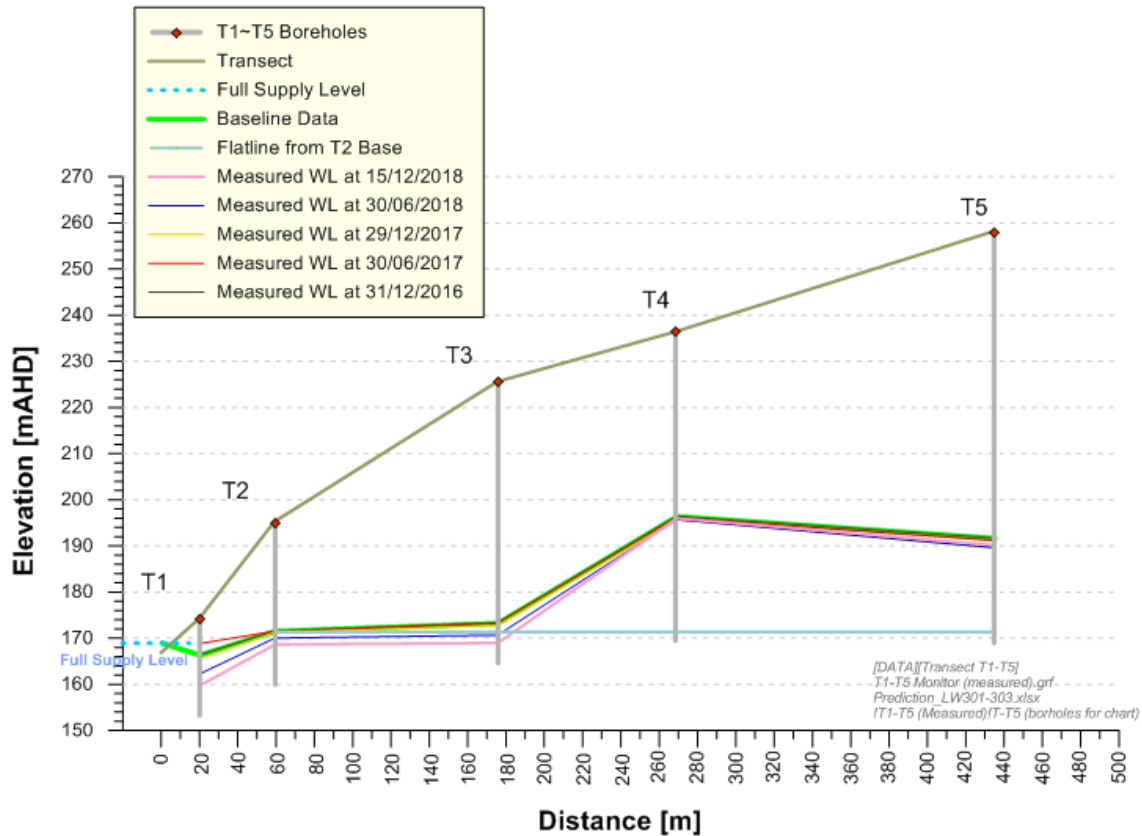
**Chart 69 Measured T1-T5 Boreholes Transect**

The measured water level transect for shallow bores T1-T5 are shown in Chart 69. The water levels measured on 15 December 2018 at T1, T2, T3 and T5 were slightly lower than previously recorded except at T5 (Appendices C1 and C2). The water level at bore T4 remains anomalous and unreliable as its head has always been higher than the head at upgradient site T5. This is considered unlikely to be a groundwater divide as it is not related to the topographic ridge well upgradient (Appendices C1 and C2).

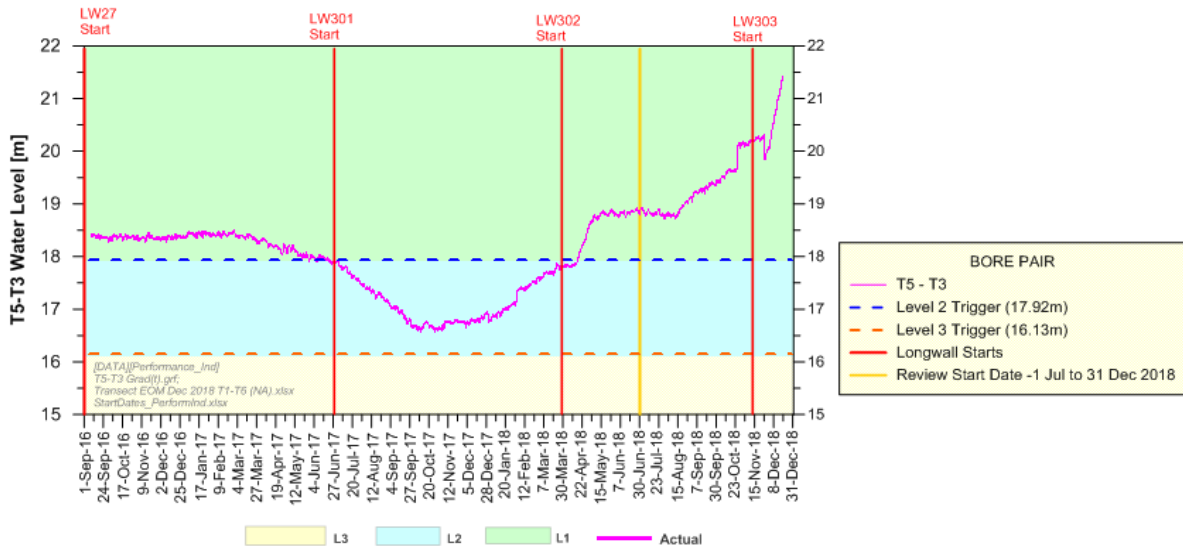
**Chart 70 Hydraulic Gradient Measured from Bore T5 to Bore T3**

The performance indicator for the hydraulic gradient from bore T5 to bore T3 was not exceeded during the reporting period (Chart 70 and Appendices C1 and C2).

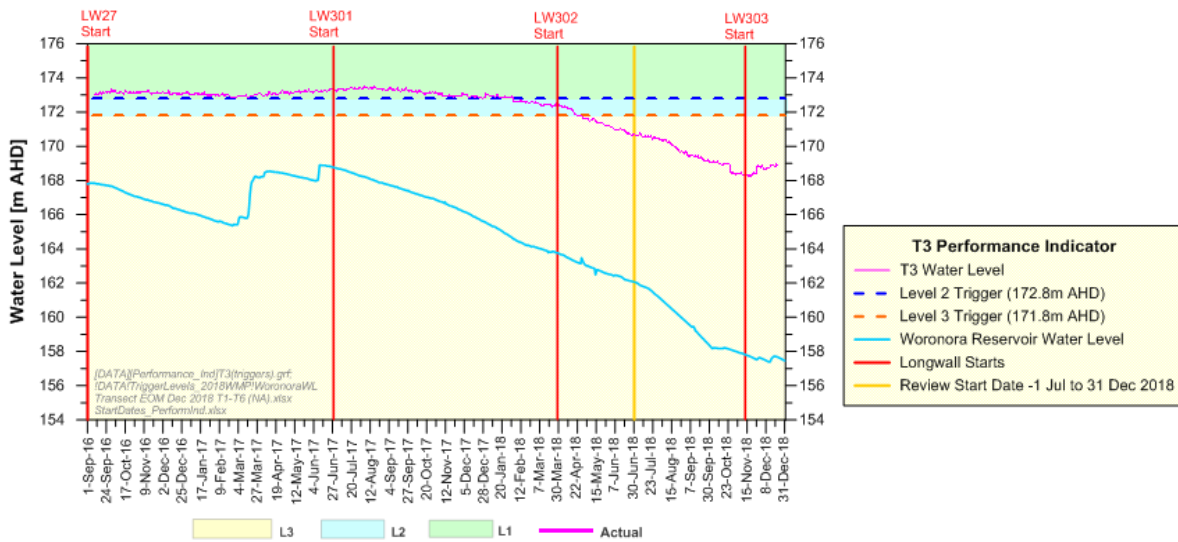
**Chart 71 Groundwater Level at Bore T3**

The performance indicator for bore T3 was exceeded in April 2018 (Chart 71) and the performance indicator for bore T2 was exceeded in July 2018 (Chart 72). The Woronora Reservoir water level has been displayed on Charts 56 and 57 to aid interpretation. An assessment against the subsidence impact performance measure, *Negligible leakage from the Woronora Reservoir*, was undertaken when the exceedance of the Level 3 Trigger and performance indicator was first identified for bore T3 in April 2018 (Appendix F1).

Charts 71 and 72 indicate that the declining water levels in bores T2 and T3 are driven by a decline in the Woronora Reservoir water level due to climatic conditions and dam operations. HydroSimulations (Appendix F1) concluded that there has not been an exceedance of the performance measure for negligible leakage from the Woronora Reservoir.

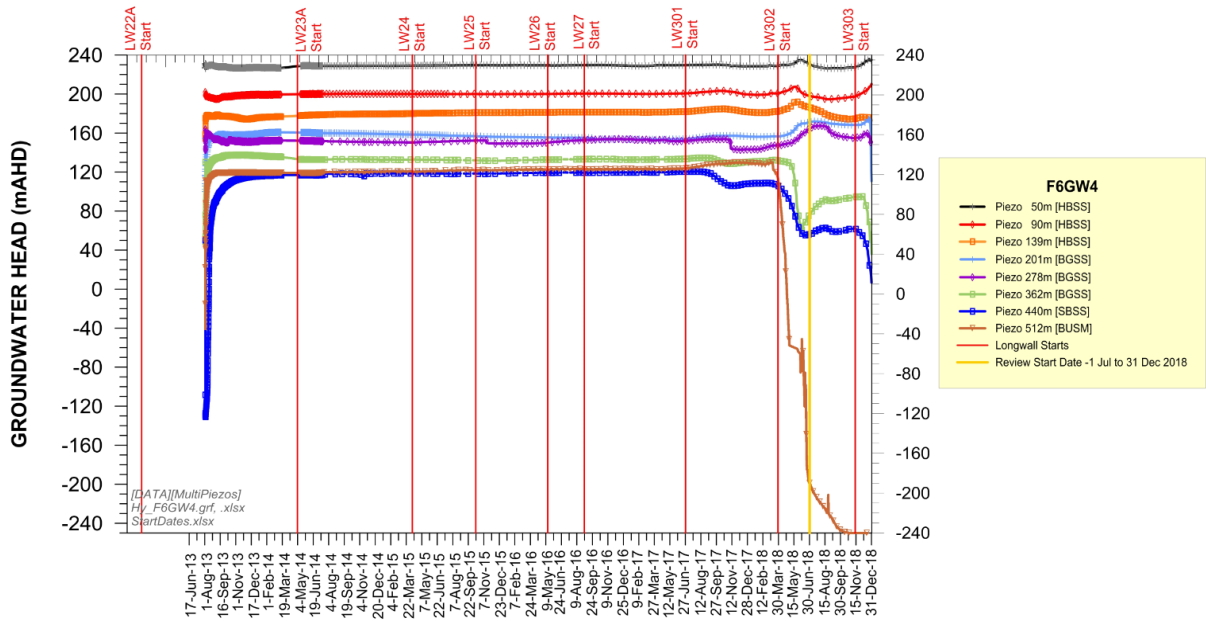
Chart 73 Time Variations in Potentiometric Heads at F6GW4A

The time-series record for bore F6GW4 is shown on Chart 73. This bore is two panel widths from Longwall 301 and one panel width from Longwall 302. The respective mining faces came closest to the bore in late-September 2017 and late-May 2018, at which times distinct features are evident on all hydrographs. The passage of Longwall 301 caused mild responses, generally short-term increases in head, while the passage of Longwall 302 caused sharp cusp-like features on the Hawkesbury Sandstone hydrographs, sustained rises in the upper and mid Bulgo Sandstone, and strong declines in the three deepest piezometers (Appendices C1 and C2). From July to December 2018, the Bulli Seam piezometer (512 m) continued to depressurise, following the passage of Longwall 302, becoming depressurised and stabilising in October 2018. The approach and passage of Longwall 303 occurred in November and December 2018 respectively. The Scarborough Sandstone and Bulgo Sandstone sensors (201 m, 278 m, 362 m, 440 m) all displayed depressurisation beginning at this time. The two upper Hawkesbury Sandstone hydrographs displayed rises during November to December 2018. The rises in head are attributable to lateral and vertical compression (Appendices C1 and C2).

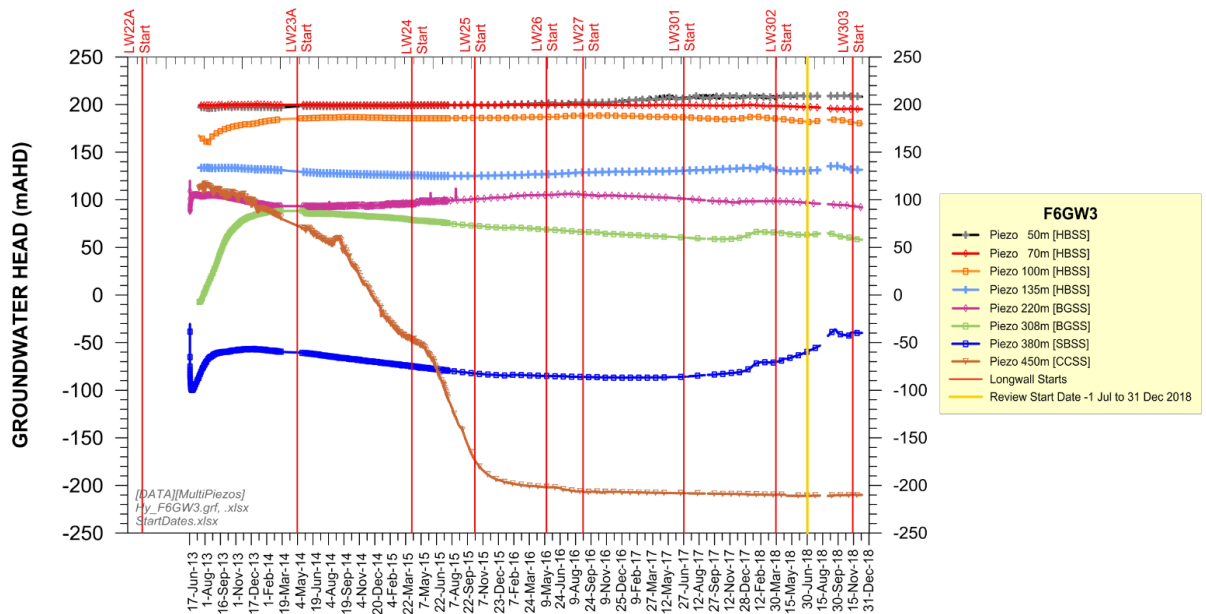
Chart 74 Time Variations in Potentiometric Heads at F6GW3A

The time-series record for bore F6GW3A is shown on Chart 74. Bore F6GW3A is located adjacent to Longwall 301, approximately 150 m beyond its southern end, and approximately 800 m from Longwall 27. Significant depressurisation has occurred from historical workings to the east at approximately 500 m distance. The 450 m deep piezometer at the base of the Coal Cliff Sandstone displays significant depressurisation continuing from the mining of the first heading in the 300 mains in November 2013. The rise in pressure in the 380 m piezometer, noted originally in March 2018 as potentially related to compression from the adjacent Longwall 302 commencing, continued to September 2018 and appears to have stabilised from October to December 2018 (Appendices C1 and C2).

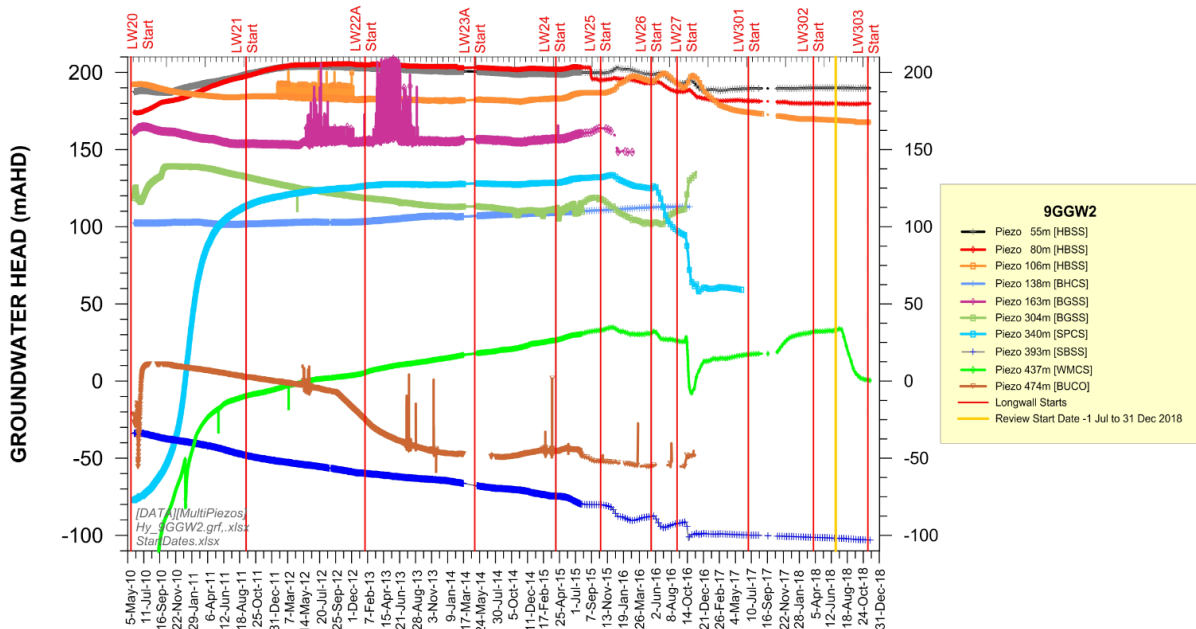
**Chart 75 Time Variations in Potentiometric Heads at 9GGW2B**

The time-series record for bore 9GGW2B is shown on Chart 75. As the hydrographs show inconsistent head variations with depth, some of the piezometers are unreliable. During the passage of Longwall 24 (>600 m away), minor drawdowns were observed in the Bulli Coal Seam and the Scarborough Sandstone, but other sensors exhibited no effect or a rise in head (Appendices C1 and C2). The passage of Longwall 25 (>400 m away) caused distinct drawdowns in the Scarborough Sandstone, Wombarra Claystone, Stanwell Park Claystone and upper Bulgo Sandstone. Characteristic arcuate segments between cusps associated with subsequent longwall crossings are evident in the Scarborough Sandstone, Wombarra Claystone and Stanwell Park Claystone, but not in the Bulli Coal Seam. The lower Bulgo Sandstone shows rising head arcuate segments for Longwall 26 and Longwall 27 crossings, due to compression at that level. Sympathetic drawdowns are also exhibited in the three Hawkesbury Sandstone piezometers at the times of the Longwall 26 and Longwall 27 crossings. The 138 m, 163 m, 304 m and 474 m deep vibrating wire piezometers have not recorded data since the end of 2016. The 340 m deep vibrating wire piezometer has not recorded data since June 2017. The mid and upper Hawkesbury Sandstone piezometers (55 m and 80 m) remained stable, and a very minor decline was observed in the lower Hawkesbury Sandstone piezometer (106 m) during the reporting period (Appendices C1 and C2).
