# METROPOLITAN COAL

## 2018 ANNUAL REVIEW

Project No. MET-19-16  
Document No. 00964839

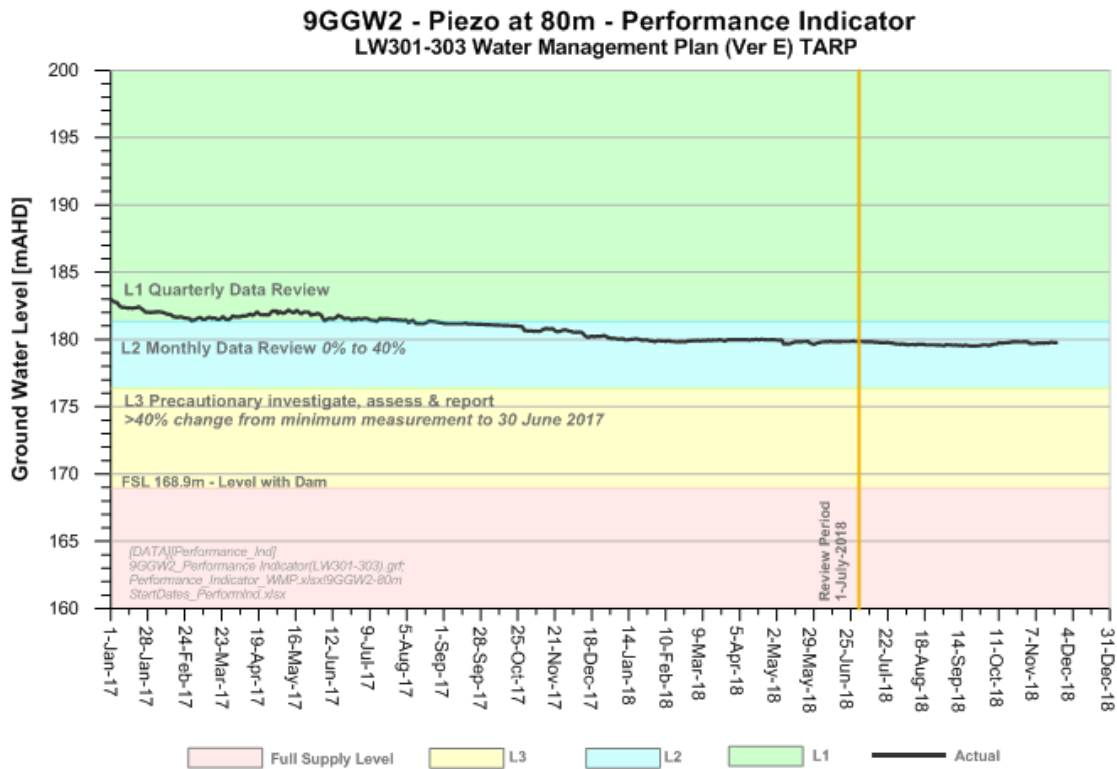
**Chart 76 7-day Average mid Hawkesbury Sandstone Groundwater Levels at 9GGW2B since 1 January 2017**

An exceedance of the Longwalls 301-303 Water Management Plan (Version D) Level 3 trigger and performance indicator was identified for bore 9GGW2B in January 2018 and an assessment against the subsidence impact performance measure, *Negligible leakage from the Woronora Reservoir*, was undertaken by HydroSimulations in February 2018 and is provided in Appendix F2. The assessment concluded the performance measure had not been exceeded and recommended the trigger levels be revised in the next revision of the Longwalls 301-303 Water Management Plan (Version E). The revised performance indicator for bore 9GGW2B was not exceeded for the remainder of the reporting period (Chart 76 and Appendices C1 and C2).

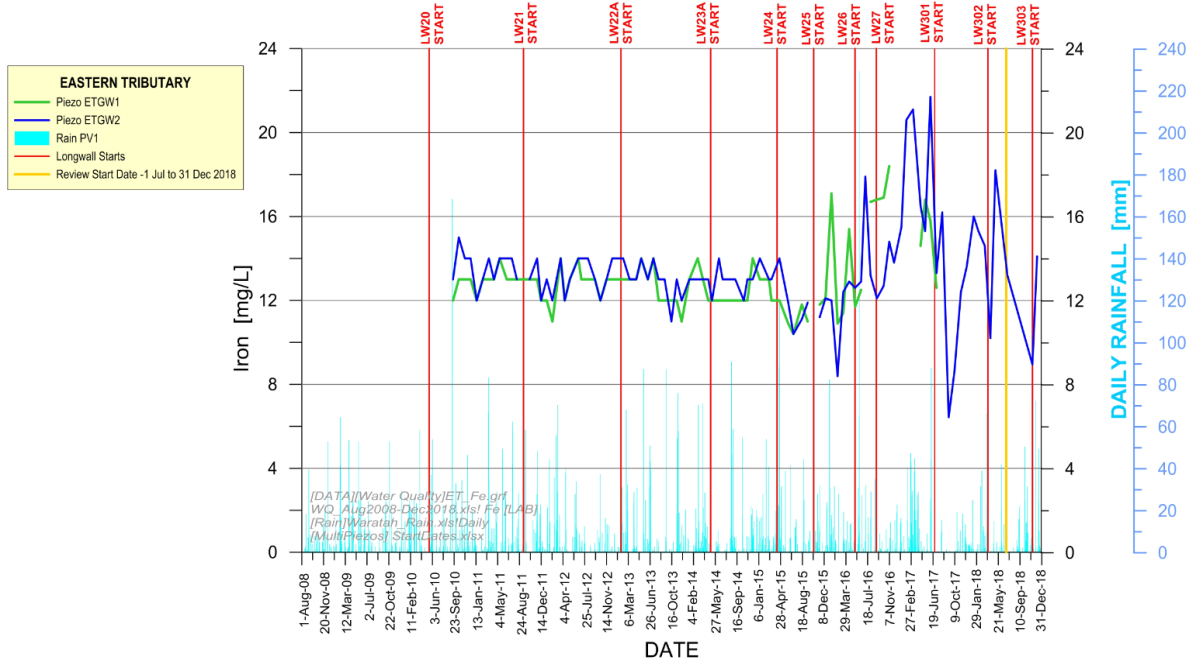
Chart 80 Iron Concentrations at ETGW1 and ETGW2

Groundwater quality at Eastern Tributary sites ETGW1 and ETGW2 (Figures 10 and 11) is shown on Charts 80 to 82 for iron, manganese and pH, respectively. Bore ETGW1 was unable to be sampled for groundwater quality from January to March 2017 and since August 2017. Bore ETGW2 was also unable to be sampled from August to October 2018.

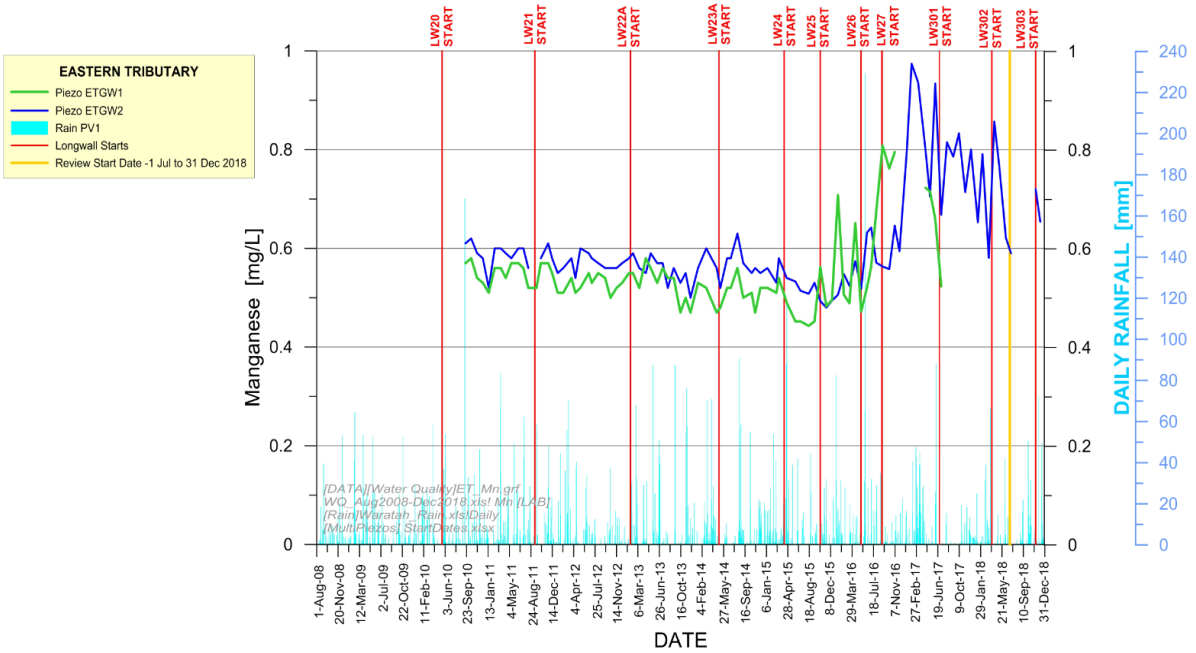
Chart 81 Manganese Concentrations at ETGW1 and ETGW2

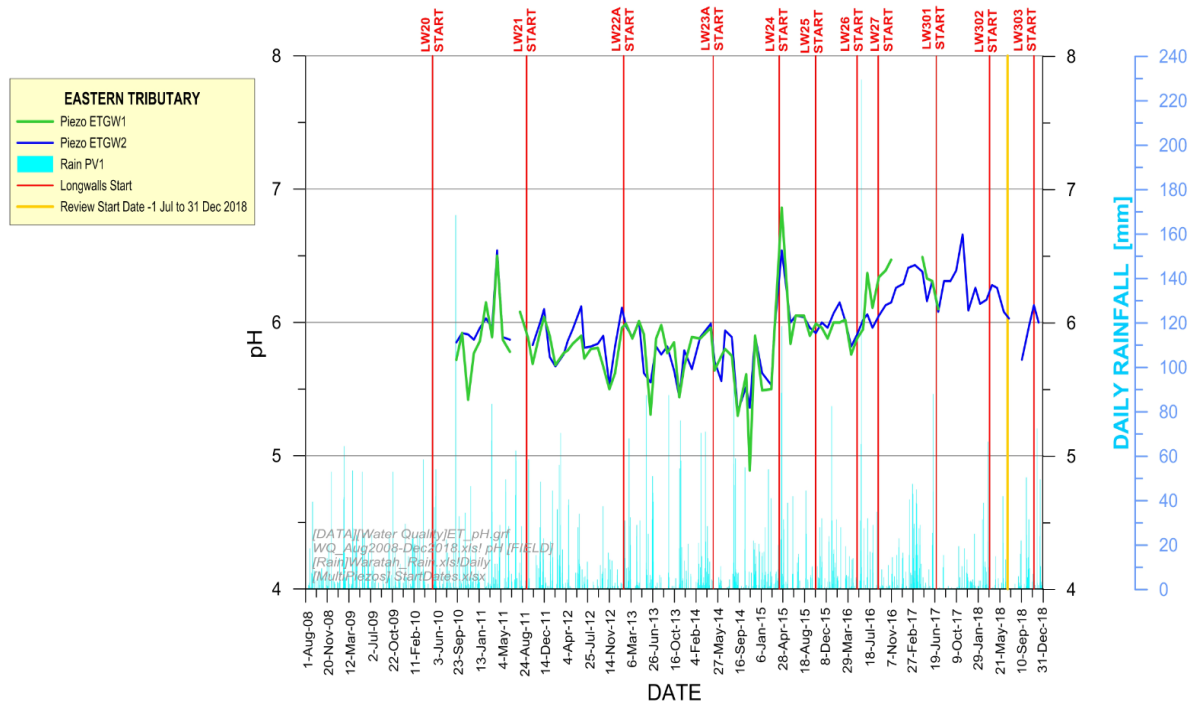
**Chart 82 pH Levels at ETGW1 and ETGW2**

The groundwater at the Eastern Tributary sites is generally acidic, ranging between pH 5.5 and pH 6.5 for most of the monitoring record (since 2010). At ETGW2, pH remained between pH 5.7 and pH 6.5 during the reporting period (Chart 82) (Appendices C1 and C2).

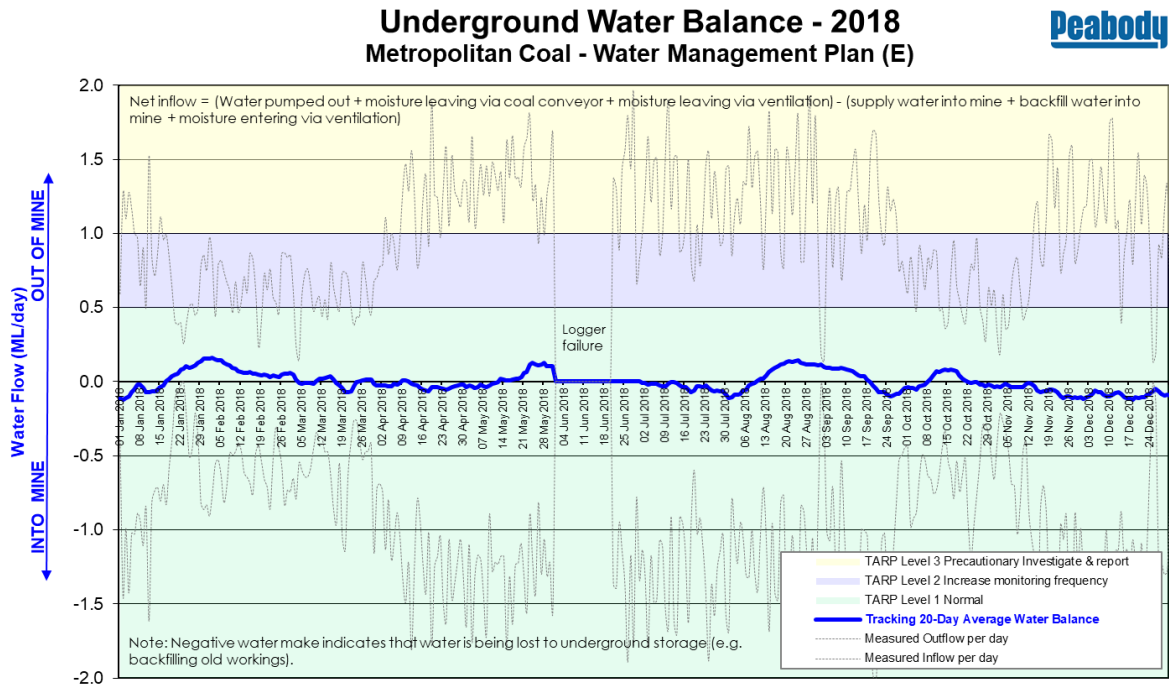
Chart 83 Estimated Daily Mine Water Make<sup>17</sup>

The 20 day average daily mine water make was less than 0.5 ML/day during the reporting period (Chart 83).

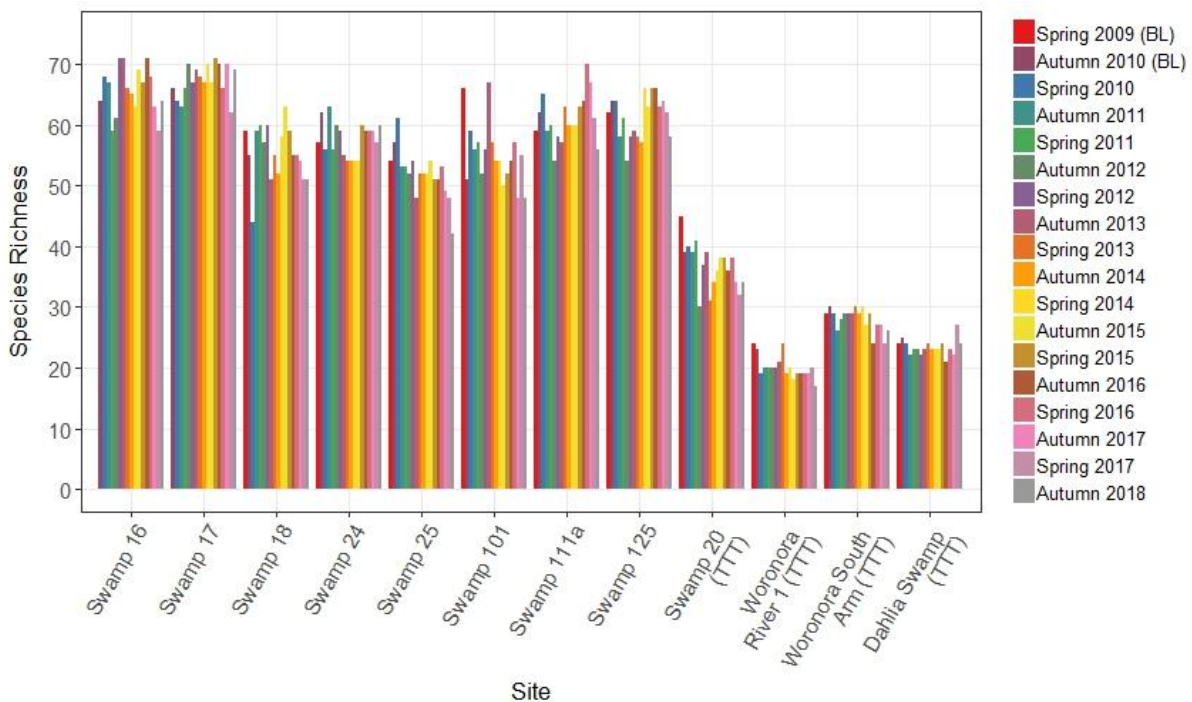
**Chart 84 Native Species Richness in Longwalls 20-22 Upland Swamp Sites, Spring 2009 – Autumn 2018**

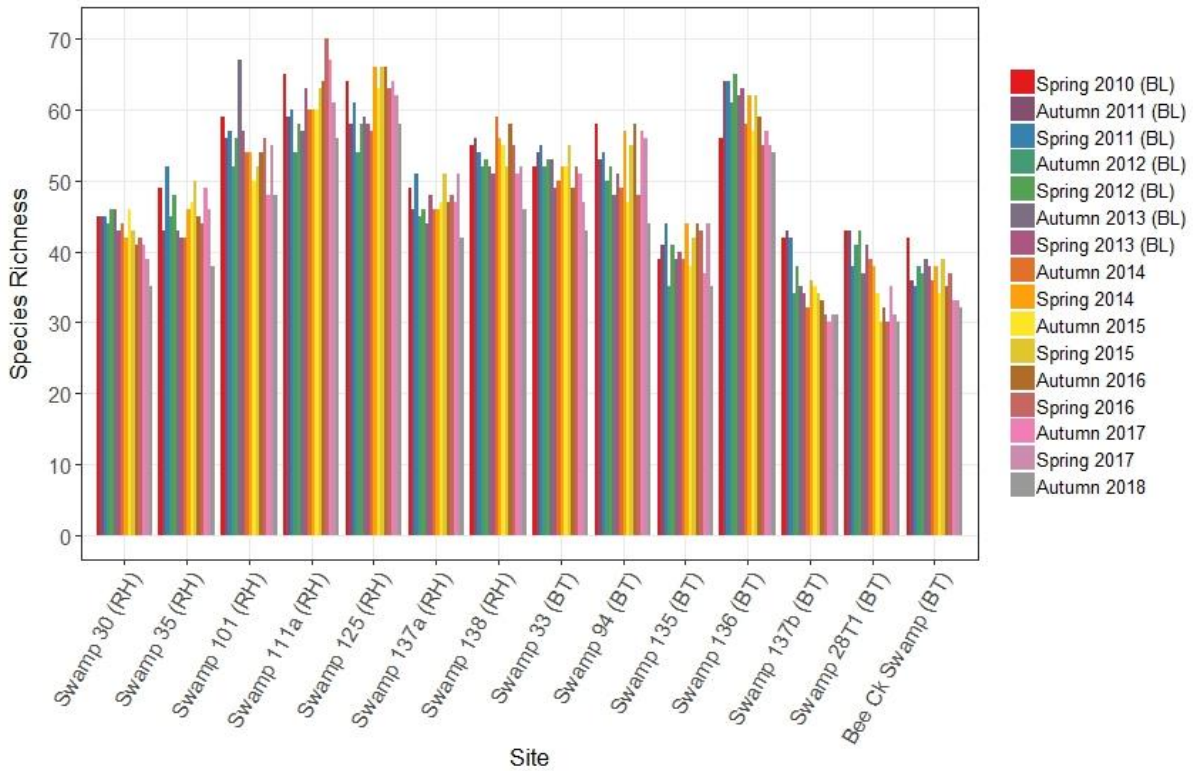
**Chart 85 Native Species Richness within Longwalls 23-27 Upland Swamp Sites Supporting Restioid Heath and Banksia Thicket, Spring 2010 – Autumn 2018**

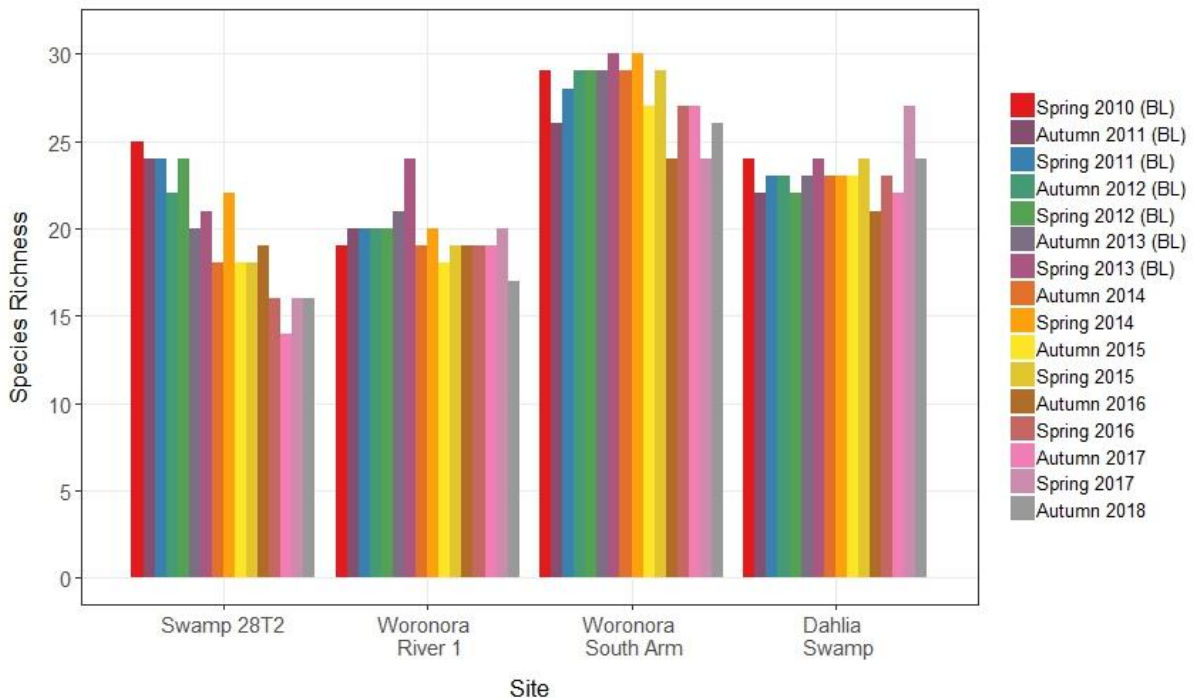
**Chart 86 Native Species Richness within Longwalls 23-27 Upland Swamp Sites Supporting Tea Tree Thicket, Spring 2010 – Autumn 2018**

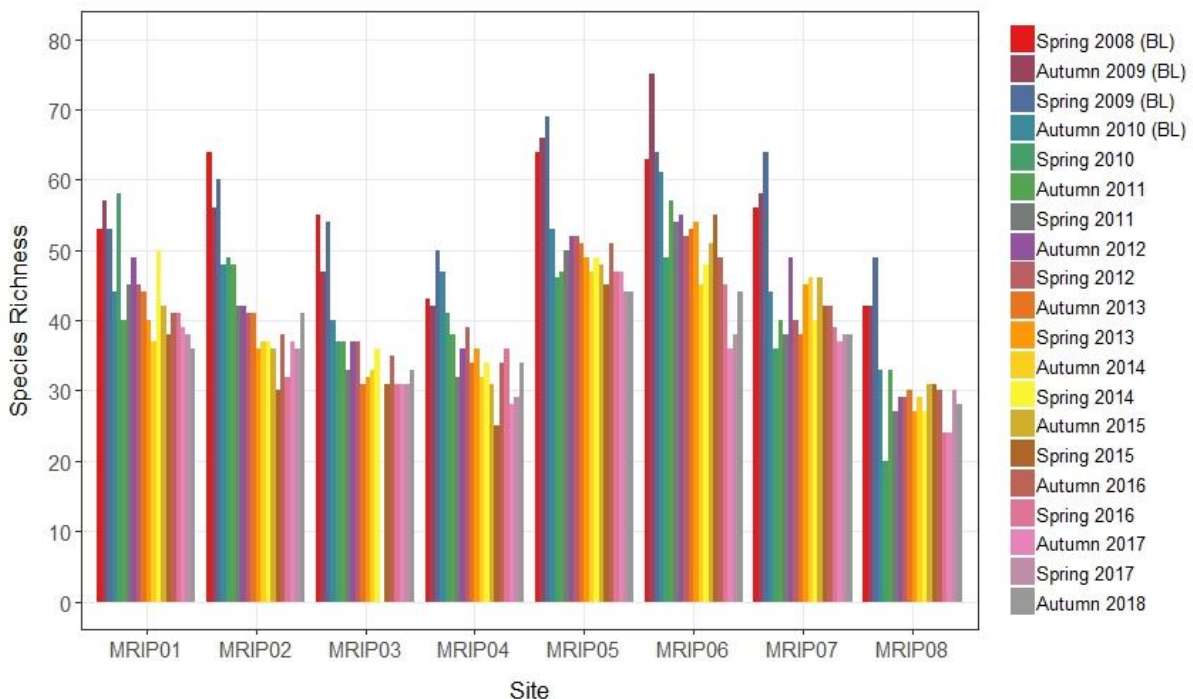
**Chart 87 Native Species Richness within Riparian Monitoring Sites across All Seasons - Longwalls 20-22 Monitoring Program**

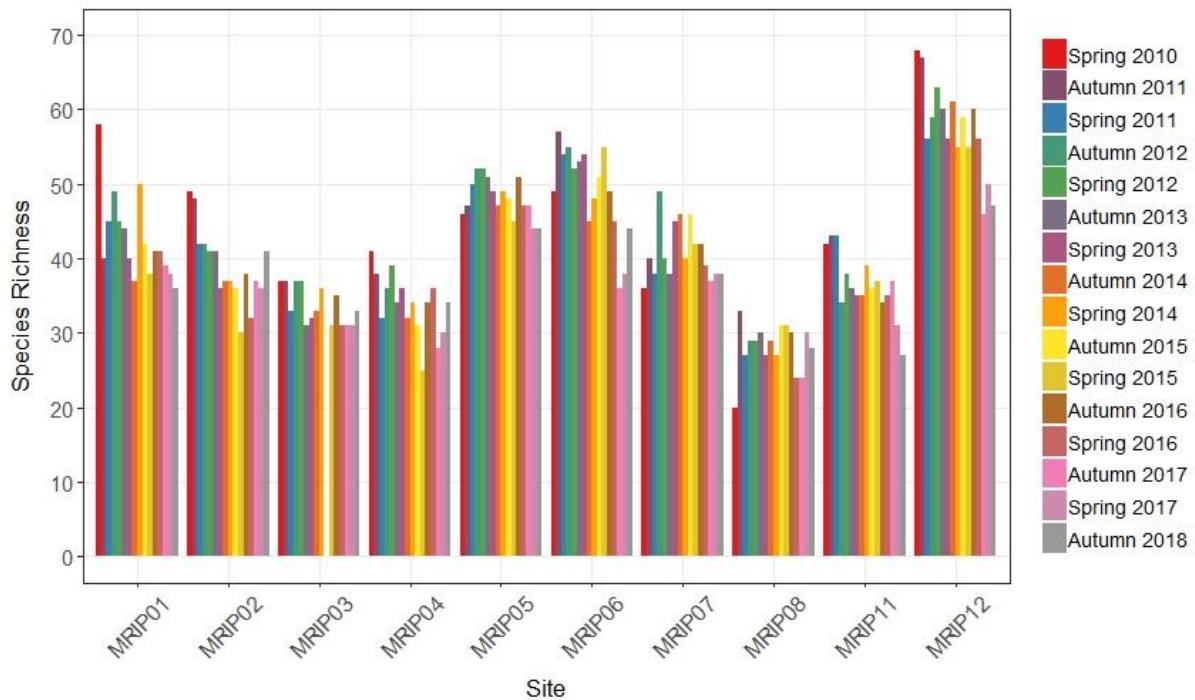
**Chart 88 Native Species Richness within Riparian Monitoring Sites across All Seasons-Longwalls 23-27 Monitoring Program**

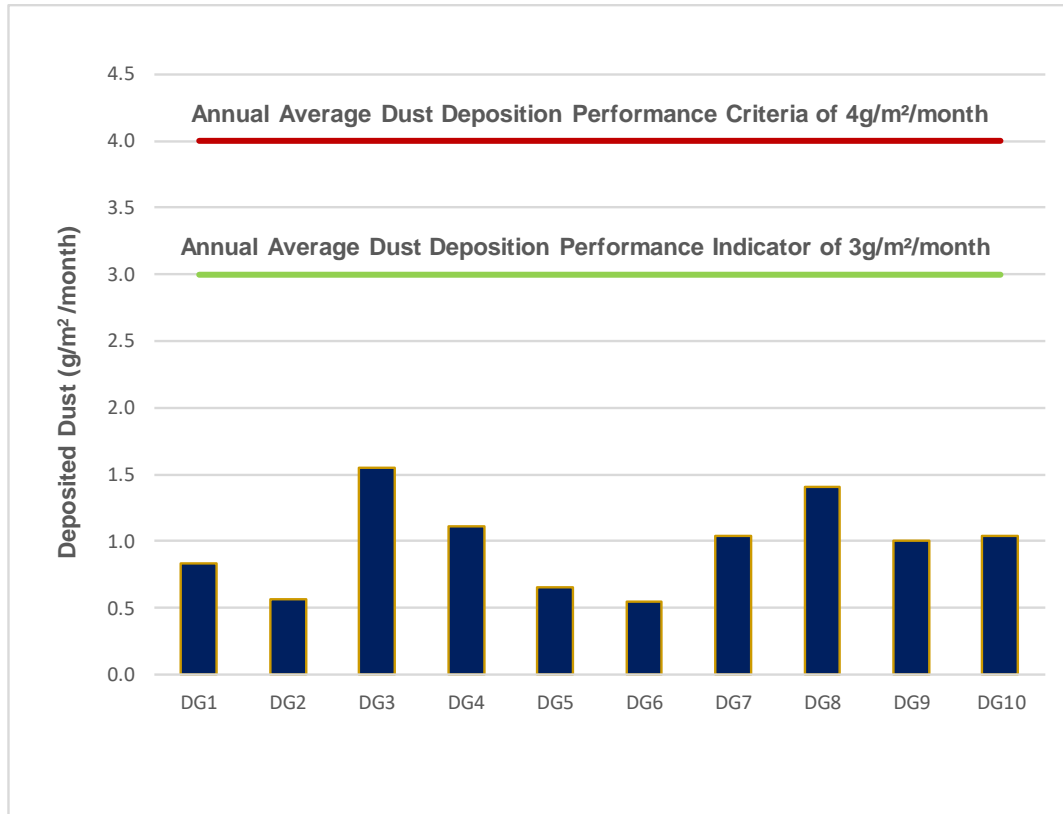
**Chart 89 Annual Average Dust Deposition Rates Measured at Dust Gauges (DG1 to DG10)**

Annual average dust deposition rates at each gauge from 2003 to 2018 are shown in Chart 90 and Chart 90a. From 2003 to 2018, there were no clear trends in dust deposition rates; however, relatively higher dust deposition rates were recorded at some sites in 2009 and 2015. The annual average dust deposition rate at each gauge in 2018 was within or below the range previously recorded for the dust gauges.

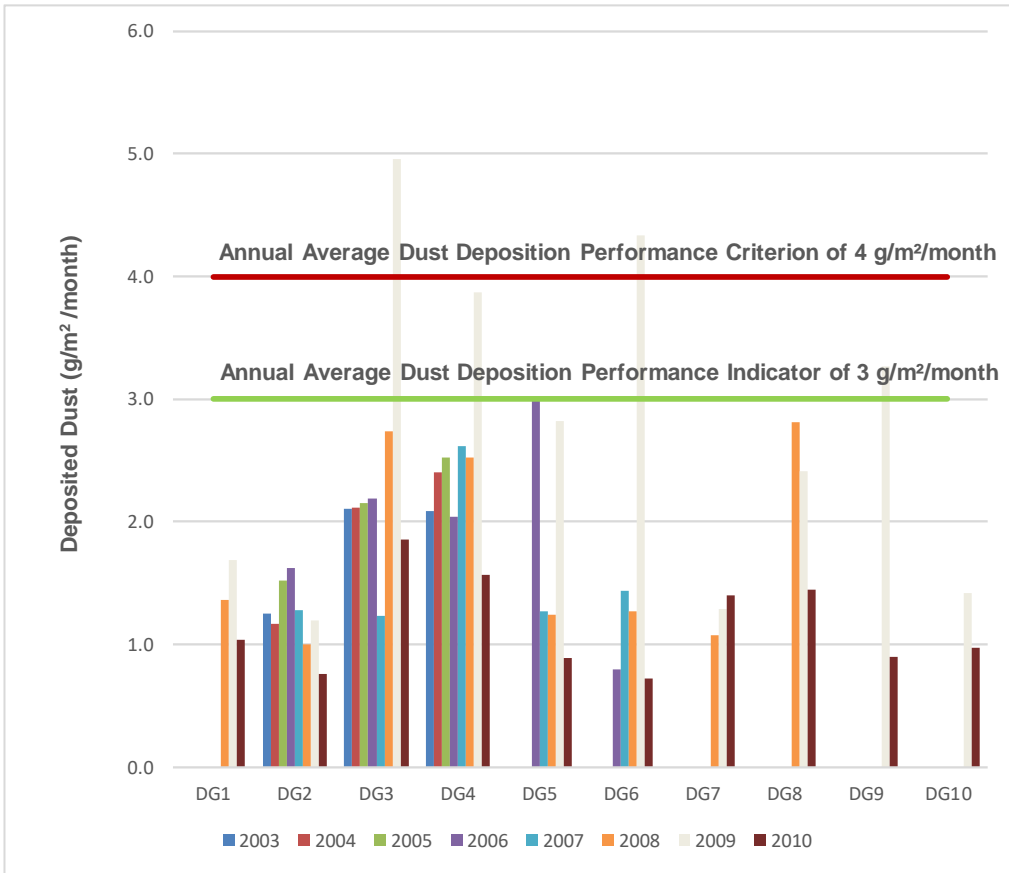
Chart 90a Annual Average Dust Deposition Rates at DG1 to DG10 from 2003 to 2010

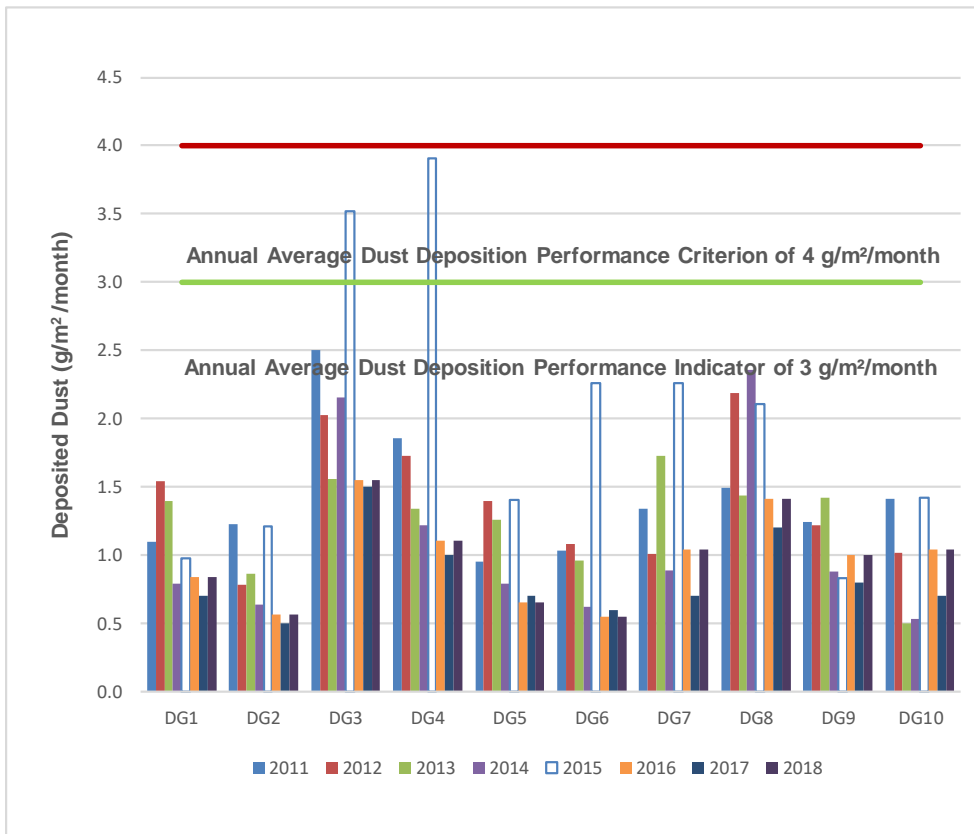
Chart 90b Annual Average Dust Deposition Rates at DG1 to DG10 from 2011 to 2018

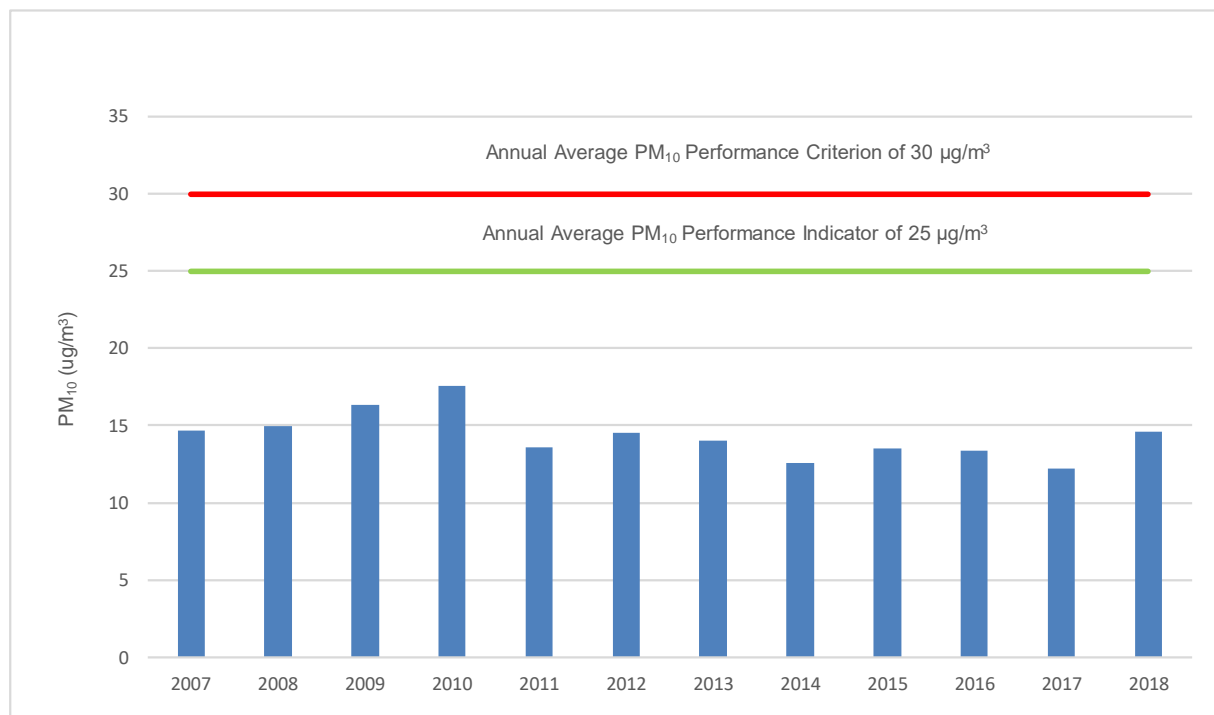
**Chart 91 Annual Average PM<sub>10</sub> Concentrations from 2007 to 2018 (measured by the HVAS)**

The annual average PM<sub>10</sub> concentrations (measured by the HVAS) from 2007 to 2018 are shown on Chart 91. The annual average PM<sub>10</sub> concentration measured at the HVAS for the review period was 14.6 micrograms per cubic metre (µg/m<sup>3</sup>), which is lower than the annual average PM<sub>10</sub> performance indicator of 25 µg/m<sup>3</sup> and well below the annual average PM<sub>10</sub> air quality impact assessment criterion of 30 µg/m<sup>3</sup> (Chart 91).

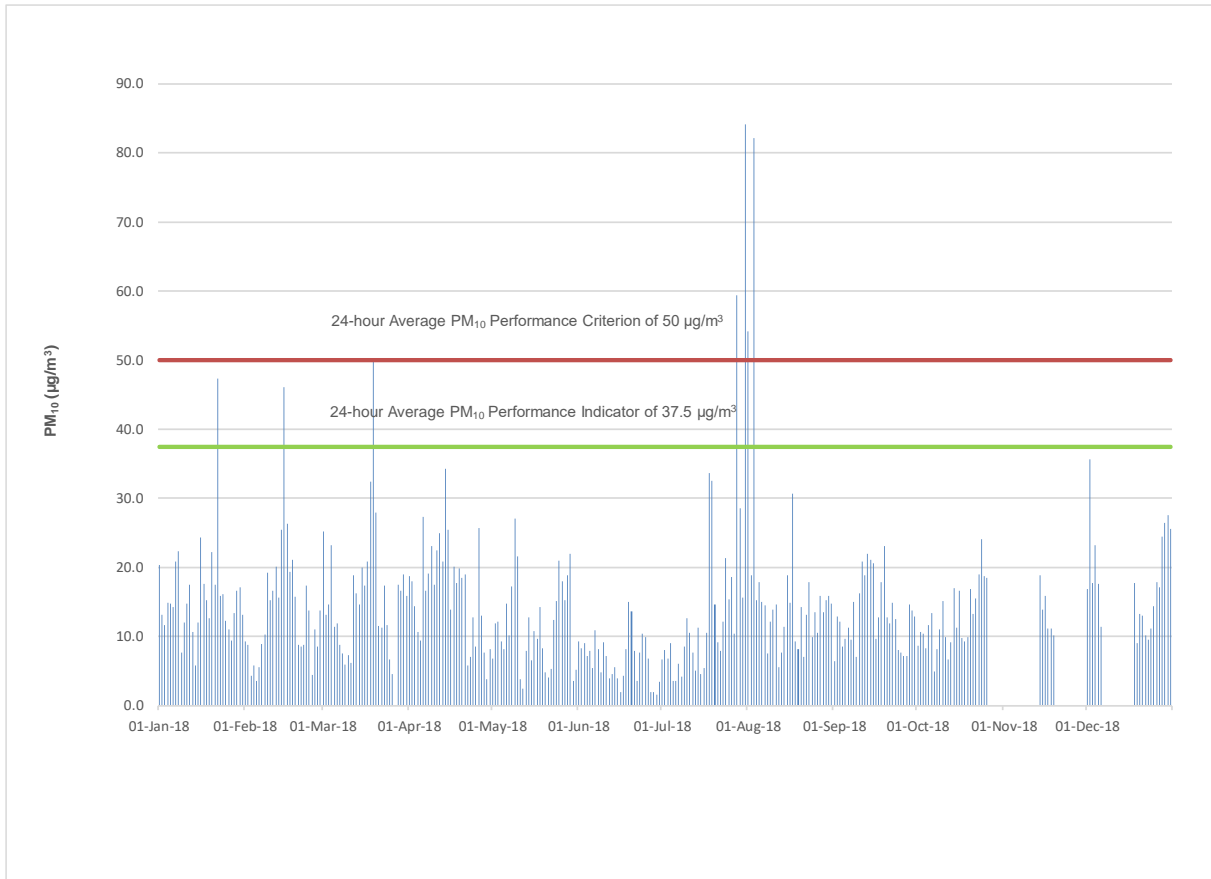
**Chart 92 24-hour Average PM<sub>10</sub> Concentrations (measured by the TEOM)**

The monitoring results in 2018 are thus considered to be lower than the Project EA predictions in relation to particulate matter.

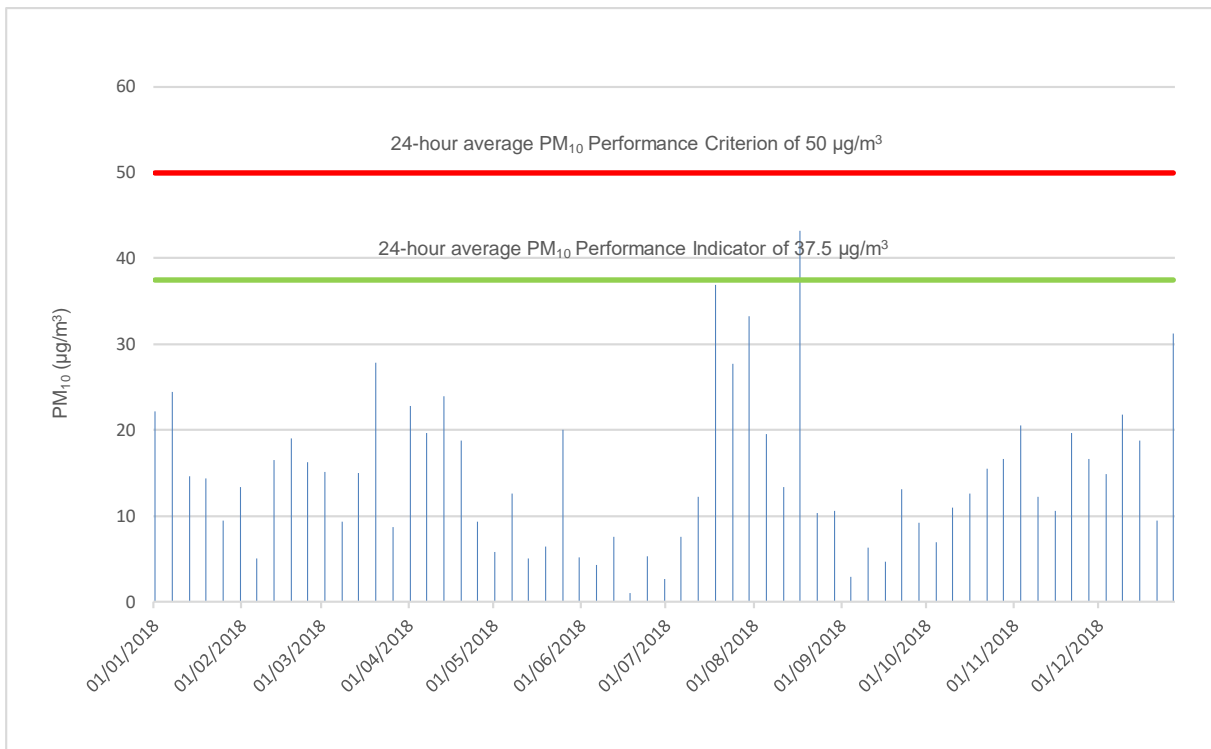
**Chart 93 24-hour Average PM<sub>10</sub> Concentrations (measured by the HVAS)**

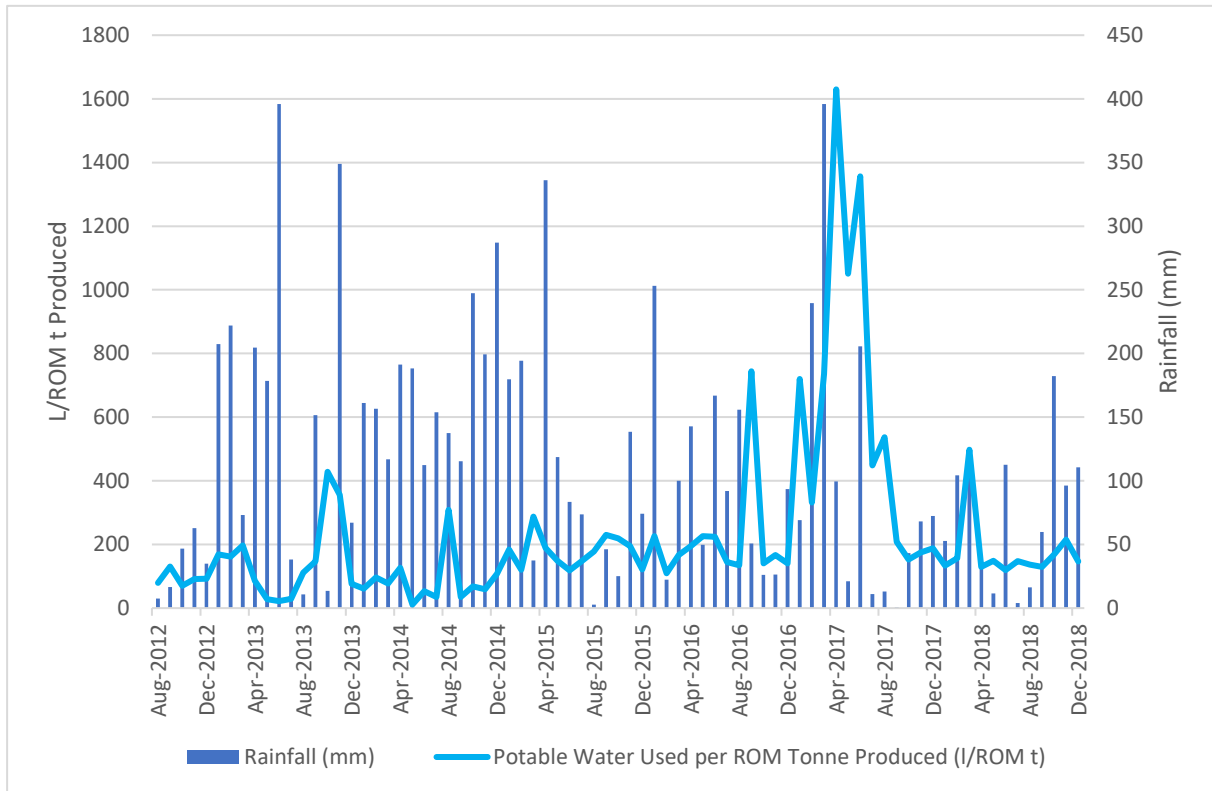
**Chart 94 Potable Water Used per ROM Tonne Produced vs Rainfall**

The use of potable water per tonne of ROM coal produced is variable and is generally higher during periods of low rainfall (Chart 94). Ongoing site auditing during the review period has not identified incidences of potable water being used where there is a viable alternative. In 2018 potable water consumption correlated well with ROM production throughout the year.

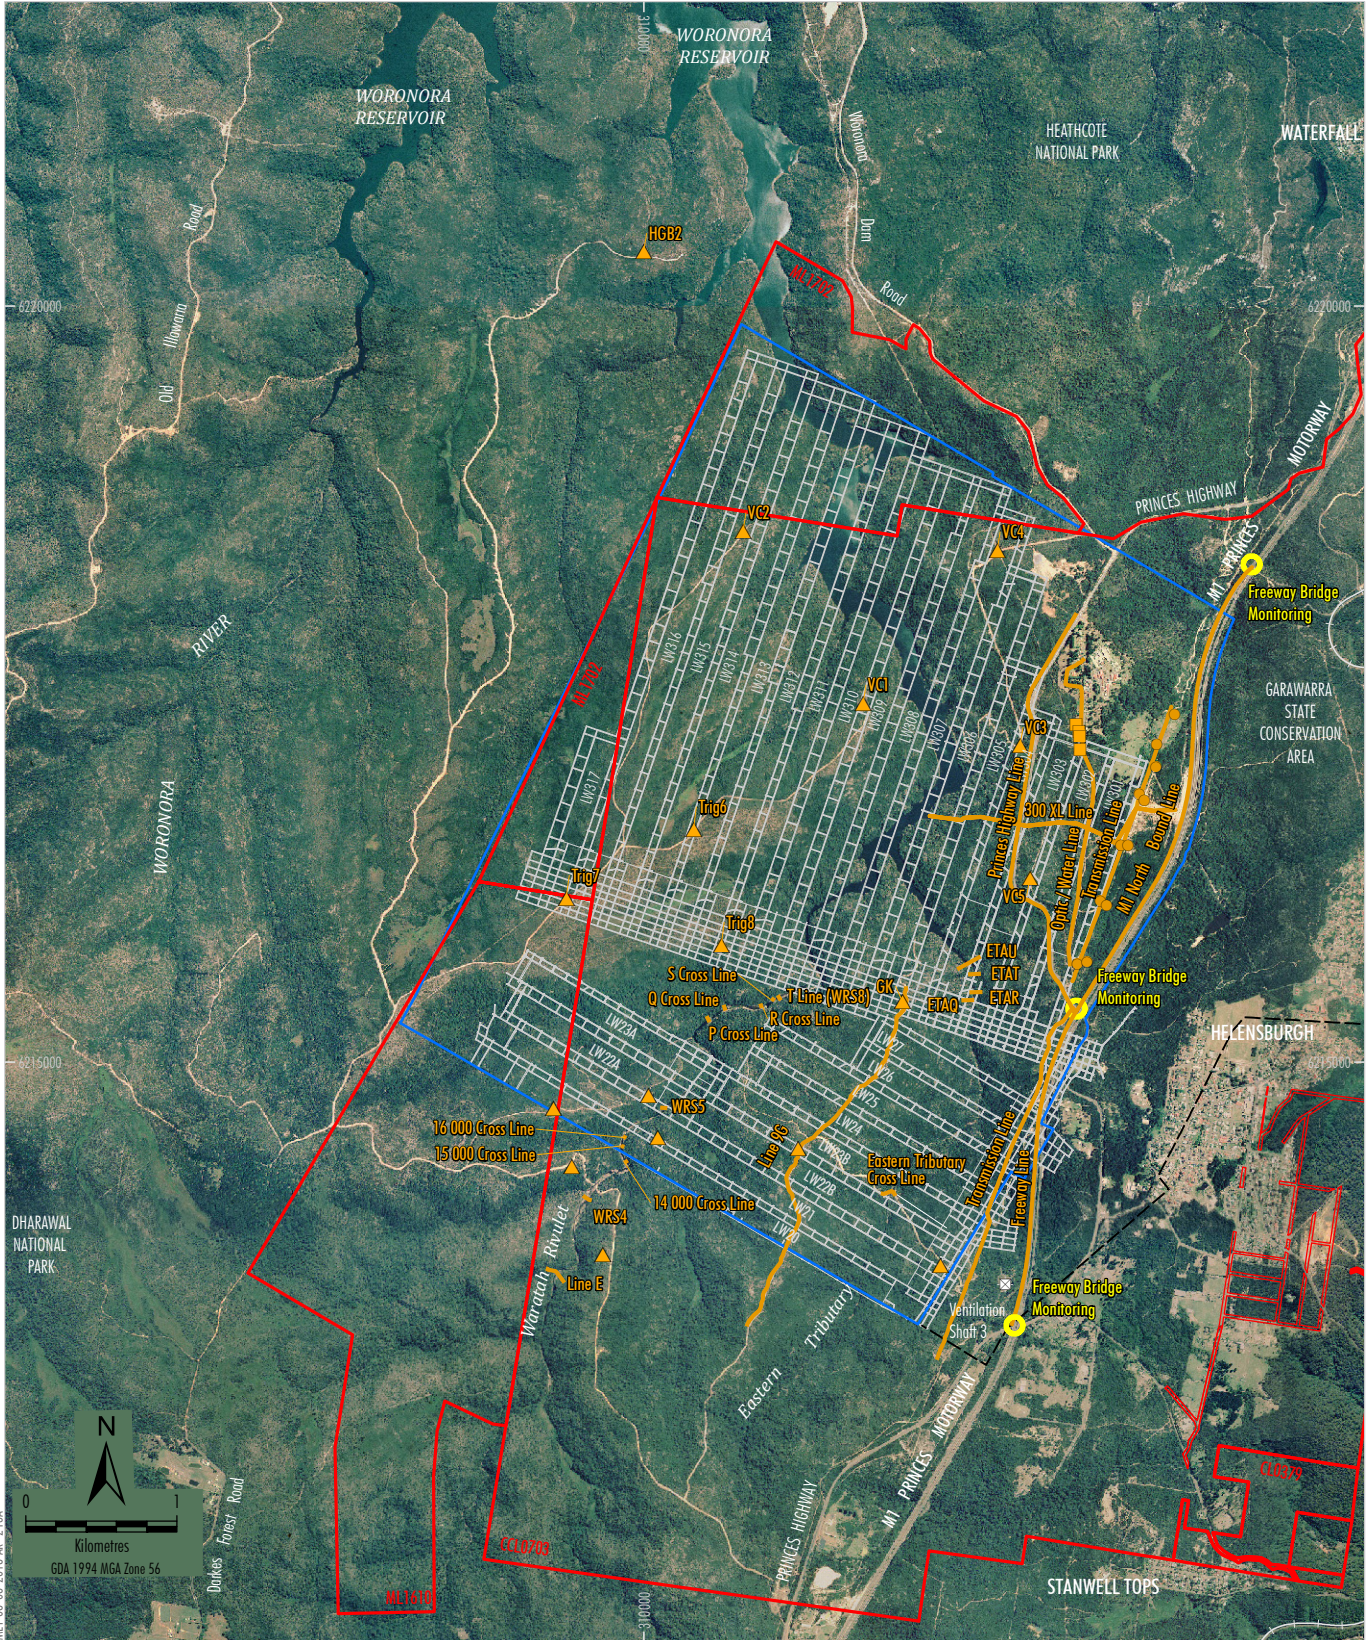
Figure 6

**Peabody**  
METROPOLITAN COAL  
Subsidence Monitoring Locations

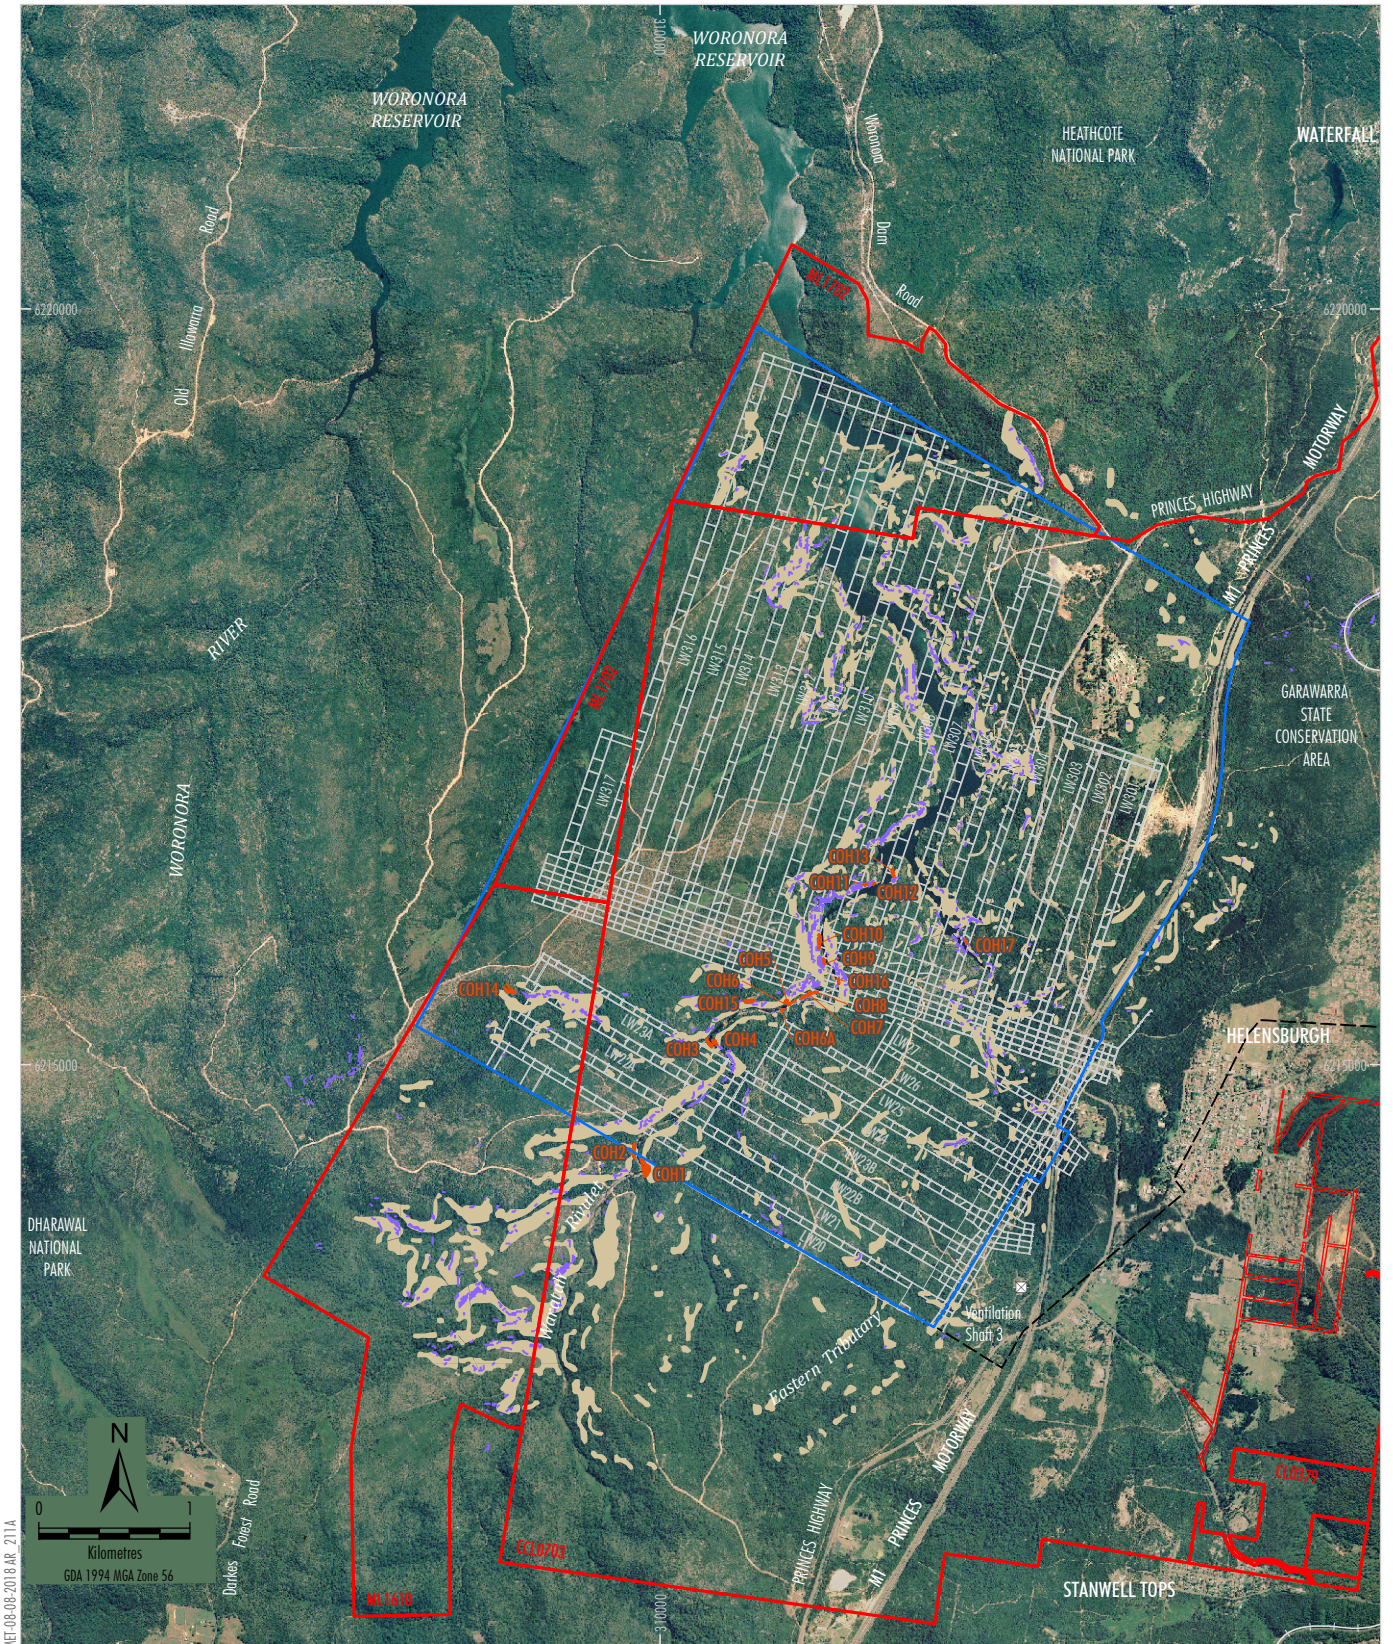
Figure 16

METROPOLITAN COAL  
Cliffs and Overhangs, Steep Slopes and  
Land in General within the Project  
Underground Mining Area and Surrounds

Visual inspections of cliffs and overhangs were conducted monthly when mining of Longwalls 20-22 and/or Longwalls 23-27 was within 400 m of sites COH1, COH2, COH3, COH4, COH5, COH6, COH6A, COH7, COH8, COH9, COH10, COH14, COH15 and COH16 (Figure 16) and following the completion of each longwall to record evidence of subsidence impacts. A vertical tension crack (approximately 50 mm wide and 15 m long) on the cliff face and a small rock fall (approximately 1.5 m long, 0.5 m wide and 0.5 m<sup>3</sup>) were recorded at site COH2 (Figure 16) in December 2013 during the mining of Longwall 22. No additional subsidence impacts at the cliff or overhang sites were recorded following the completion of Longwall 27.

<sup>20</sup> A new cliff and overhang site (COH17) was identified below the full supply level on the Eastern Tributary arm of the Woronora Reservoir subsequent to the reporting period in August 2018 (Figure 16). Detailed baseline recording for this site has been conducted and will be included in the LW304 Extraction Plan.

<sup>10</sup> A new cliff and overhang site (COH17) was identified below the full supply level on the Eastern Tributary arm of the Woronora Reservoir in August 2018. Detailed baseline recording for this site has been conducted and will be included in the Longwall 304 Extraction Plan. The location of the site COH17 is shown on Figure 16.
