# METROPOLITAN COAL

## 2018 ANNUAL REVIEW

Project No. MET-19-16  
Document No. 00964839

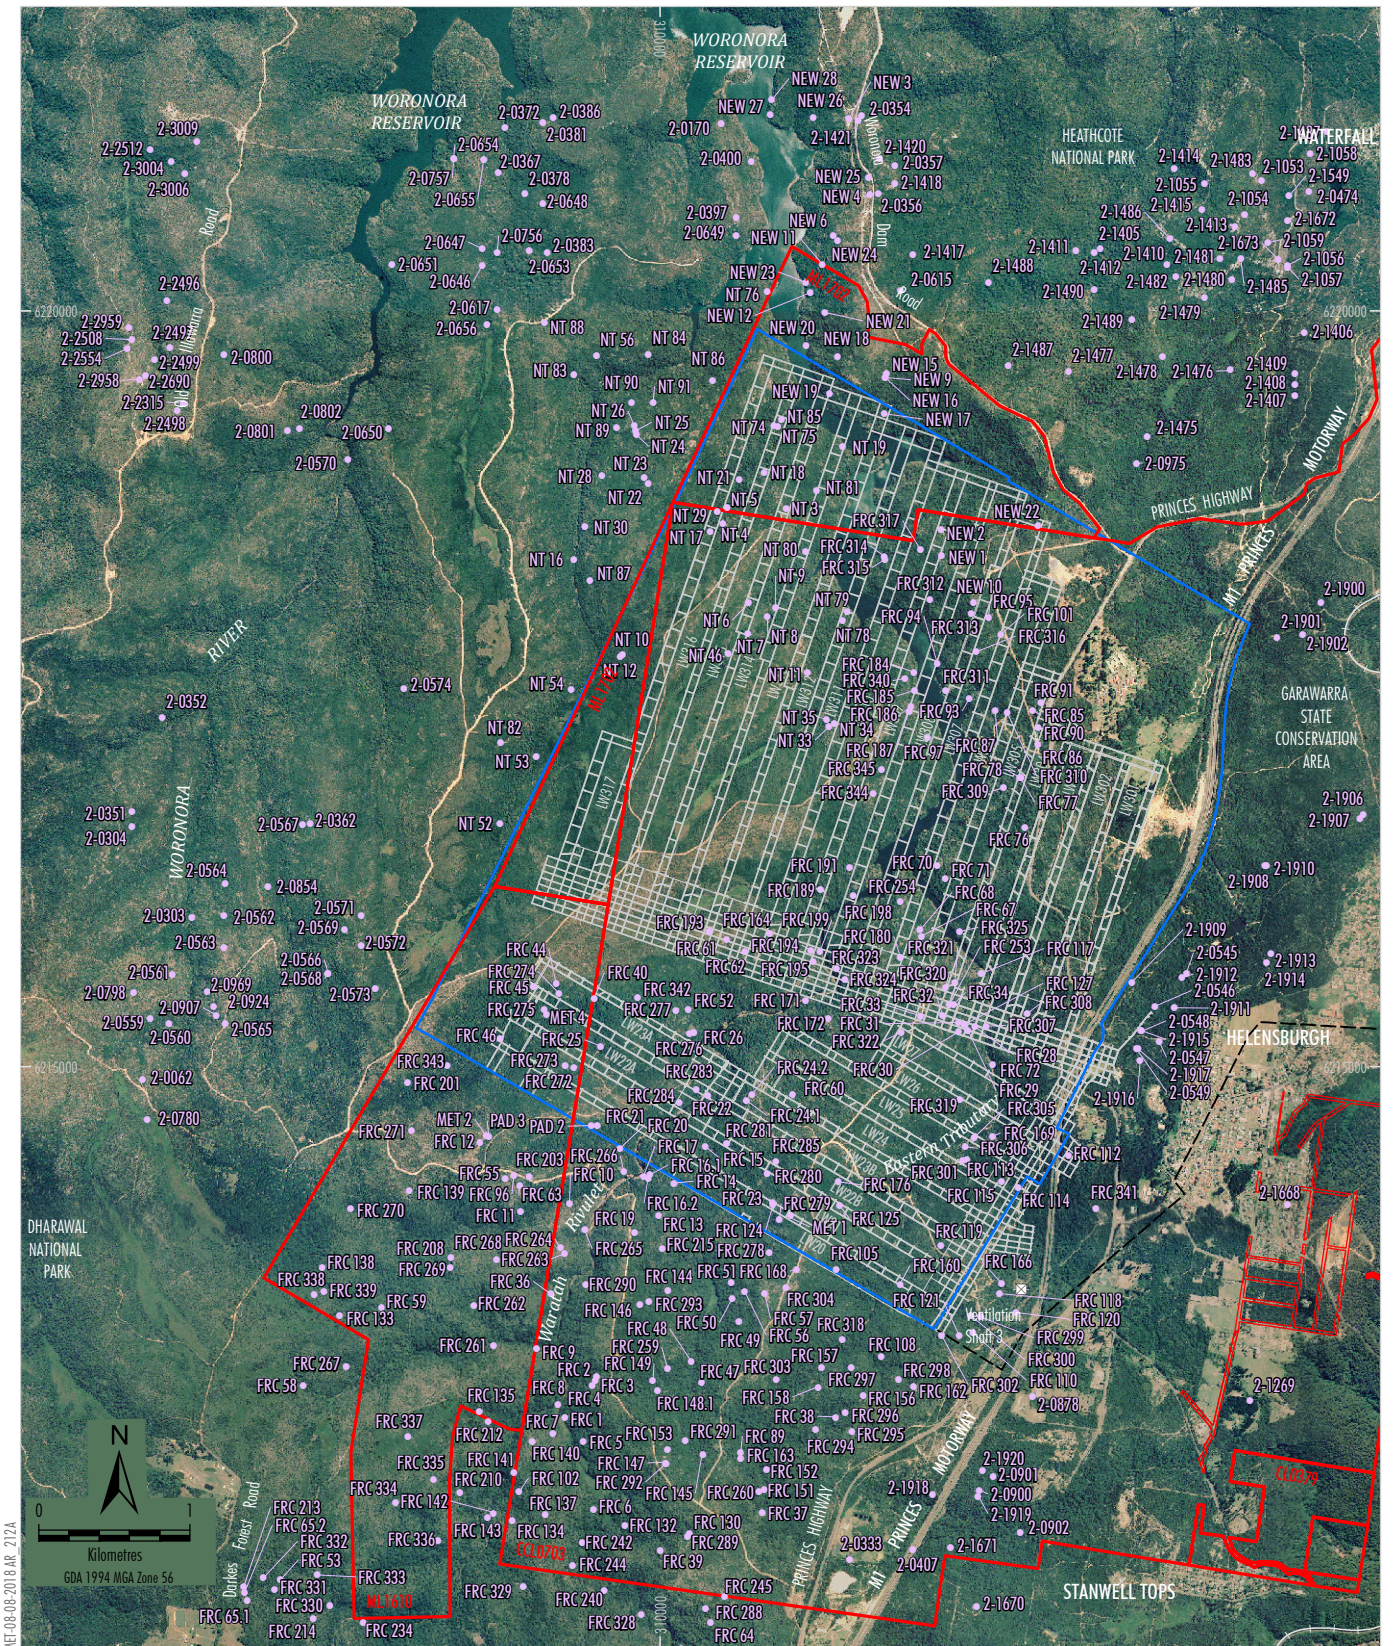
Figure 17

Known Aboriginal Heritage Sites  
Within Project Underground Mining Area  
and Surrounds

Five Aboriginal heritage sites (FRC 15, FRC 281, FRC 283, FRC 284 and MET 1) have been determined to have changes due to mining induced subsidence from Longwalls 20-22 (Figure 17). The observed impacts at each site were as follows:

Seven Aboriginal heritage sites (FRC 28, FRC 29, FRC 34, FRC 60, FRC 176, FRC 275 and FRC 301) have been determined to have changes due to mining induced subsidence from Longwalls 23-27 (Figure 17). The observed impacts at each site were as follows:

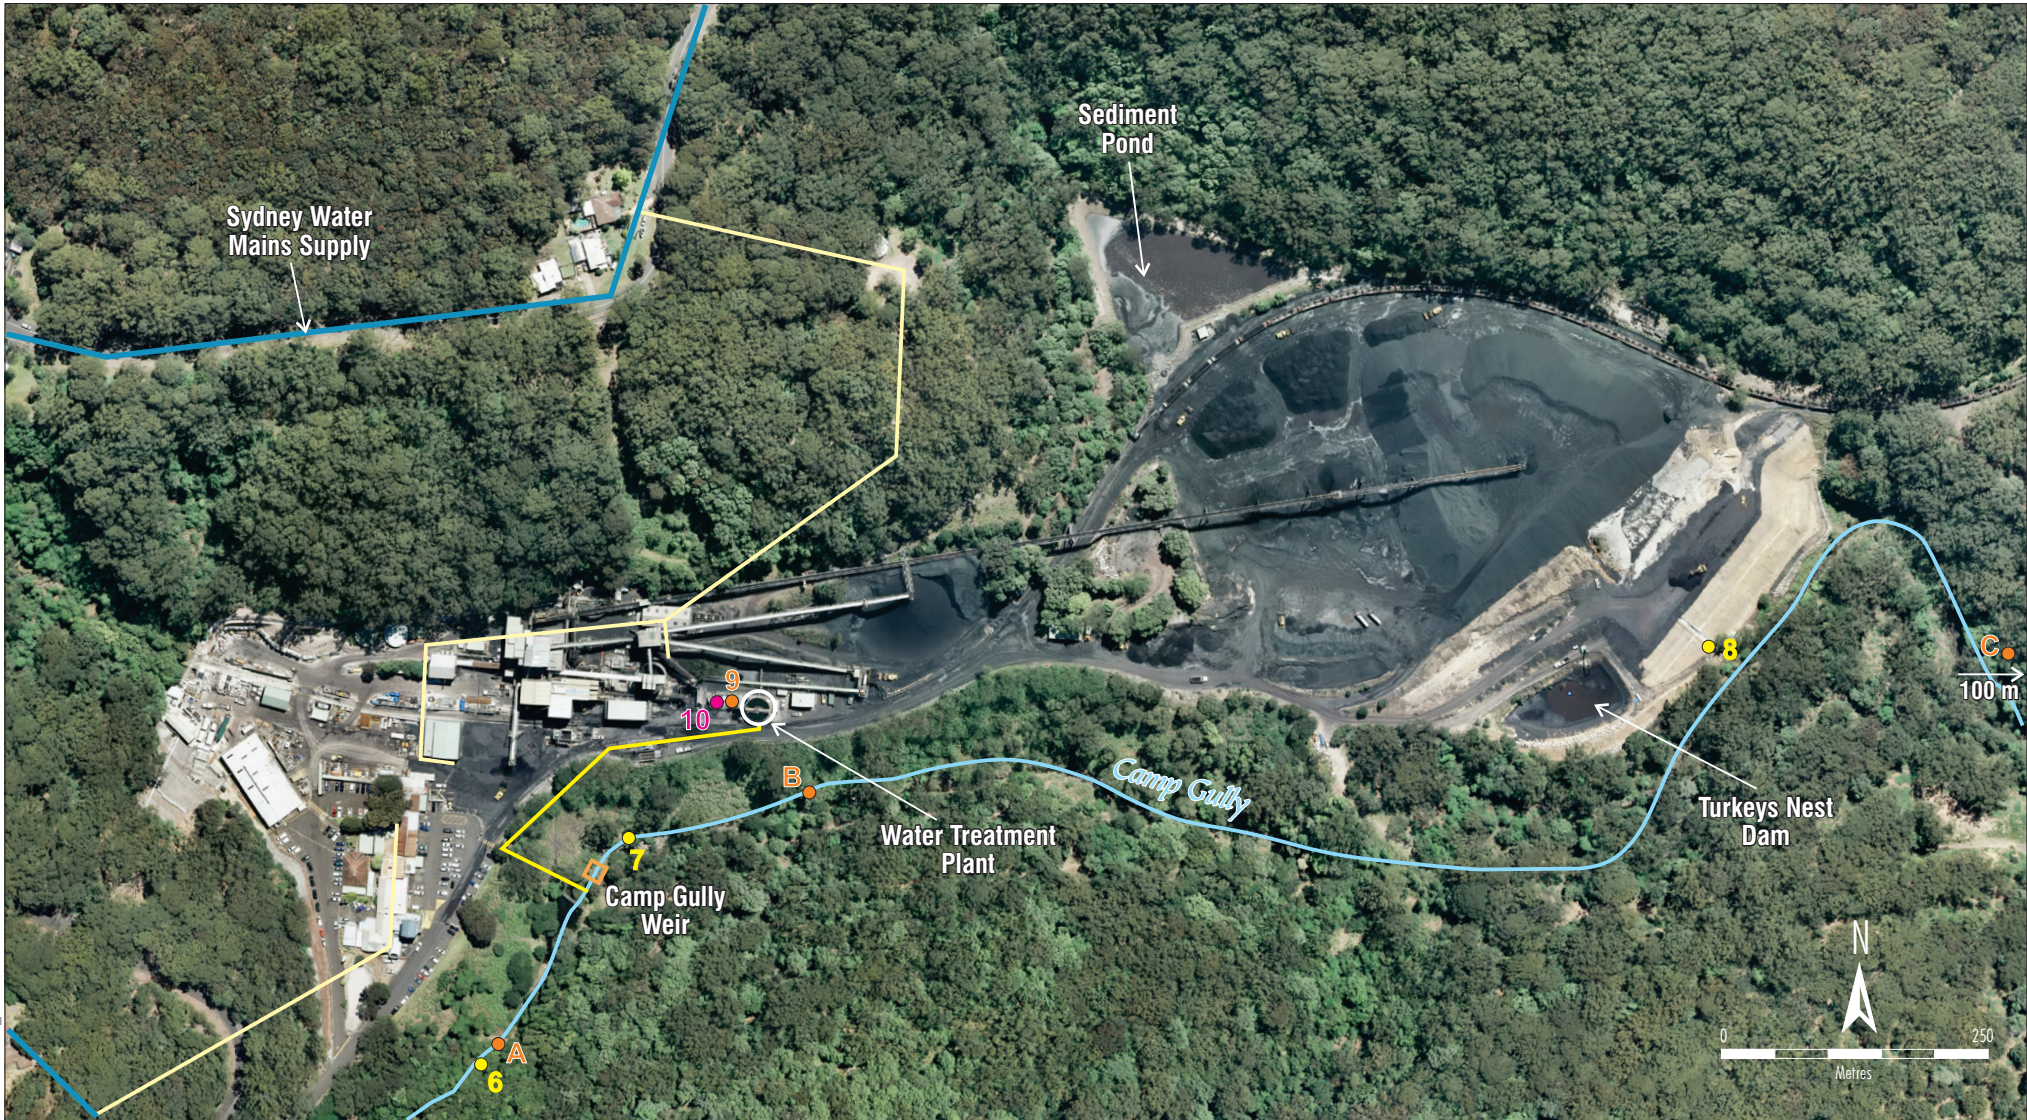
**Figure 22**

Surface Facilities Area  
Water Monitoring Sites

Camp Gully runs adjacent to the southern edge of Metropolitan Coal's surface facilities area (Figure 22). Metropolitan Coal's extraction of water from Camp Gully is specifically regulated by the Camp Creek Weir Surface Water Certificate of Title and more generally by the *Water Act, 1912* and the *Water Management Act, 2000*.

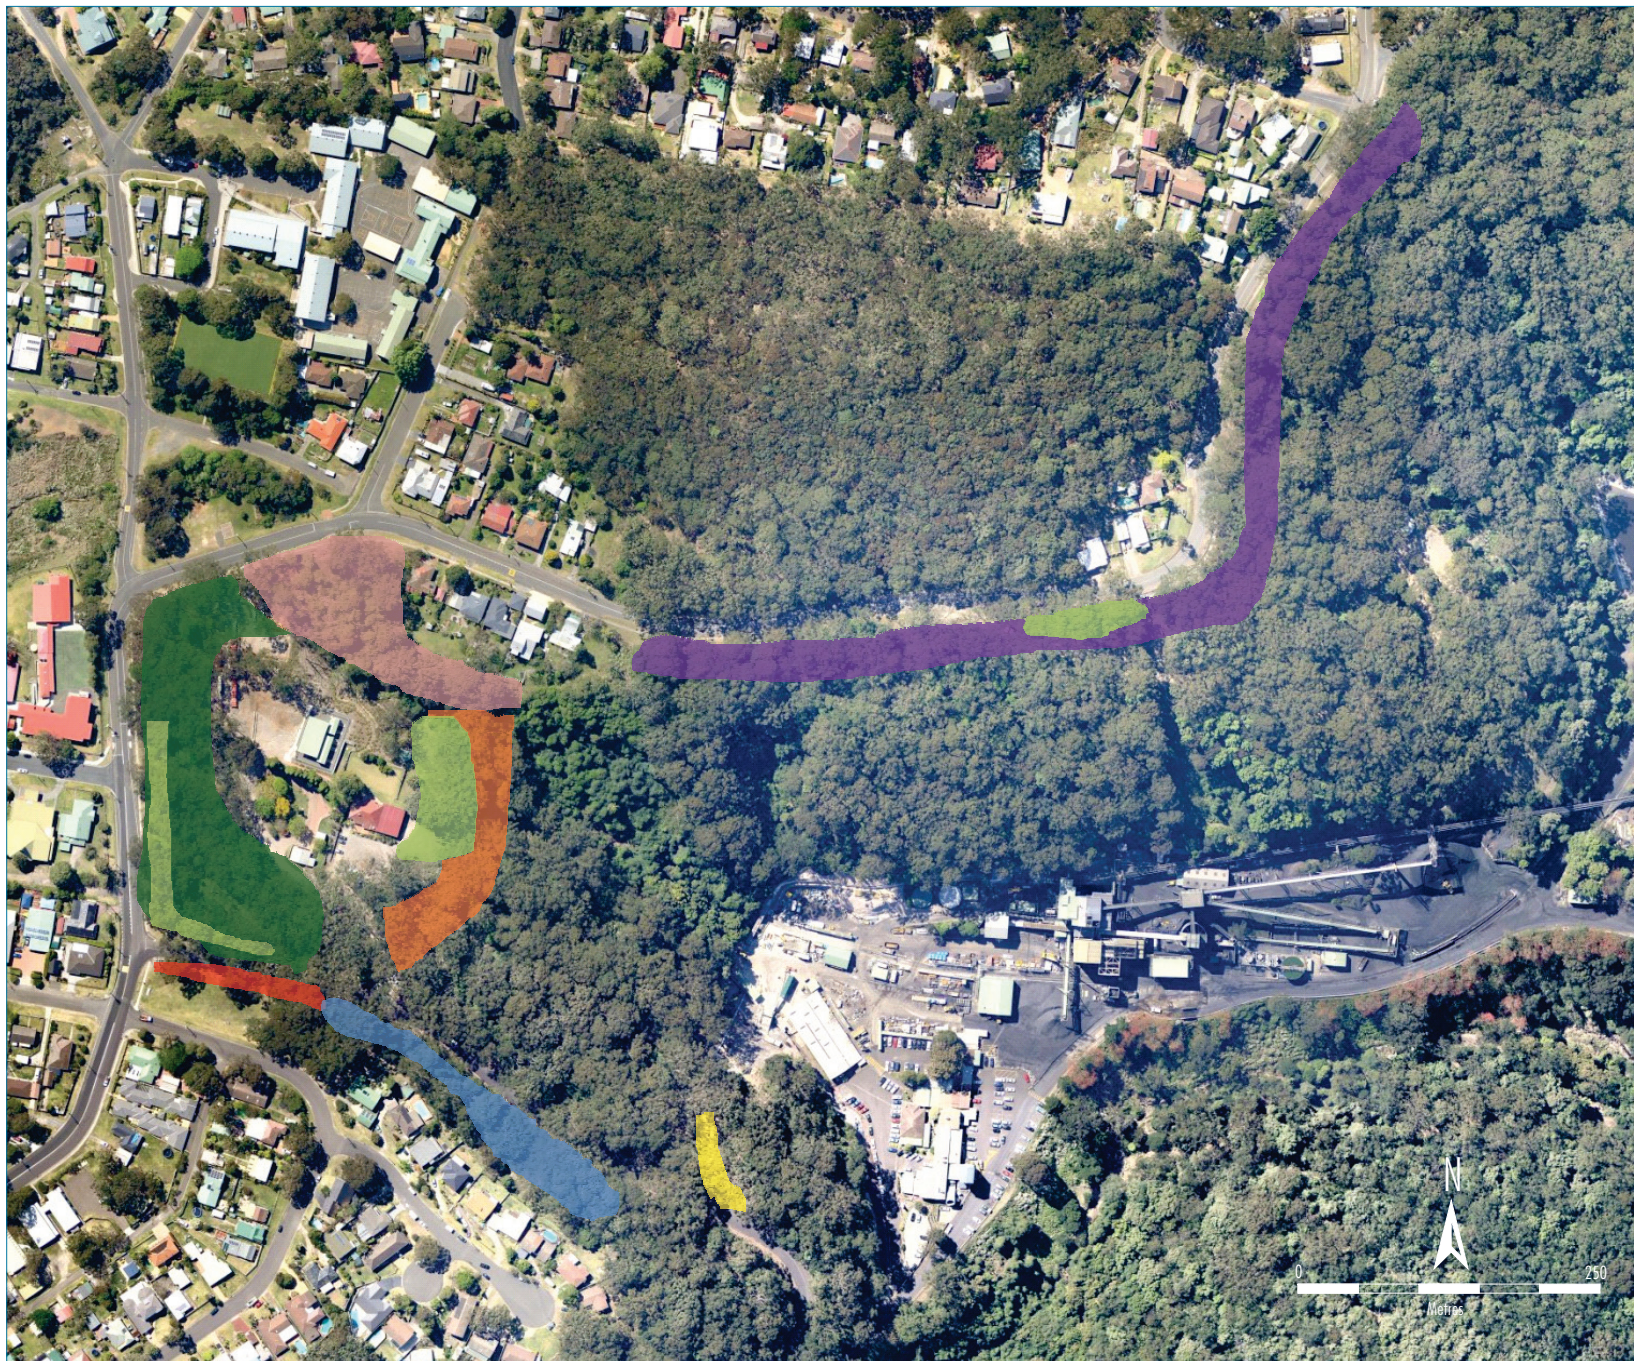
**Figure 23**

**Peabody**  
 METROPOLITAN COAL  
 Rehabilitation Zones Currently Available at the Surface Facilities Area

Figure 23 shows the designated rehabilitation zones (1 to 7) that are currently available for rehabilitation at the surface facilities area. Rehabilitation activities undertaken during the review period included control of introduced and environmental weeds across the designated rehabilitation zones (in particular Lantana [*Lantana camara*], Ginger Lily [*Hedychium gardnerianum*], Crofton Weed [*Ageratina adenophora*] and Mistflower [*Ageratina riparia*]). Control works were also undertaken on noxious weeds identified on Camp Creek (namely Pampas Grass [*Cortaderia selloana*] and Senegal Tea Plant [*Gymnocoronis spilanthoides*]).
