METROPOLITAN COAL LONGWALLS 311-316

WATER MANAGEMENT PLAN

November 2024

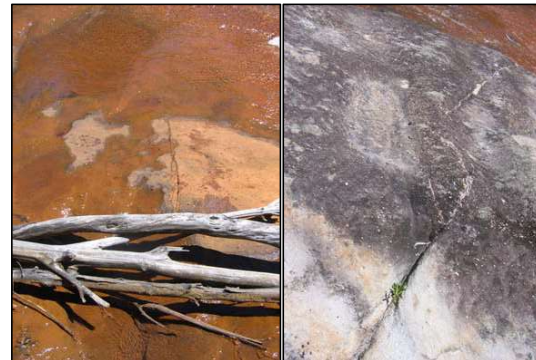
H-8 and H-9 Cracks in rockbar, 5mm wide, 5m apart.

- Pool length is approximately 40m. Width is approximately 9m to 20m. Average depth is approximately 1m to 1.5m.
- Algae and alluvial deposits on the southern side of the pool bed.
- Alluvial deposits on southern bank.
- Rockbar H approximately 27 to 37m wide.
- Pool flows out onto rockbar. Narrow turbulent flow over rockbar and some ponding. Rock shelf both sides of flow approximately 1m above water level.
- Cross bedding present. Boulders present along northern side of pool.
- Minor cracking at downstream end of rockbar H.

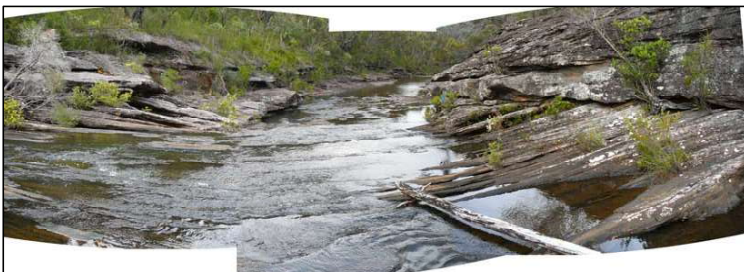
S-5 Iron staining at seepage

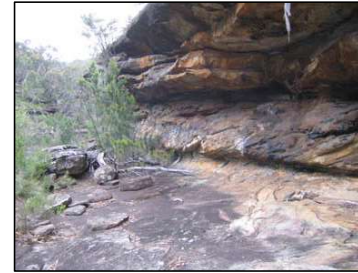
T-3 Iron stain at seepage, south east bank

- Average width is approximately 14m. Depth varies from approximately 0.1m to 0.5m with an average of approximately 0.3m. The length of Pool T is approximately 80m.
- Base of the pool is sandstone with pot holes at about the middle of the pool and sediment at the upstream end.
- Sandstone ledges with cross bedding present both sides of the pool. Distance between ledges is approximately 30m.
- Minor seepage and iron staining observed at cross bedding in sandstone ledges.
- Rockbar T is approximately 22m long and 27m wide and has pot holes.
- Water from Pool T flows over the surface of Rockbar T to a small pool which is approximately 5m in diameter. Flow from the small pool enters the rockbar as underflow and emerges at Pool U.

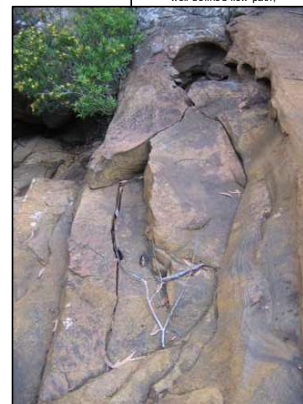
ETZ-10 Cracking at step down in sandstone

- Rockbar downstream of Pool ETZ is approximately 3m to 4m wide.
- Boulder field located on the south eastern side of the rockbar.
- Water emerges approximately 15m downstream of Pool ETZ
- There is a large change in vertical height over the boulder field located between exposed sandstone (could not be measured on site).
- Several potholes observed in exposed sandstone.
- A possible dry pool is located close to the upstream end of Pool ETAA.
- Boulder fields have sandstone blocks up to approximately 4m to 5m size.

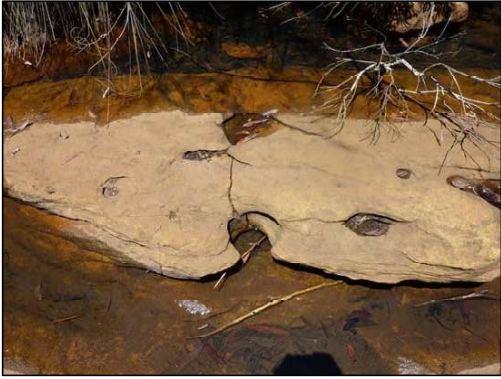
TA26-1 Cracking in rock

- Cracking through rock surface at downstream end of ponding
- Exposed sandstone upstream of Pool TA-J
- No visible flow from minor tributary into Tributary A at confluence, but minor flow visible further downstream
- Approximate 3m change in height from Pool TA-J to minor tributary

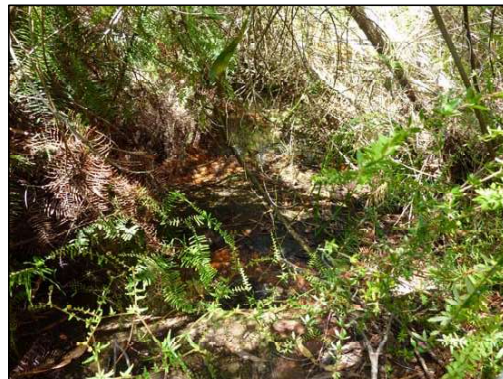
TB016-4 Ponding and iron staining looking Downstream

- Rockbar at TB014 approximately 1m wide, with alluvial deposits upstream and downstream
- Rockbar at TB015 approximately 1.5m wide, with alluvial deposits upstream and vegetation downstream
- Ponding with iron staining at TB016
