METROPOLITAN COAL

2020 ANNUAL REVIEW

Project No. MET-21-24
Document No. 01078829

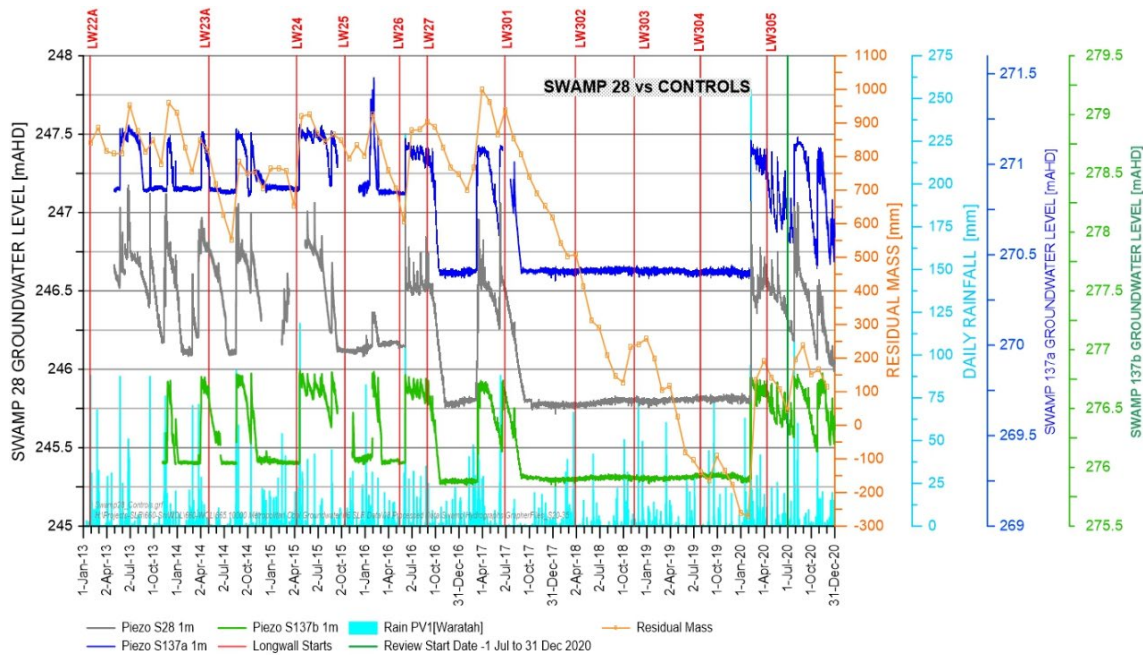
Chart 61 Groundwater Hydrographs at Swamp 28 and Two Control Swamps (137a and 137b)

A mining effect to the substrate water levels of Swamp 28 (overlying Longwall 24) was identified in 2016 based on the incomplete recovery of substrate water levels following rainfall events (Chart 61 and Appendices C1 and C2). Swamp 28 is considered to have an impact from mining of Longwall 25, although no effect on swamp substrate water levels occurred when Longwall 24 passed directly beneath the monitoring site (Appendices C1 and C2). The substrate piezometer at Swamp 28 returned to dry conditions from September 2017, remaining so until the end of December 2019, as did the two control swamp piezometers (Swamps 137a and 137b; Chart 61). With the large rain in February 2020, the water level in both the substrate and the shallow piezometer recovered. The substrate recorded saturated conditions until the end of the reporting period in December 2020, placing the substrate groundwater levels above the two standard deviation limit.

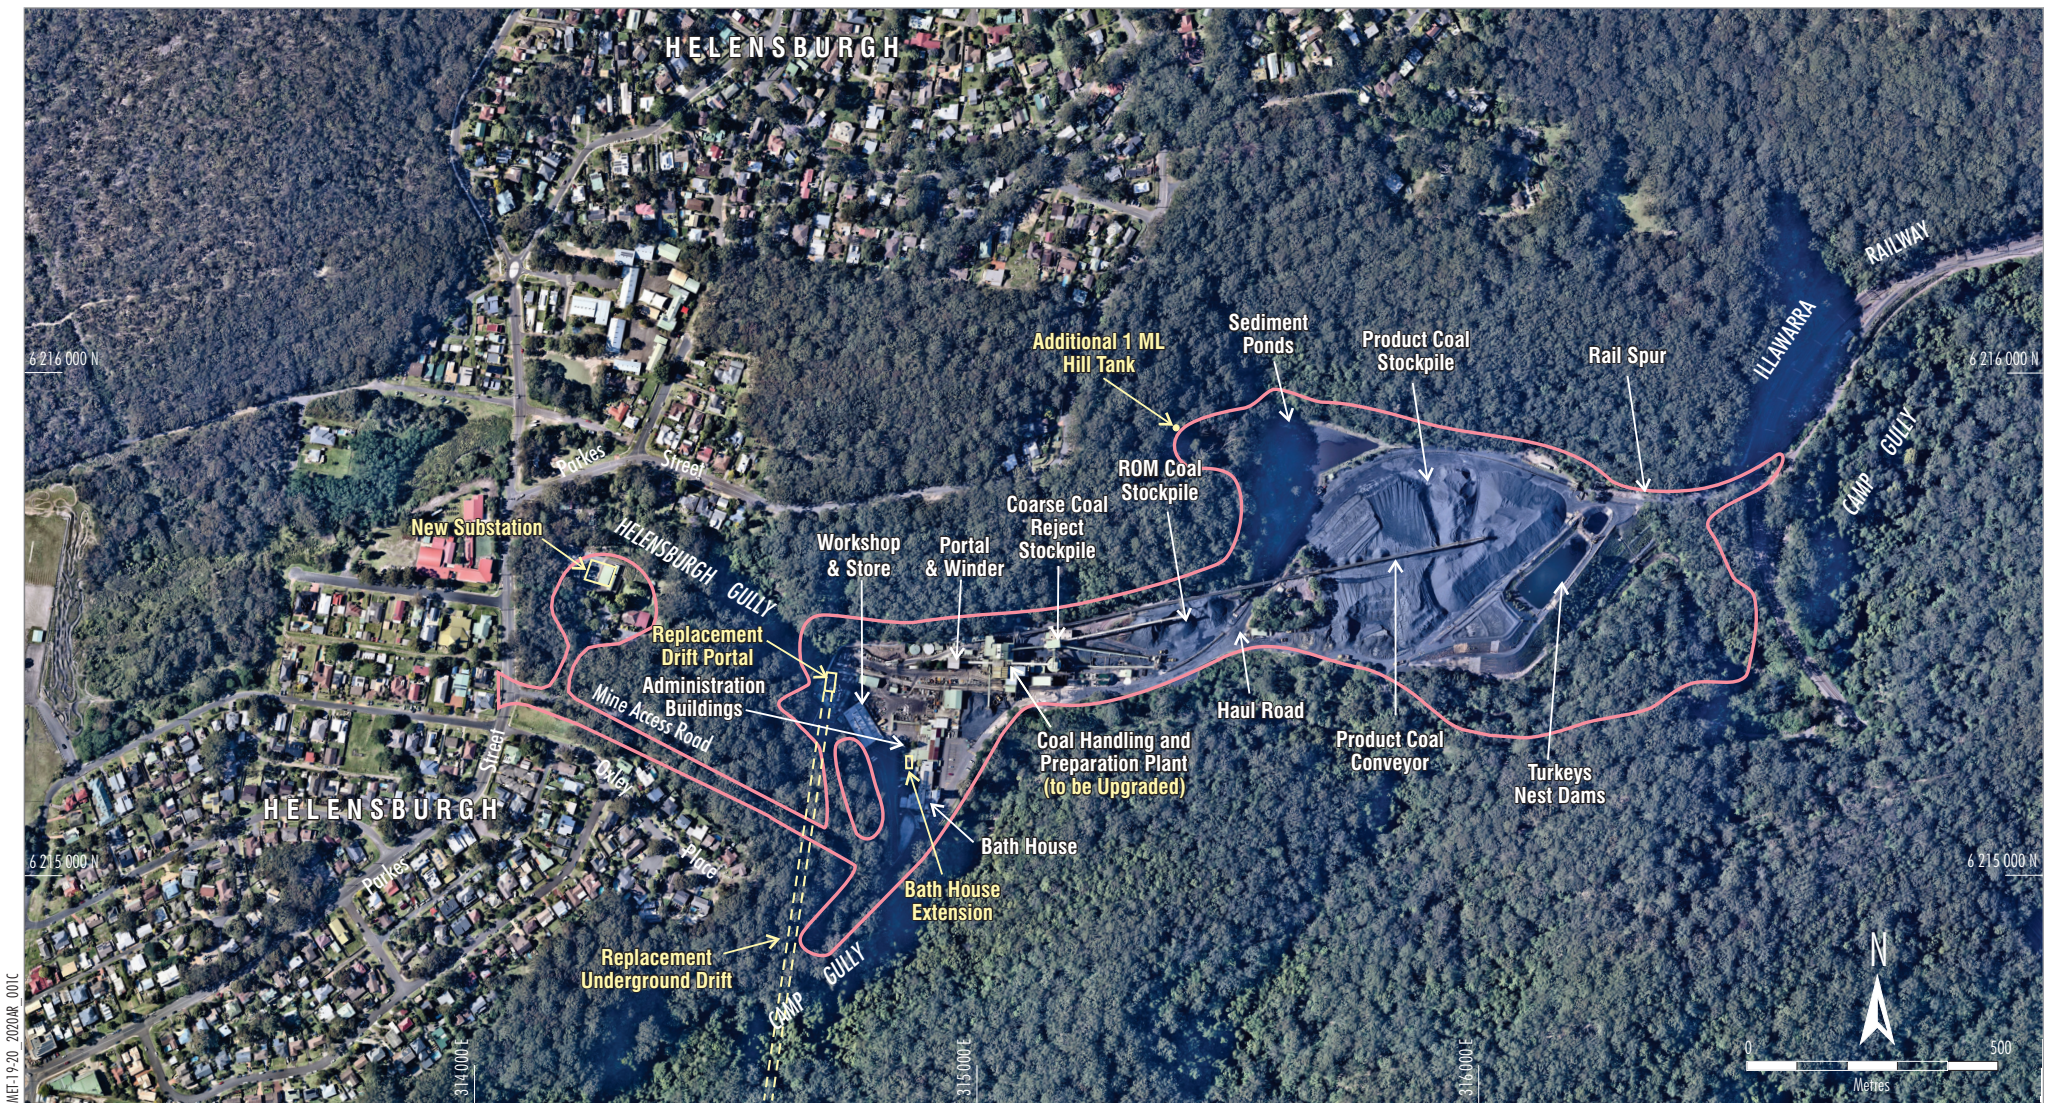
The mining area is defined by the Project Approval and is shown on Figure 1 of this report (labelled as Project Underground Mining Area Longwalls 20-27 and 301-317). There are 143 Aboriginal heritage sites within the mining area.

Peabody
 METROPOLITAN COAL
 Project Longwalls 20-27
 and Longwalls 301-317 Layout

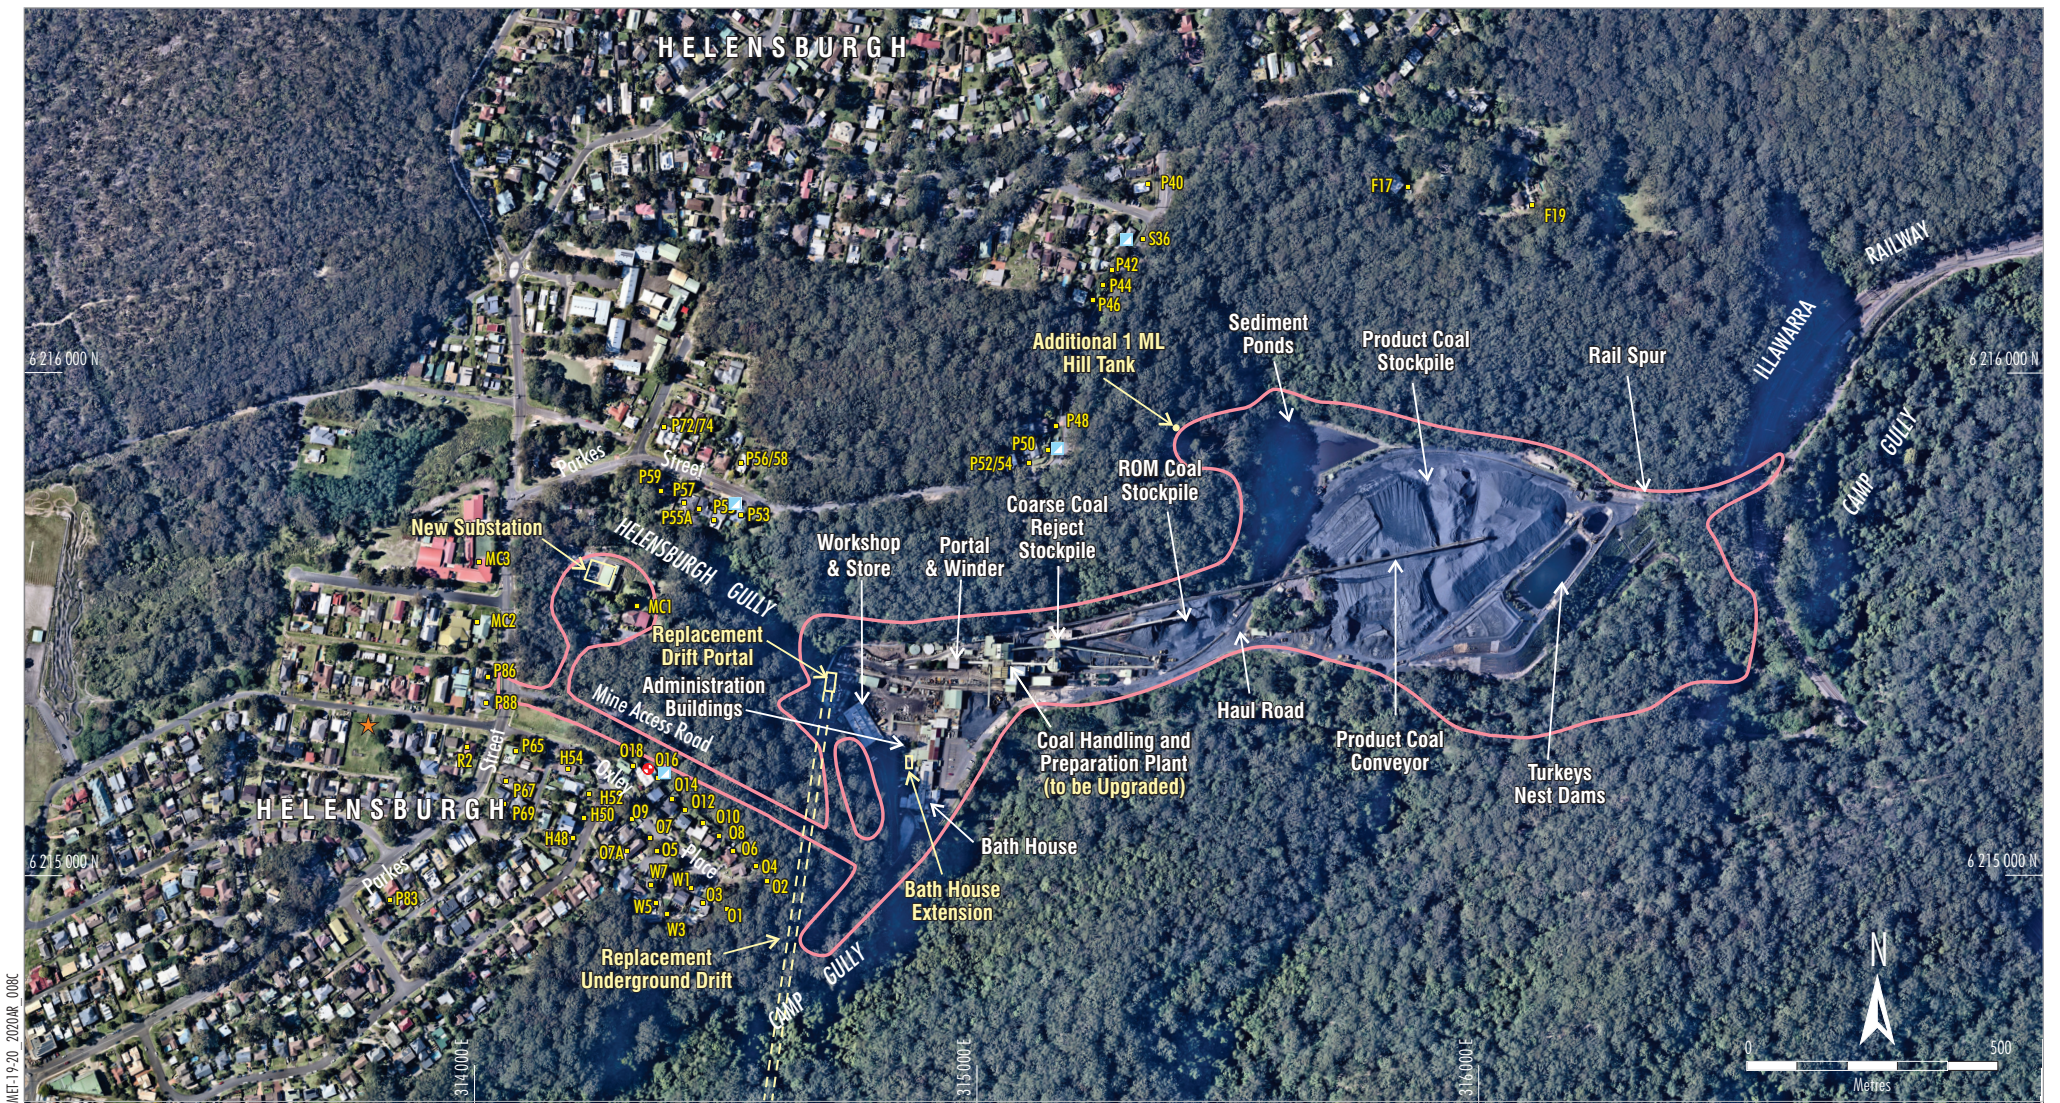
Figure 17

Five Aboriginal heritage sites (FRC 15, FRC 281, FRC 283, FRC 284 and MET 1) have been determined to have changes due to mining induced subsidence from Longwalls 20-22 (Figure 17). The observed impacts at each site were as follows:

Seven Aboriginal heritage sites (FRC 28, FRC 29, FRC 34, FRC 60, FRC 176, FRC 275 and FRC 301) have been determined to have changes due to mining induced subsidence from Longwalls 23-27 (Figure 17). The observed impacts at each site were as follows:

Peabody
METROPOLITAN COAL
Known Aboriginal Heritage Sites
Within Project Underground Mining Area
and Surrounds

In accordance with the Metropolitan Coal Longwall 304 Heritage Management Plan, monitoring of Aboriginal heritage sites FRC 76, FRC 77, FRC 78, FRC 86, FRC 90 and FRC 309 (Figure 17) was undertaken within three months of the completion of Longwall 304.

In accordance with the Metropolitan Coal Longwalls 305-307 Heritage Management Plan, monitoring of Aboriginal heritage sites FRC 67, FRC 68, FRC 70, FRC 71, FRC 76, FRC 77, FRC 78, FRC 85, FRC 86, FRC 87, FRC 90, FRC 91, FRC 93, FRC 117, FRC 309, FRC 310 and FRC 325 (Figure 17) was undertaken in 2021 (i.e. within three months of the completion of Longwall 305). The results of this survey will be reported in the 2021 Metropolitan Coal Six-Monthly Review.

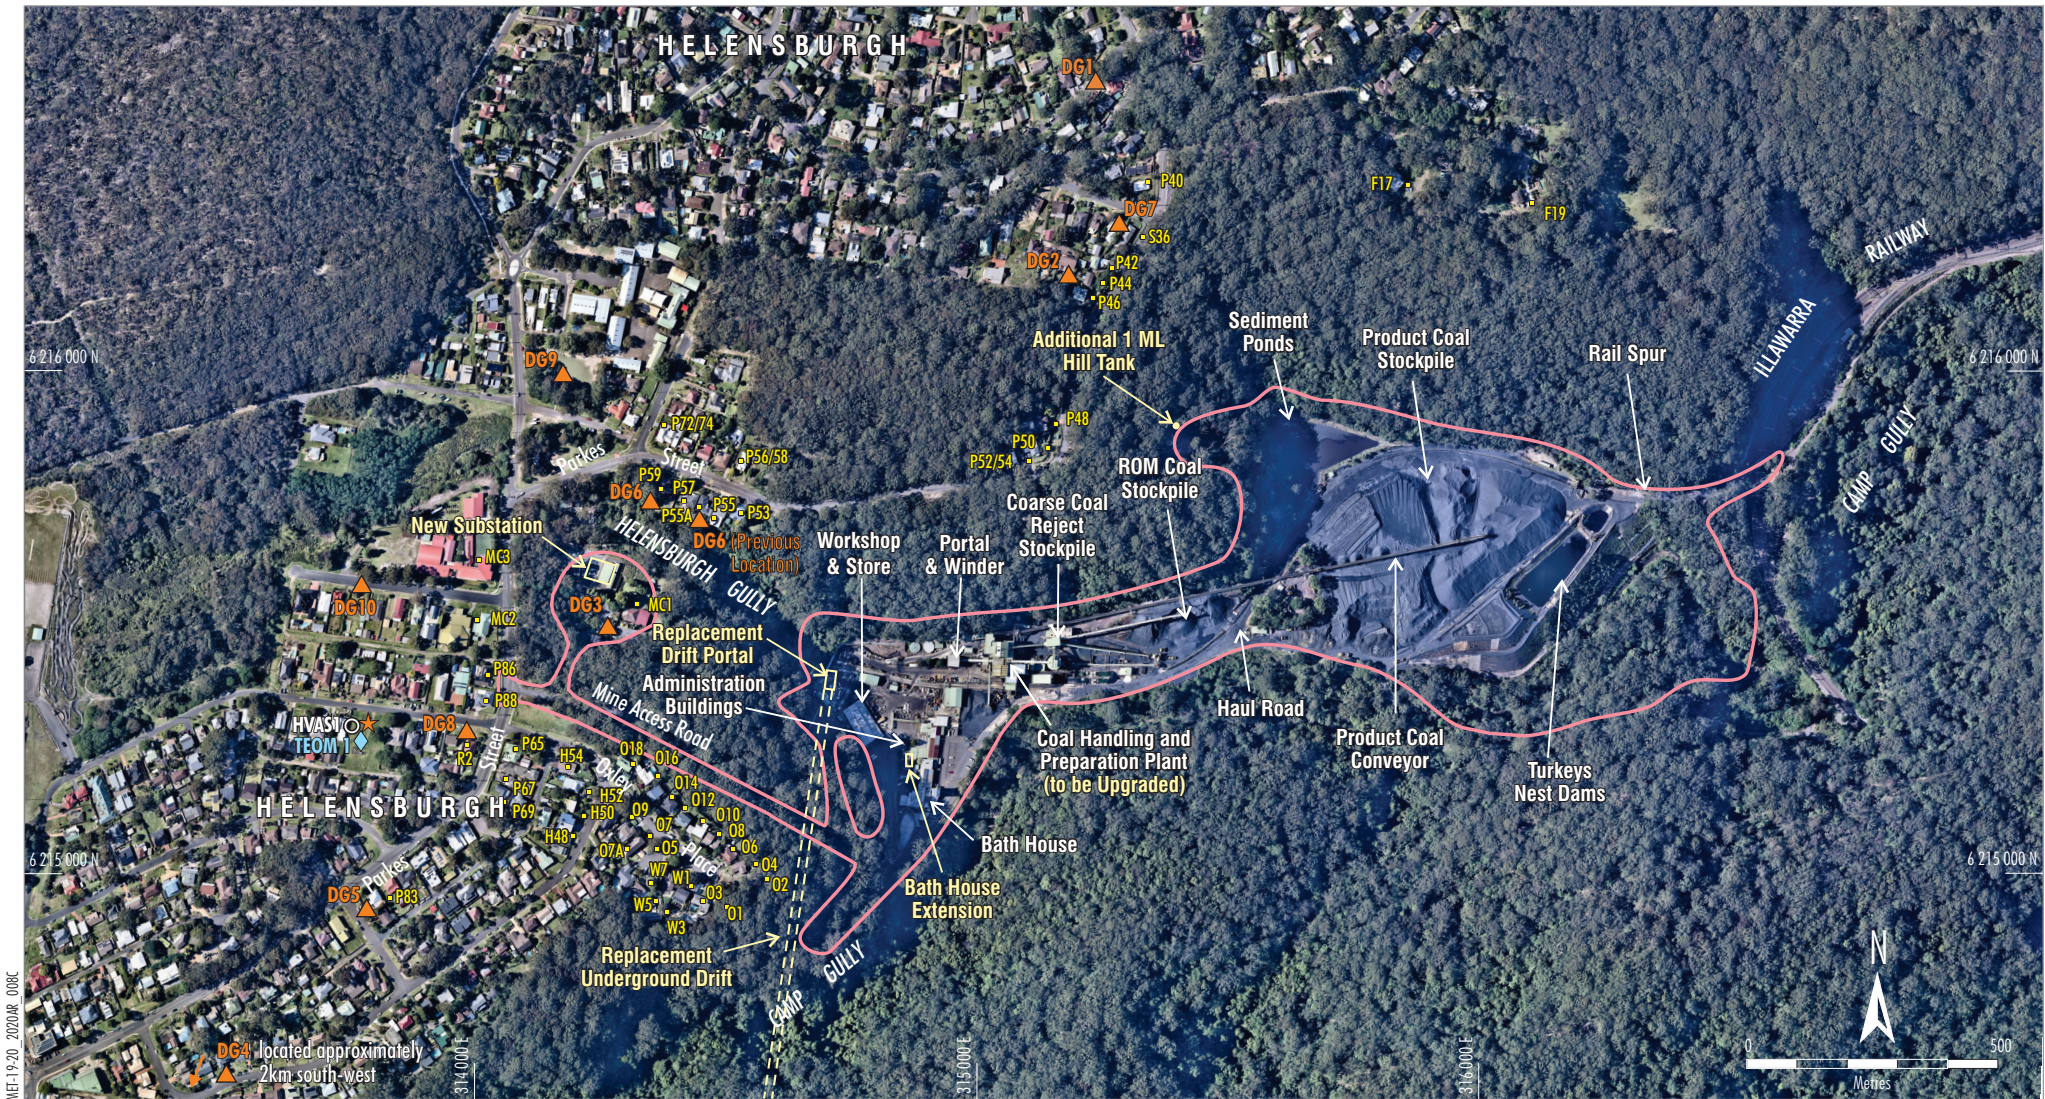
Figure 19d

The attended quarterly noise monitoring and compliance results for the review period are available in the quarterly monitoring reports prepared by SLR (Appendix L). A comparison of the quarterly attended monitoring results at each location for the period September 2010 to December 2020 is provided in Figures 19a to 19d.

METROPOLITAN COAL
Quarterly Operator Attended
Noise Monitoring Results at 36 Old Station Road
(September 2010 to December 2020)

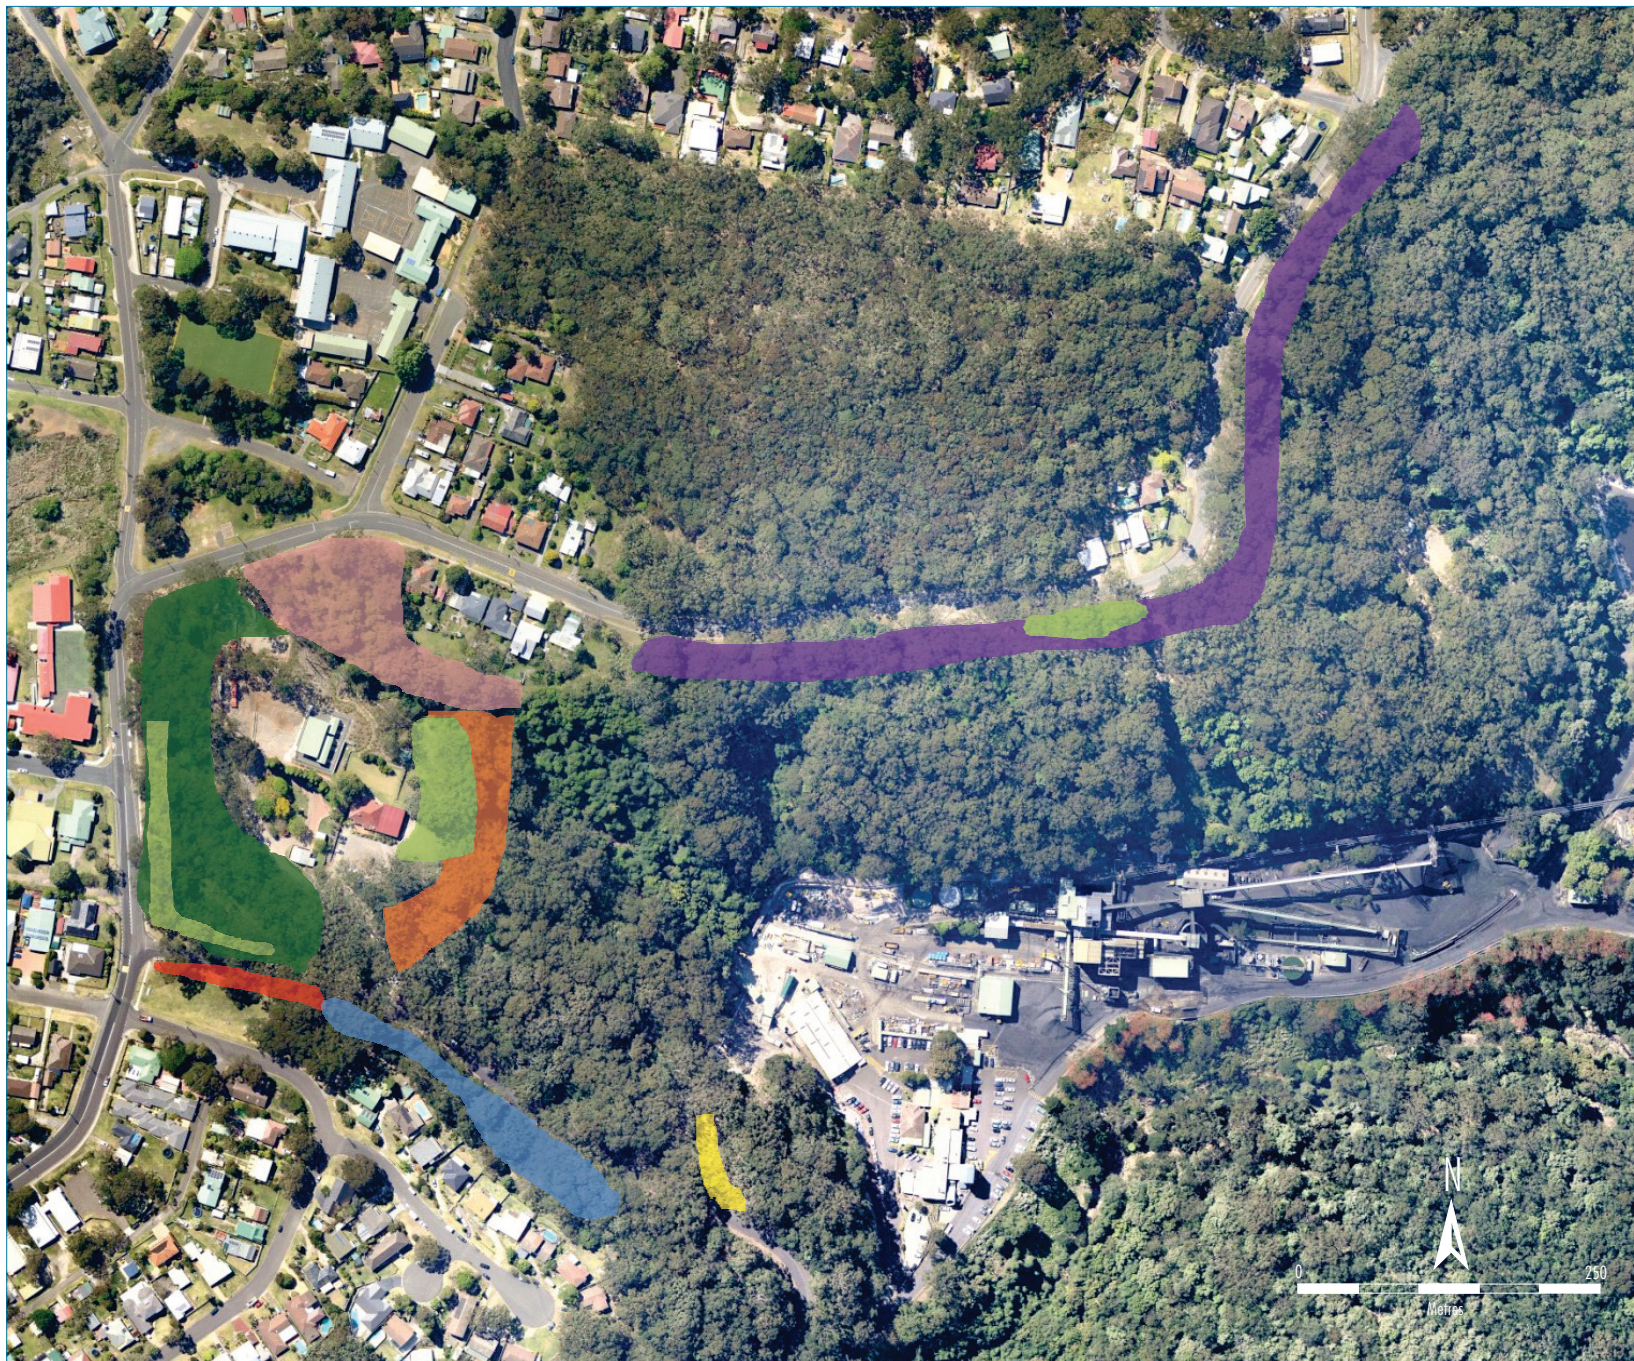
Figure 22

Camp Gully runs adjacent to the southern edge of Metropolitan Coal's surface facilities area (Figure 22). Metropolitan Coal's extraction of water from Camp Gully is specifically regulated by the Camp Creek Weir Surface Water Certificate of Title and more generally by the *Water Act, 1912* and the *Water Management Act, 2000*.

Peabody
 METROPOLITAN COAL
 Surface Facilities Area
 Water Monitoring Sites
