**WAMBO COAL PTY LTD
2016 ANNUAL REVIEW**

1 January – 31 December 2016

Name of operation	Wambo Coal Mine
Name of operator	Wambo Coal Pty Ltd
Development consent /Project Approval #	DA305-7-2003, DA177-8-2004, EPBC 2003/1138
Name of holder of development consent	Wambo Coal Pty Ltd
Title/Mining lease #	CL365, CL374, CL397, CCL743, ML1402, ML1572, ML1594, A444, EL7211
Name of holder of mining lease	Wambo Coal Pty Ltd
Water licence #	As per Table 3
Name of holder of water licence	Wambo Coal Pty Ltd
MOP start date	31 March 2015
MOP end date	30 March 2020
Annual Review start date	1 January 2016
Annual Review end date	31 December 2016
<p>I, Steven Peart, certify that this audit report is a true and accurate record of the compliance status of Wambo Coal Mine for the period 1 January 2016 to 31 December 2016 and that I am authorised to make this statement on behalf of Wambo Coal Pty Ltd</p> <p><i>Note.</i></p> <p>a) <i>The Annual Review is an ‘environmental audit’ for the purposes of section 122B(2) of the Environmental Planning and Assessment Act 1979. Section 122E provides that a person must not include false or misleading information (or provide information for inclusion in) an audit r

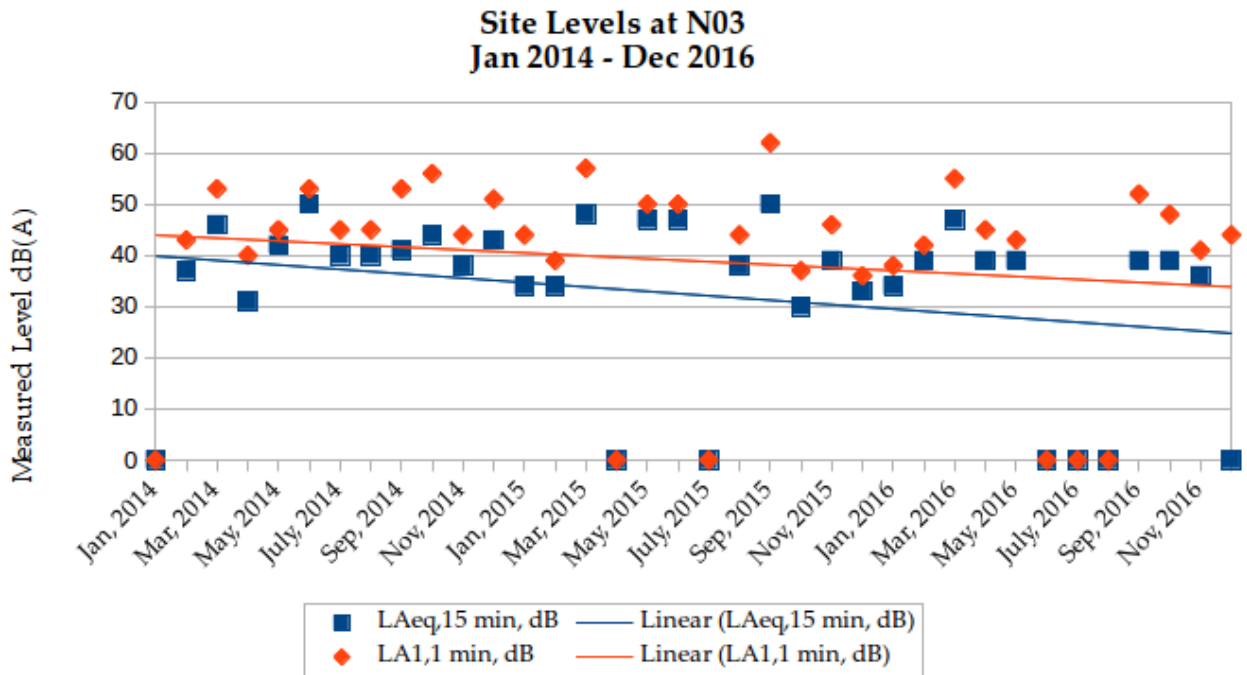
4.5.2 N03 - Kelly

Figure 3: Summary of Measured Site Noise levels, N03 – Kelly

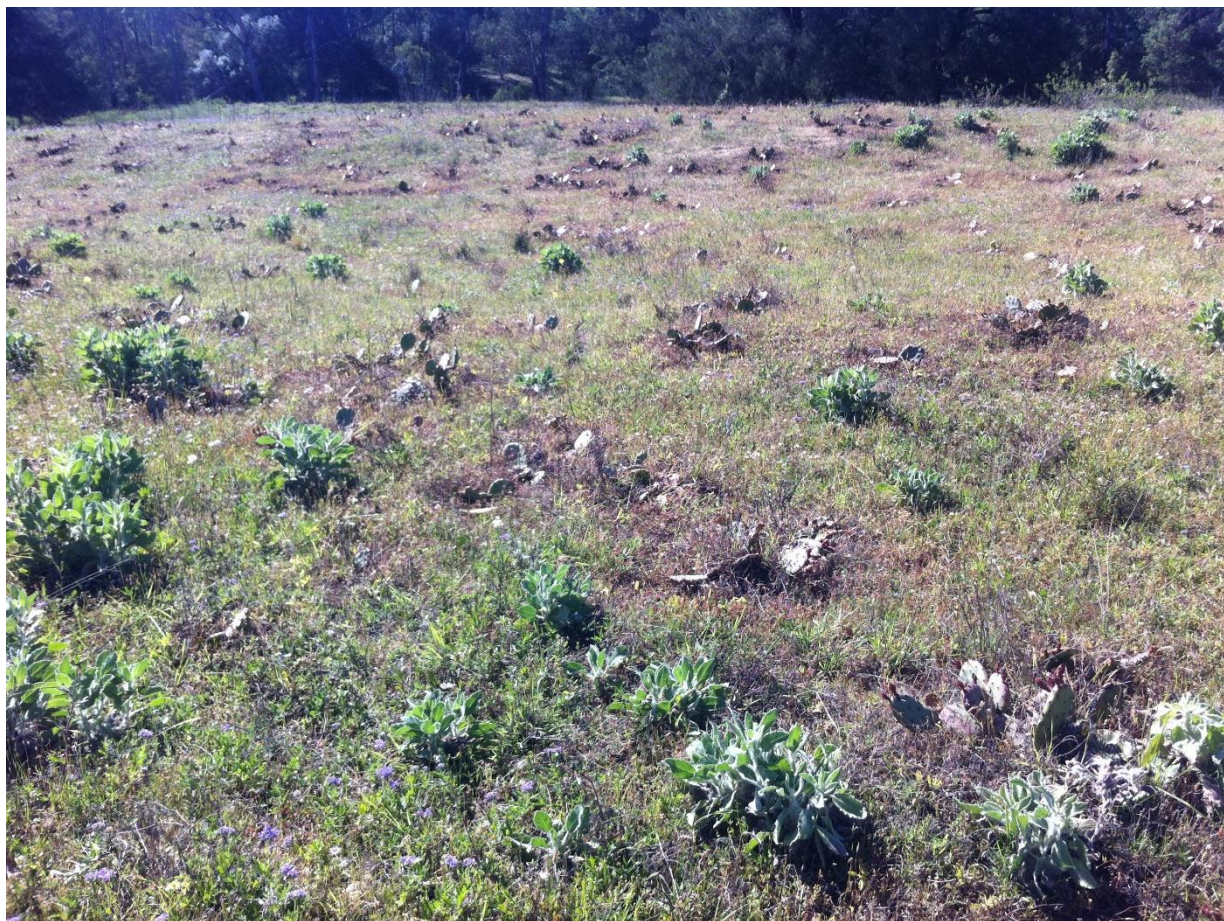
Cleared areas of the Wollombi Brook floodplain are not sampled as part of the monitoring program, however these areas have highest exotic cover and have been targeted by WCPL's weed control program. Herbicide treatment of *Opuntia* species was observed in RWEA A during the monitoring program (**Plate 2**).

Plate 2: *Opuntia humifusa* (Creeping Pear) infestation treated with herbicide in previously cleared areas of RWEA A

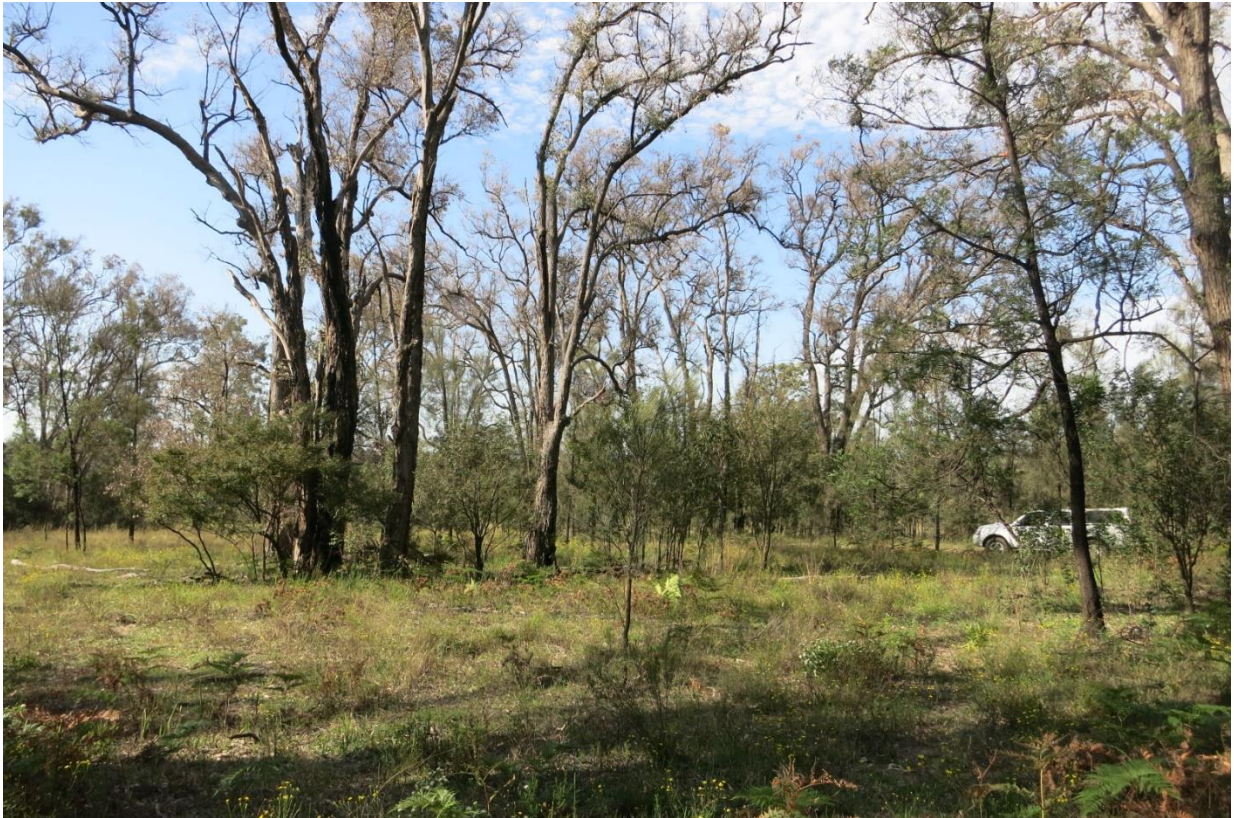
Dieback of *Angophora floribunda* (Rough-barked Apple) was noticed in sections of this community away from monitoring plots (**Plate 4 and 5**) and was severe in some locations. However this phenomenon did not appear to be restricted to the RWEA as dieback of *A. floribunda* was also noticed along Putty Road at the time. An investigation should aim to determine the cause of this dieback within WCPL lands with additional monitoring of the issue to determine whether management actions are required and what (if anything) can be done to remedy the issue.

Plate 4: *Angophora floribunda* canopy dieback in parts of Warkworth Sands Woodland in RWEA A

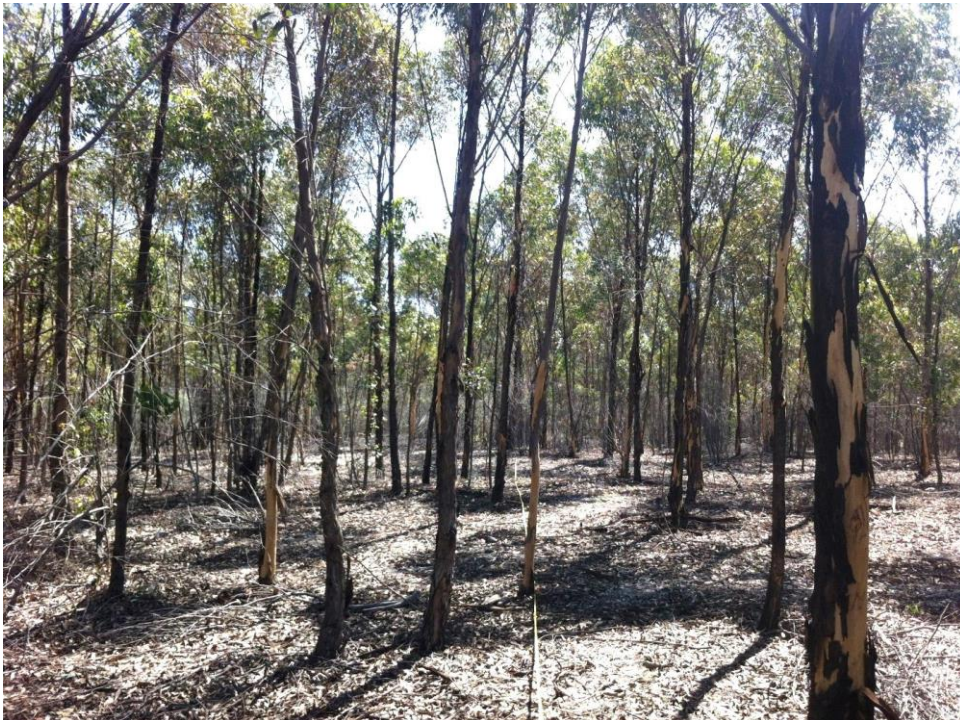
Plate 11: Woodland rehabilitation at site 3R

The area surrounding monitoring plot 6R appears to be the oldest area of woodland rehabilitation with ~ 8 m tall trees at 15 cm Diameter at Breast Height (DBH) and more than twice as many native species as the other three woodland rehabilitation areas. No particular issues with exotic weeds were identified in these areas, however small patches of *Galenia pubescens* were common in monitoring plots 6R and 8R and surrounds. Results from these woodland rehabilitation areas remain very similar to 2015 (when they were first sampled floristically). The number of native species remains generally low when compared to natural woodland sites nearby. Mid-storey and groundcover remain very sparse, with no groundcover score recorded along biometric transects for 2 of the 4 monitoring sites.

One small clump of *Lantana camara* (Lantana), a weed of national significance, was observed in the rehabilitation area of the mine. This observation is notable, as this species was not observed in natural areas surrounding the mine and has the potential to invade sheltered gully's and damp woodland sites.

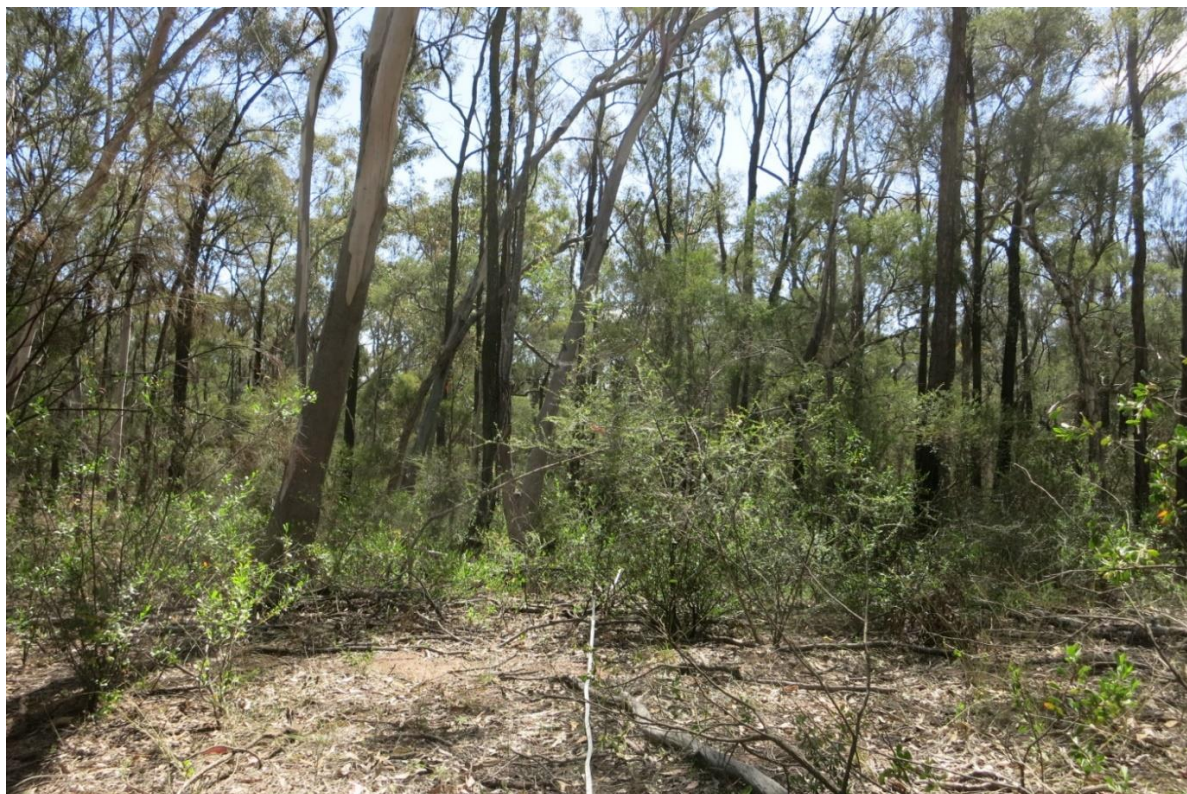
No subsidence impacts were observed at vegetation monitoring site V6-B1c, which was observed to be in good condition and met most performance criteria for vegetation monitoring. Cracking was observed at site V11-B1 however impacts on vegetation were very minor and limited to the 10 cm wide crack itself (**Plate 12**). Subsidence impacts were noted to the east of Site V6-B2c (**Table 15**), however these did not extend into the vegetation monitoring plot.

Plate 12: Vegetation monitoring plot V11-B1 – a small subsidence crack was observed at this location, however impacts on vegetation were very minor

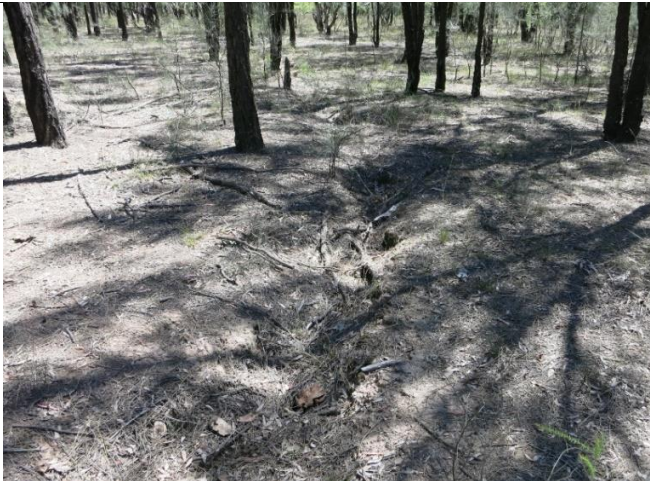
Notes	Location		Photo
	X coordinate	Y coordinate	
1.5 m deep hole ~ 40 x 100 cm wide. Close to eastern boundary of RWEA C , near flora monitoring plot V6-B2c	309563	6393020

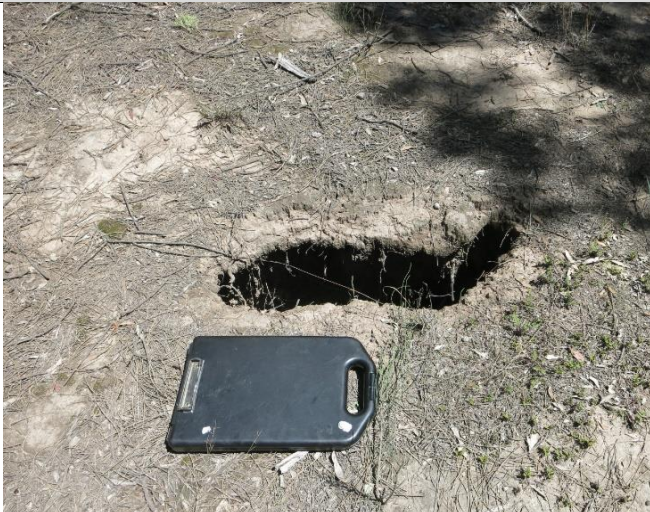
Subsidence hole 1.5 m deep x 1m wide, RWEA C, near flora monitoring plot V6-B2c	309526	6392970

A range of subsidence features were observed at WCPL. At present impacts to vegetation in RWEAs appears to be minimal, and as such, performance indicators in the draft BMP have not been exceeded. In addition, many smaller cracks and depressions are likely to self-repair over time. However, some of these features are impacting on EEC through water logging and deeper holes pose a risk to wildlife and humans. Some features on road edges may also become exacerbated by erosion. Suggestions for subsidence management in the draft BMP (WCPL 2016), including the filling of minor cracks with appropriate material, should be considered.

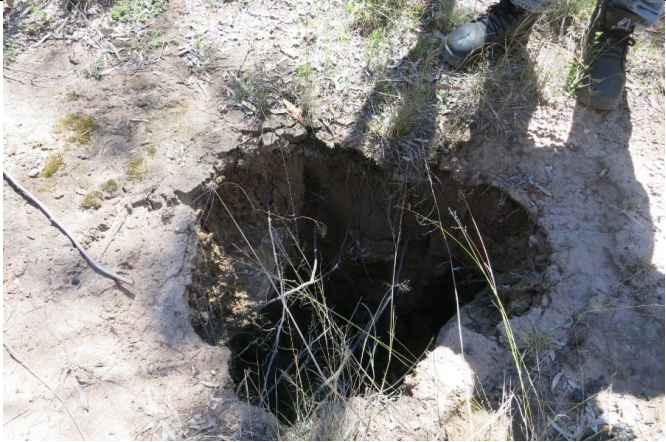
Notes	Location		Photo
	X coordinate	Y coordinate	
Damage to road at entry gate to RWEA C. Varies from 10 - 50 cm wide and runs for ~ 20 m	308095	6394238

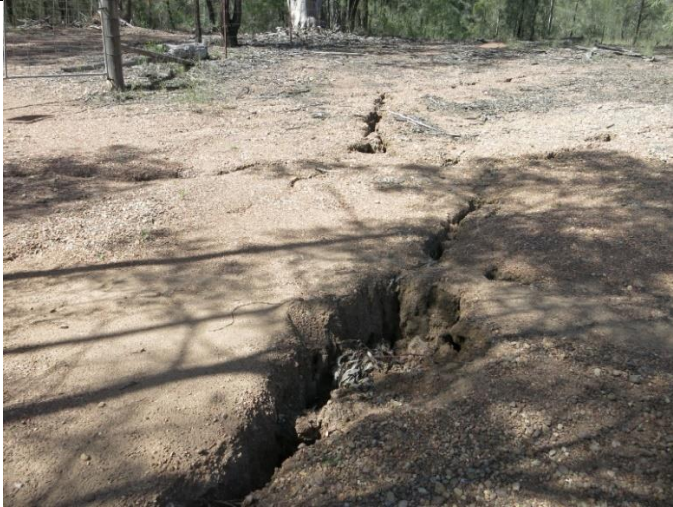
Subsidence cracks in access road in RWEA C, ~40 cm deep	308180	6394165

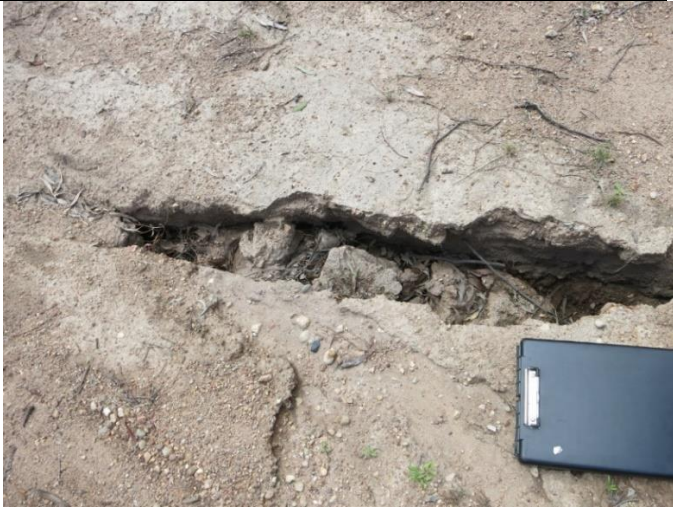
Notes	Location		Photo
	X coordinate	Y coordinate	
Subsidence crack generally 10 cm wide >30 cm deep through vegetation monitoring plot V11-B1. Crack runs for >60 m through <i>E. crebra</i> and <i>E. punctata</i> dominated vegetation. Vegetation damage surrounding this crack is very minimal.	308286	6394163

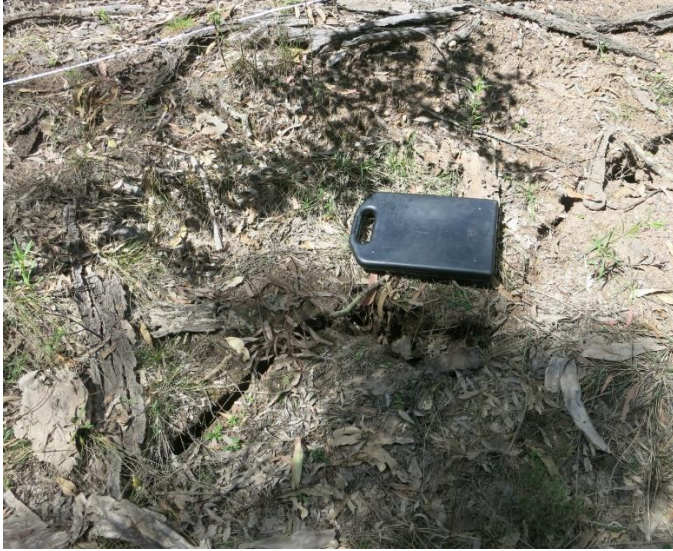
One of several cracks on ridgeline road in RWEA B, 1 m deep x 80cm wide crack which has been enlarged through erosion. No significant damage to vegetation nearby was observed.	308877	6392276

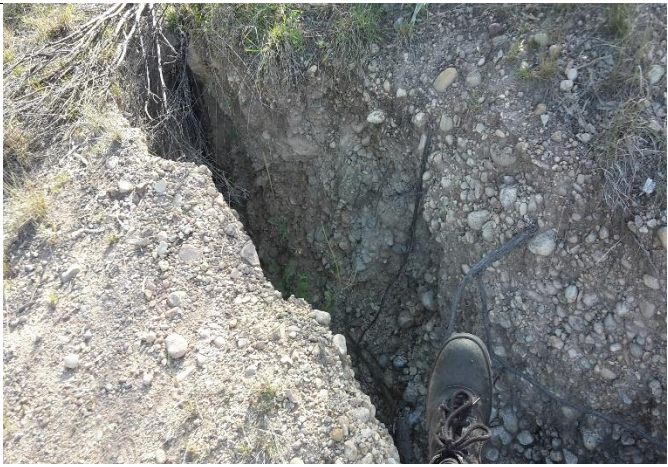
Notes	Location		Photo
	X coordinate	Y coordinate	
Several smaller cracks on access track on western boundary of RWEA C	3008002	6393577

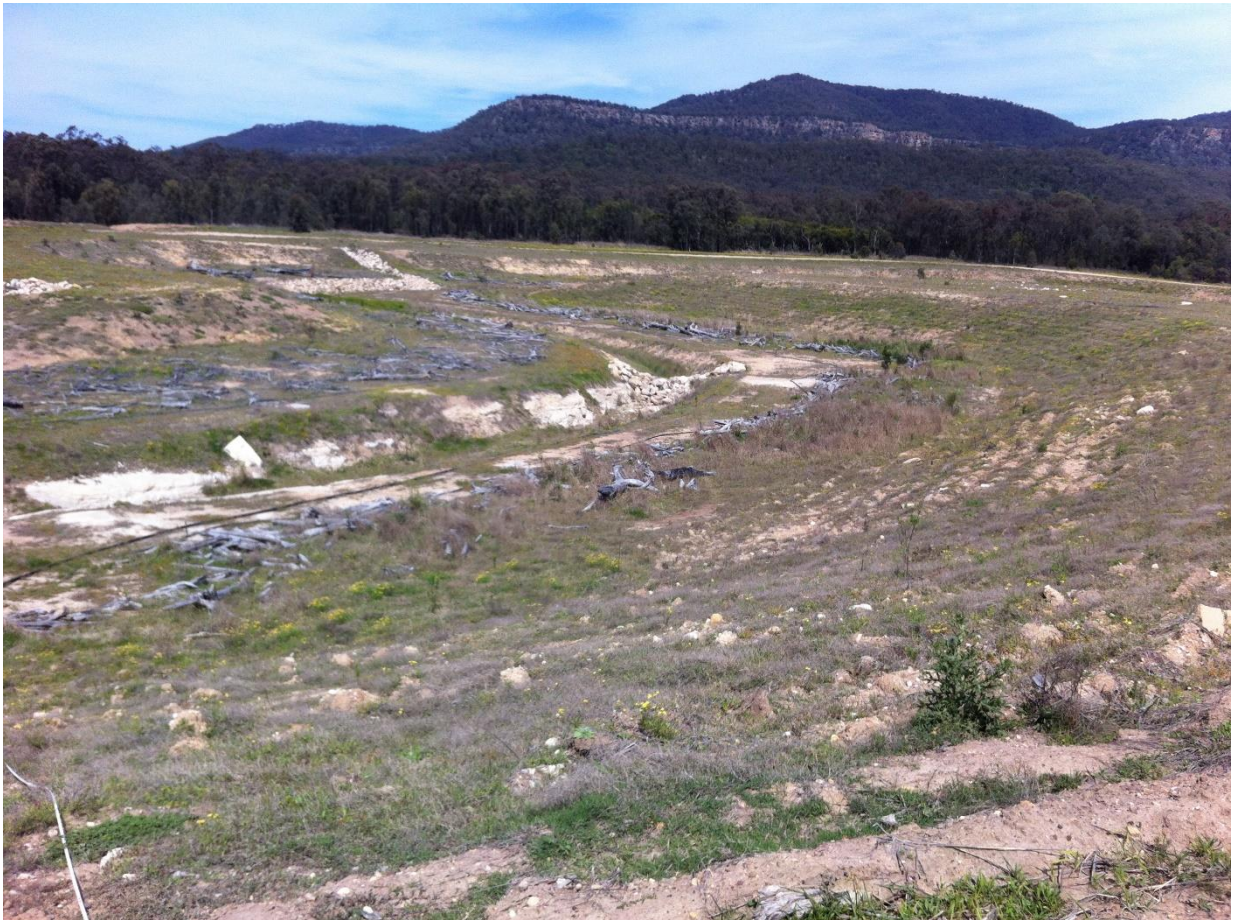
Plate 13: North Wambo Creek diversion near site 25R

Monitoring sites within the North Wambo Creek Diversion area are variable in condition and landscape functionality with individual monitoring sites described in **Table 18**. All monitoring sites have few native plant species and consist of predominantly low pasture, with tussocks of *Chloris gayana* (Rhodes Grass), *Galenia pubescens* and *Anagallis arvensis* (Scarlet Pimpernel) with other exotic pasture grasses and herbs. Areas of bare soil are prevalent throughout the diversion area, particularly to the south where recent ripping of soil and seeding has occurred during 2015 in an attempt to control weeds and establish cover (**Plate 13**). Some of the steeper slopes are experiencing erosion issues such as rilling (**Plate 14**:

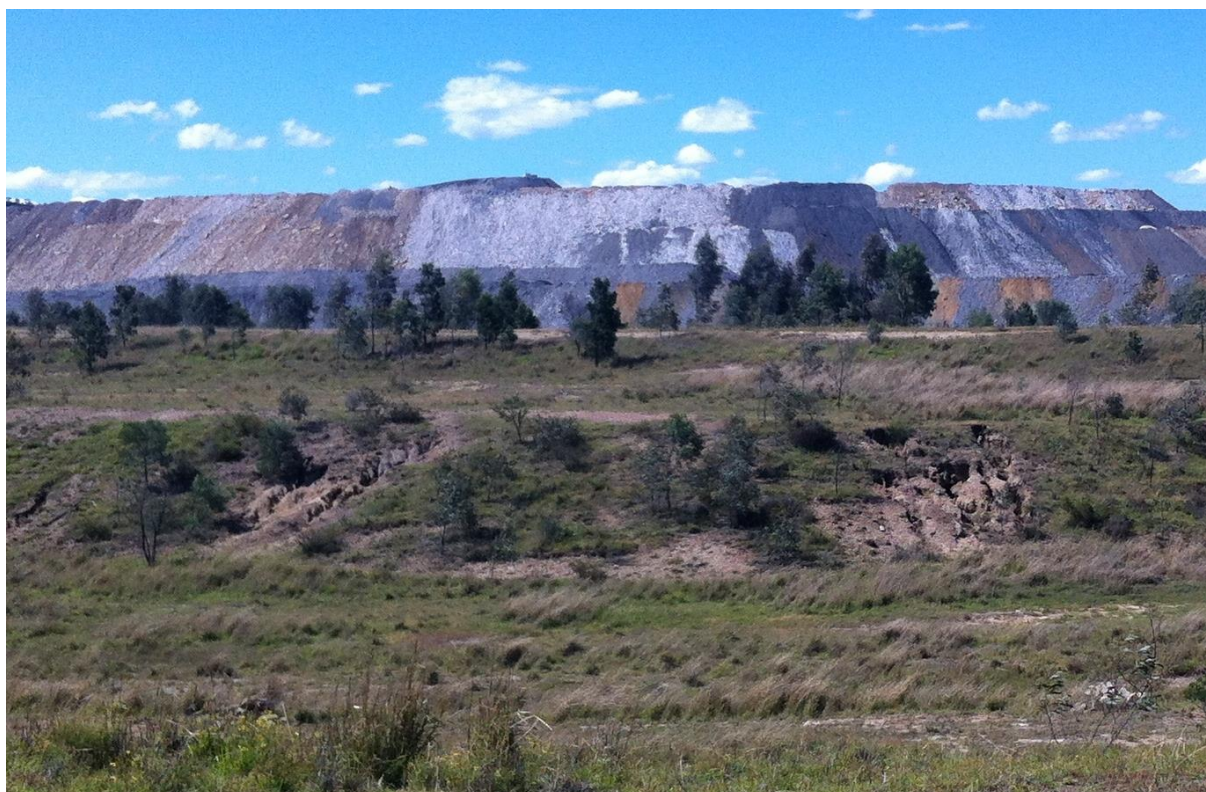
Plate 14: Soil erosion in sections of the North Wambo Creek diversion

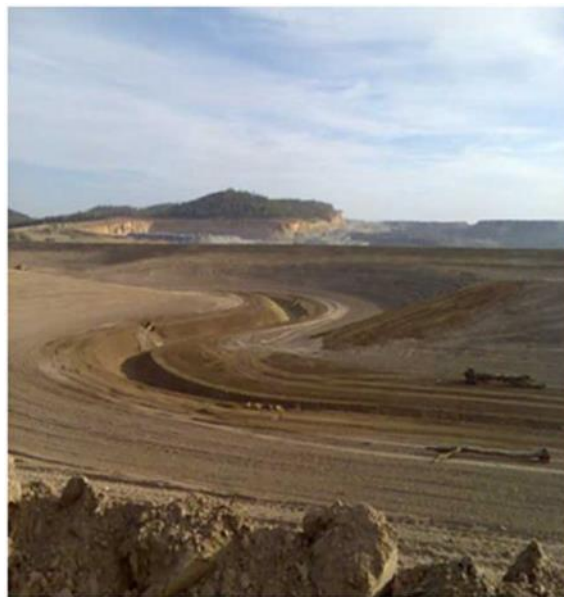
Plate 15: Construction stage of the North Wambo Creek diversion prior to completion in 2008 (Daracon, 2016)

An examination of previous LFA results reveals that landscape organisation scores appear to have either increased slightly or remained constant since the previous monitoring event in 2015. In a comparison with data collected in previous years, mean landscape organisation index were very low in 2008, reflecting the recently completed diversion area (**Plate 15**). Values for LOI then increased dramatically in 2009, likely due to cover crops of grasses establishing (**Plate 16**).

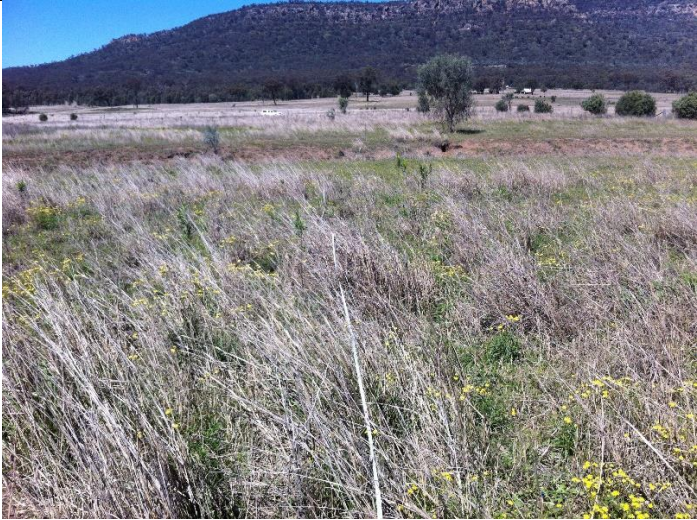
Transect	Notes	Photograph
17R	<p>Transect consists of relatively flat ground covered in pasture and appears relatively stable. Exotic vegetation dominates the area with <i>Chloris gayana</i> (Rhodes Grass) and <i>Senecio madagascariensis</i> (Fireweed) common throughout.</p> <p>Landscape organisation index and stability index values remain larger than performance criteria, due to dense pasture cover and relatively flat ground that is less prone to erosion. Infiltration and nutrient cycling indices remain below performance criteria, however these values are larger than all other riparian sites.</p>

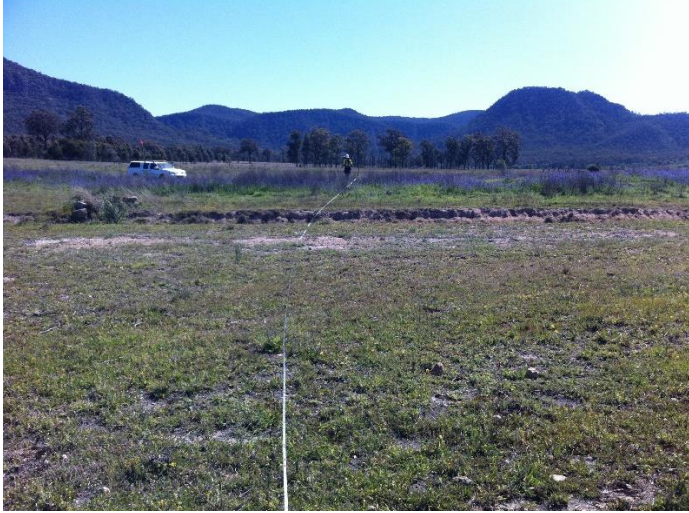
Transect	Notes	Photograph
19R	<p>Transect relatively flat, with several small patches of bare soil throughout. <i>Chloris gayana</i> dominates the vegetation species present. A mound of soil on the western bank is covered with dense <i>Echium plantagineum</i> (Patterson’s Curse - a noxious weed) and <i>Galenia pubescens</i> (Galenia). Young <i>Eucalyptus</i> and <i>Acacia</i> species are growing on creek banks downstream.</p>

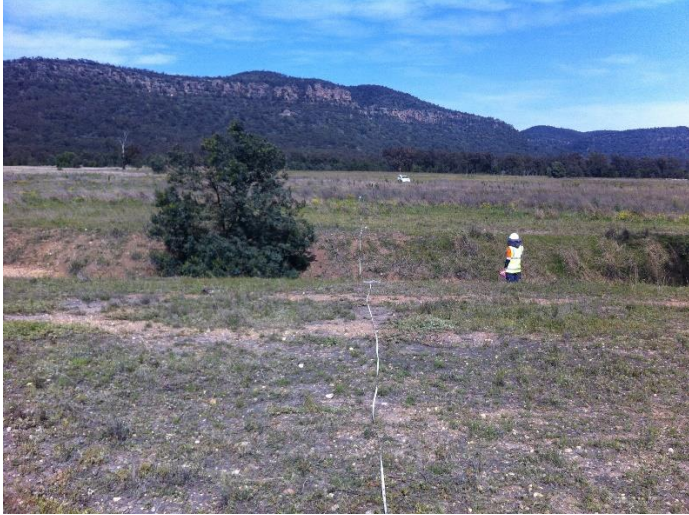
21R	<p>Transect relatively flat grassland, with low sparse grass and exotic herb patches dispersed by areas of bare stony soil.</p>

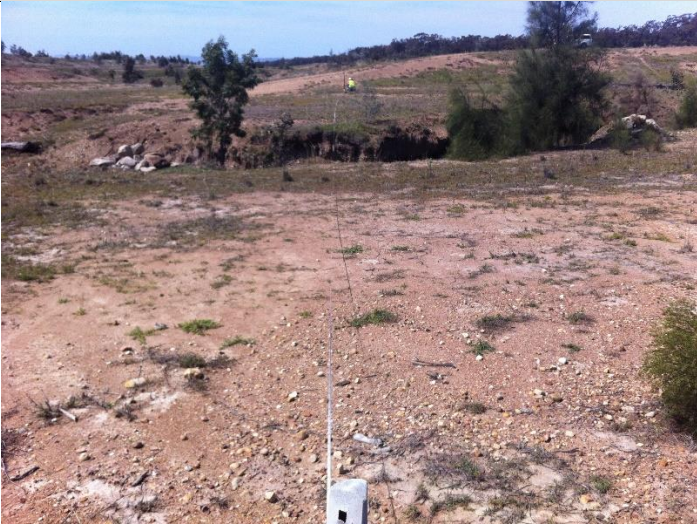
Transect	Notes	Photograph
23R	<p>Low, primarily exotic vegetation with some extensive areas of bare soil and stony ground. The creek bank is undercut and slumping on western bank. A stand of ~5m tall <i>Casuarina cunninghamiana</i> and seedlings and some young Eucalypts are growing on creek banks.</p>

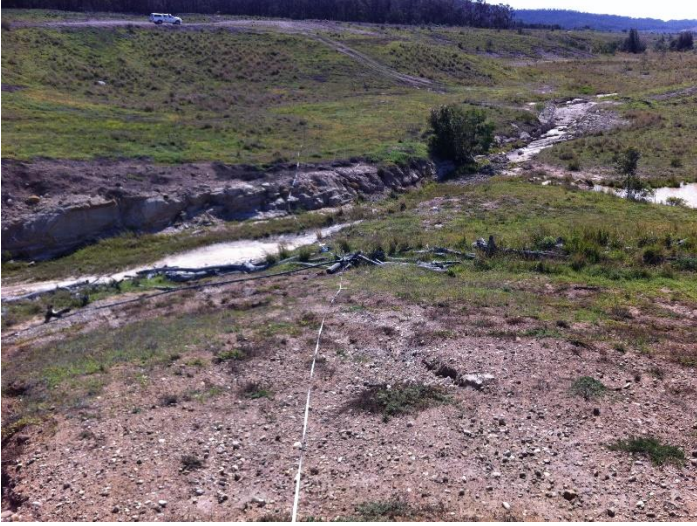
28R	<p>Transect primarily samples the relatively steep eastern bank then crosses the creek. The eastern bank consists of a large bare patch of stony soil with <i>Galenia pubescens</i>. Rill and terracette erosion present nearby on this slope. <i>Cynodon dactylon</i> (Couch Grass) dominates the lower slopes. The creek channel has been cut into the sandstone bedrock from this point downstream, creating shallow soils in the riparian zone.</p>

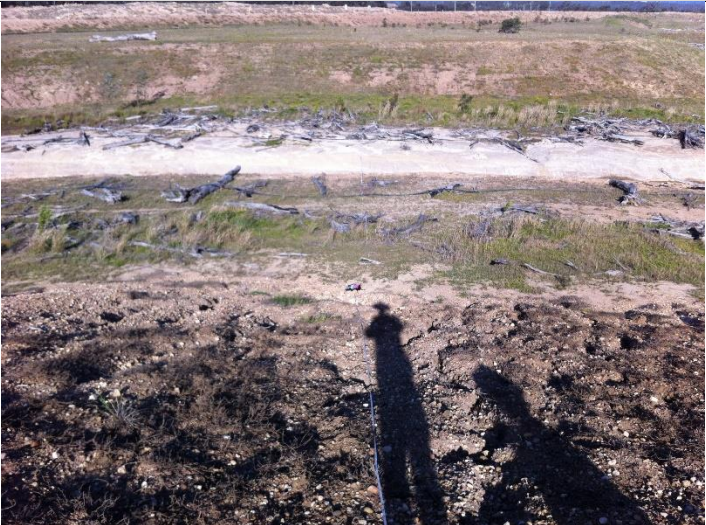
Transect	Notes	Photograph
27R	<p>Transect samples the relatively steep western bank of the cutting. Bare stony soil with patches of dead <i>Galenia pubescens</i> and moderate to severe erosion issues dominate this bank. Low sparse grasses and logs dominate the flat area adjacent to the creek channel.</p>

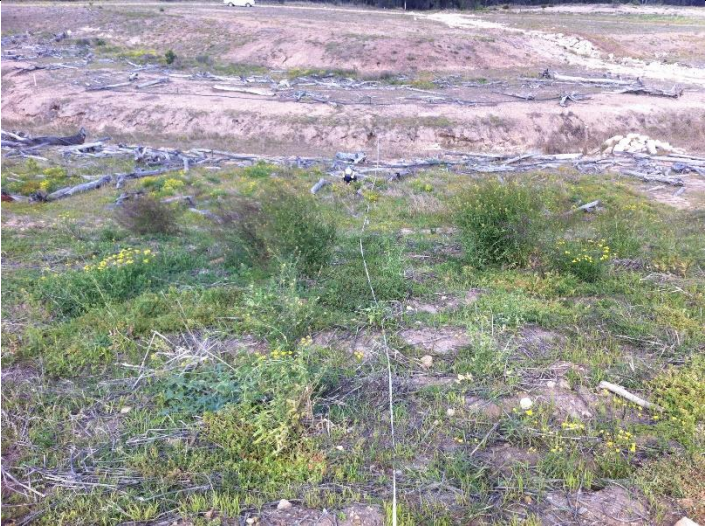
26R	<p>Transect samples the relatively steep eastern bank to the edge of the creek channel. Exotic vegetation dominates the monitoring transect with some small bare soil areas.</p>

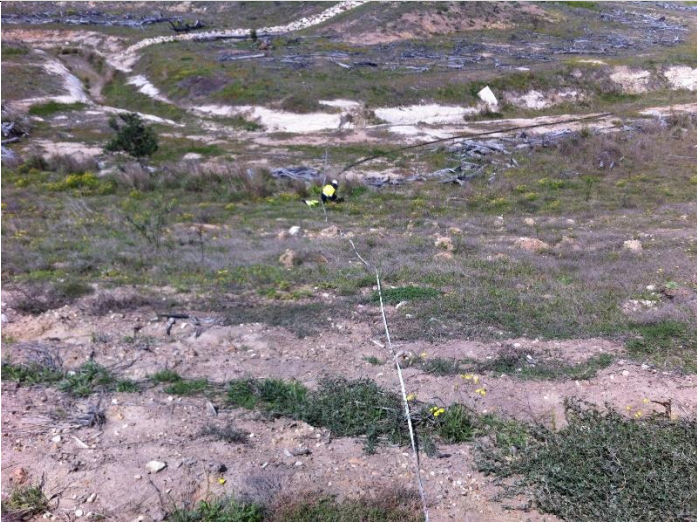
Transect	Notes	Photograph
25R	<p>This slope is relatively steep with bare patches from recent (late 2015) ripping of the soil. Grasses and herbs have colonised trough areas. Large tussock grasses (<i>Chloris gayana</i>) and logs are present at the bottom of the transect near the creek channel.</p>

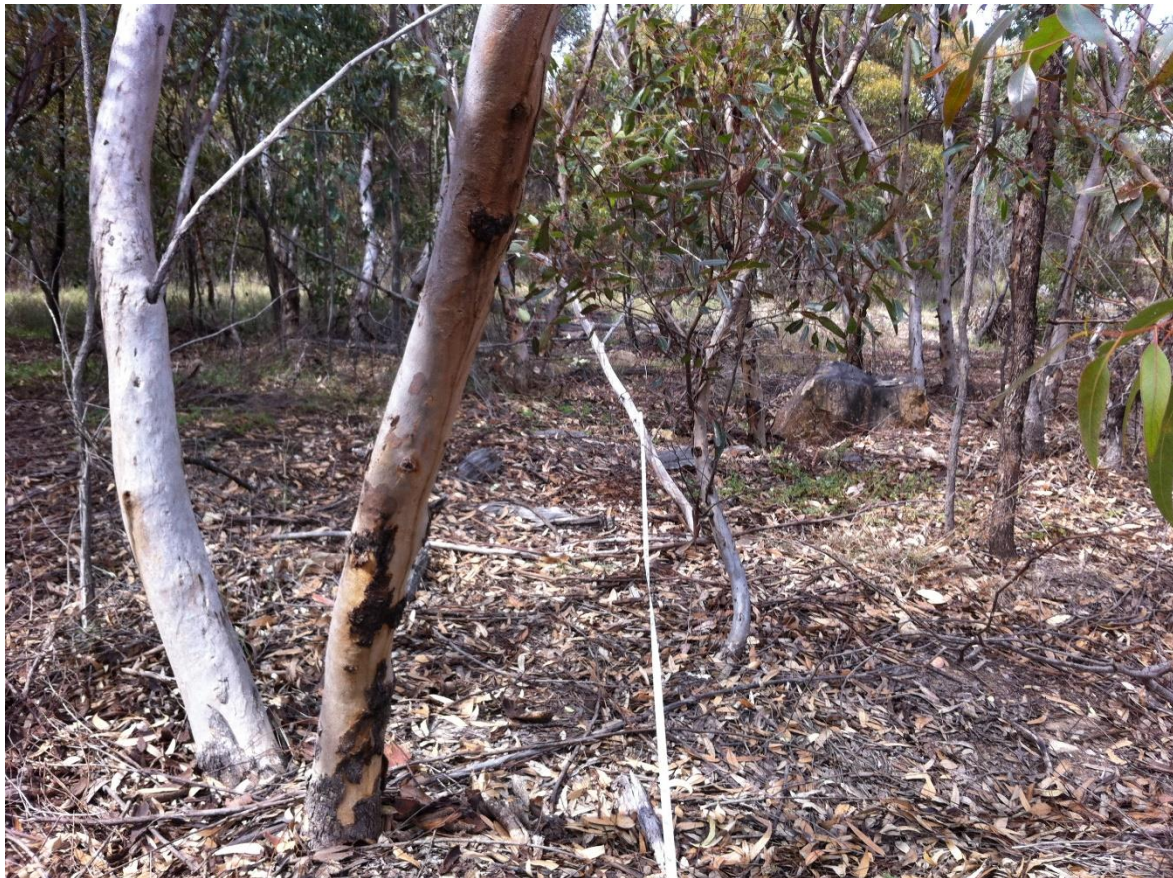
Plate 17: Woodland rehabilitation monitoring site 6R in 2016

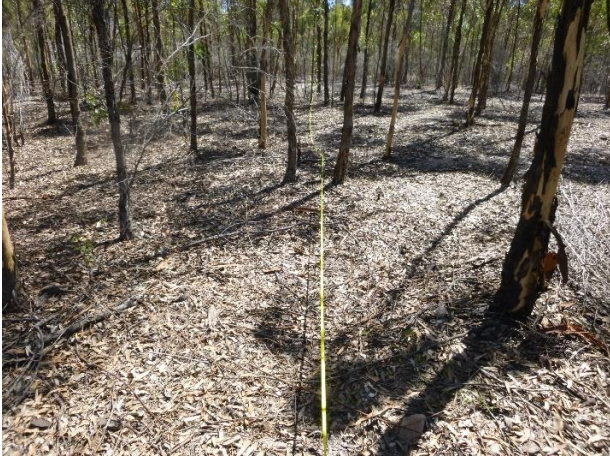
Transect	Note	Photograph
3R	<p>A relatively flat transect through a planting of <i>Eucalyptus cladocalyx</i> (Sugar Gum). The understory is very sparse and leaf litter is the major patch type. Some bare rocky soil areas are present at the end of the transect.</p>

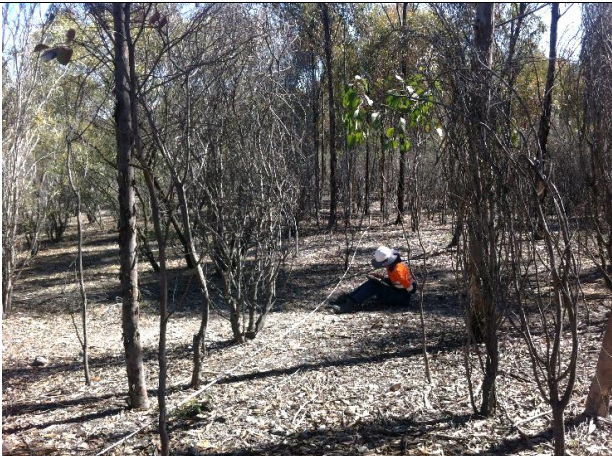
4R	<p>This transect travels along a small ridge and slopes slightly towards the end. The transect is surrounded by plantings of <i>Eucalyptus cladocalyx</i> and <i>Corymbia maculata</i> (Spotted Gum). Understory is very sparse and again leaf litter is the major patch type</p>

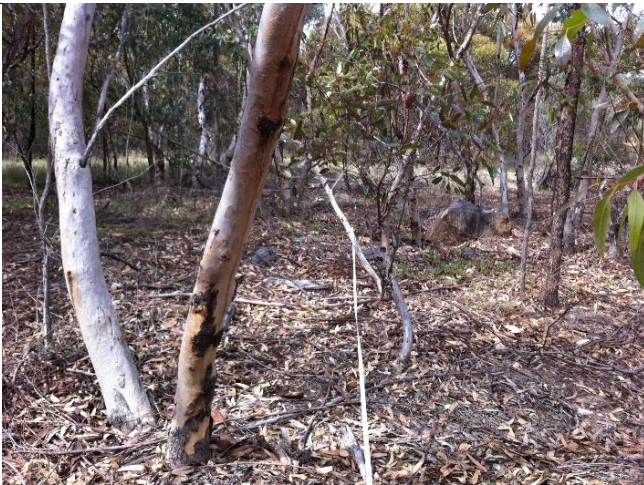
.6R	<p>This site is the best performing woodland rehabilitation monitoring site. A canopy of <i>Eucalyptus cladocalyx</i> is present with several native midstory species and native grasses and herbs. The weed <i>Galenia pubescens</i> also occurs in small patches. A dense cover of leaf-litter is present.</p>

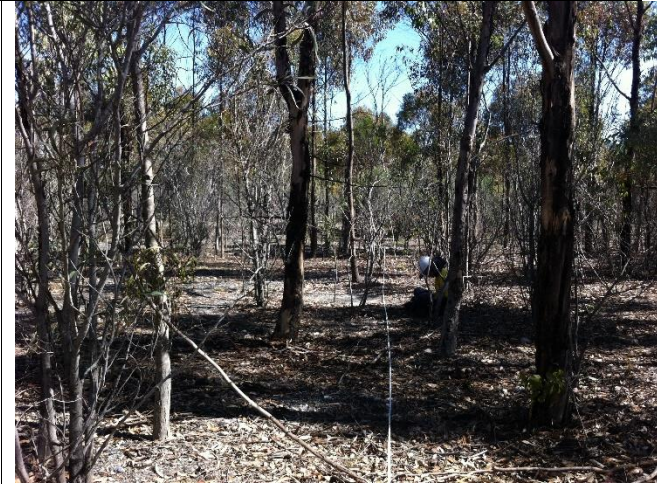
8R

This transect is located on a lightly sloping site with plantings of *Eucalyptus cladocalyx* and *Corymbia maculata*. Leaf litter and rock are the major patch types. Several areas of bare rocky soil are present.

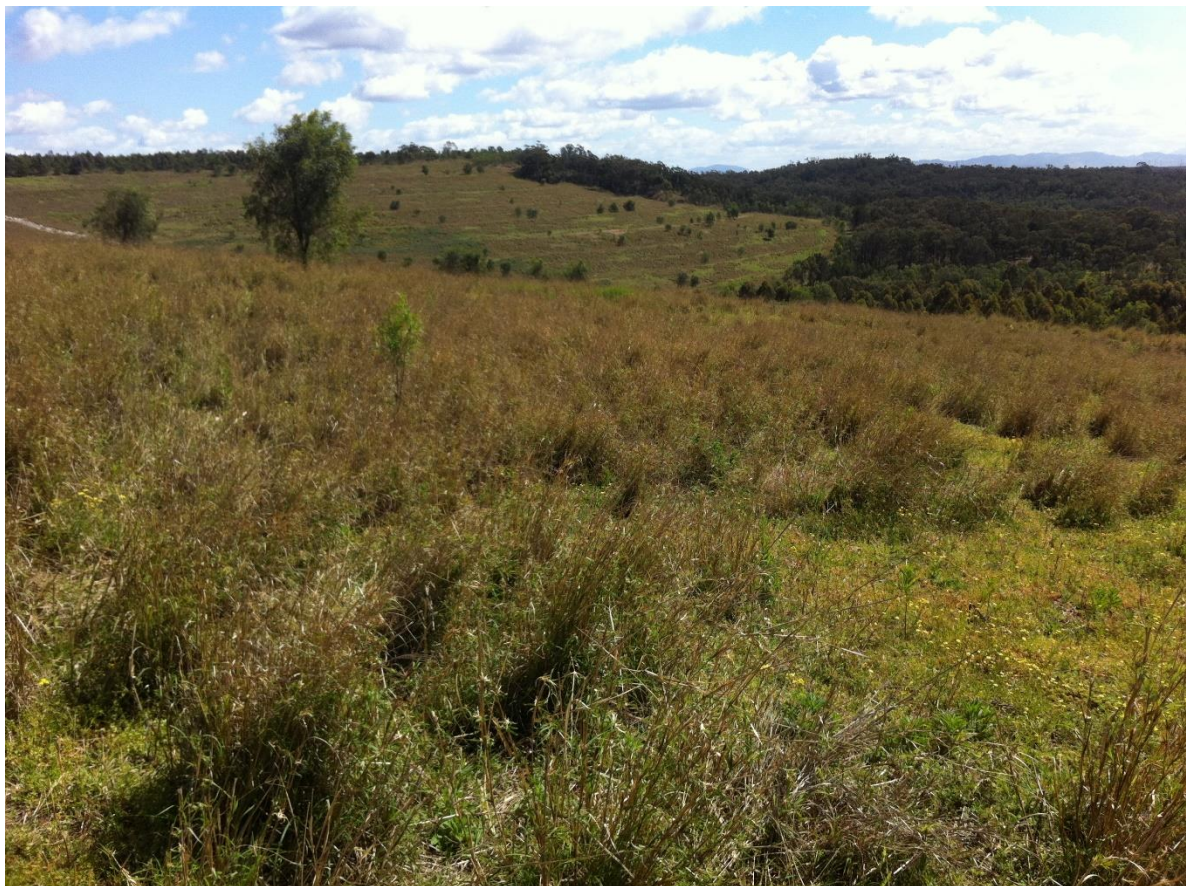
Plate 18: Pasture rehabilitation area dominated by *Chloris gayana* (Rhodes Grass), near site 7R

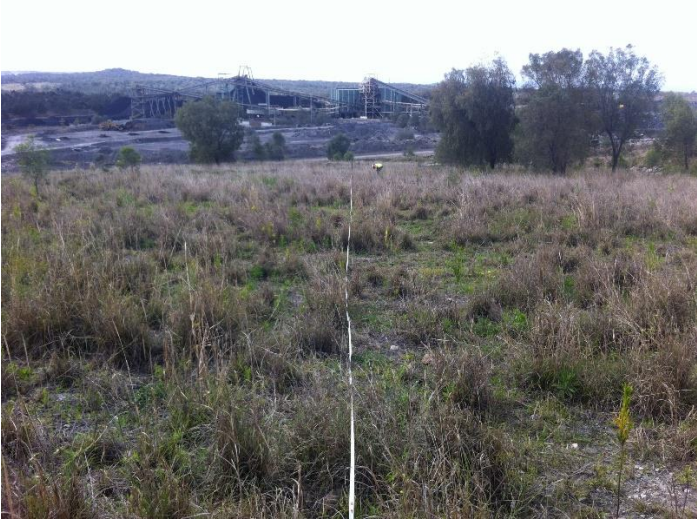
Transect	Notes	Photograph
1R	<p>Large clumps of <i>Chloris gayana</i> are the main stabilising feature of this rehabilitation area near the coal preparation plant.</p>

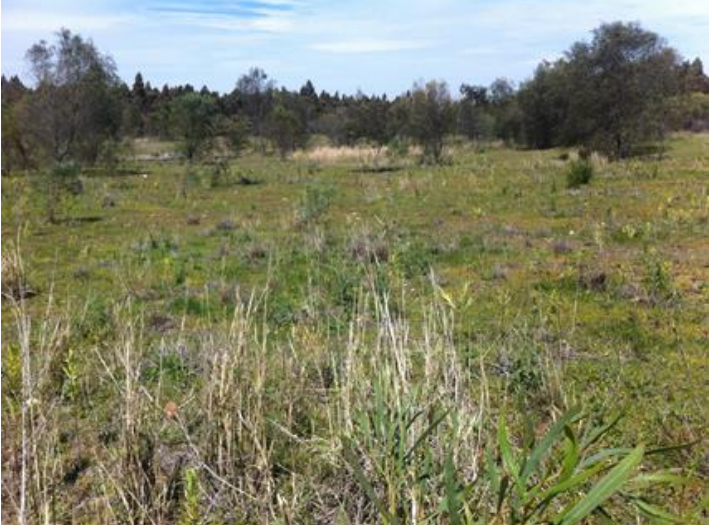
Transect	Notes	Photograph
2R	<p>This transect runs down a very slight slope and is composed of low grasses and herbs with several bare patches.</p>

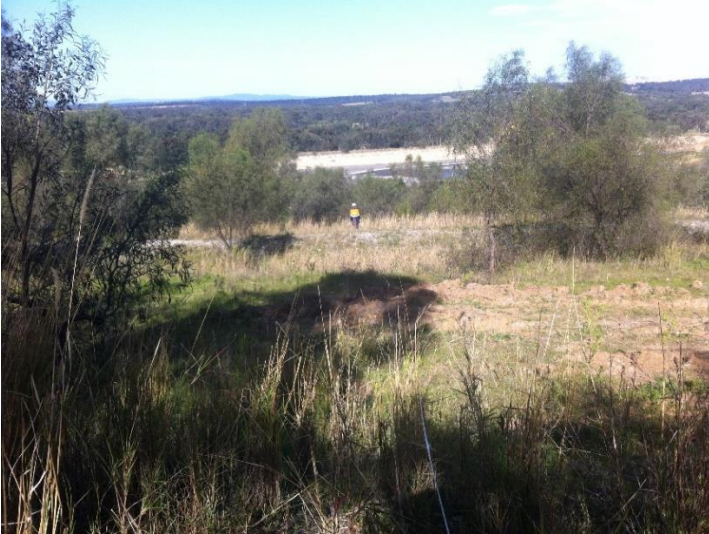
5R	<p>Construction appeared to be underway on a road through this transect, with several bare patches and disturbed ground. This transect should be relocated or removed from the pasture monitoring program.</p>

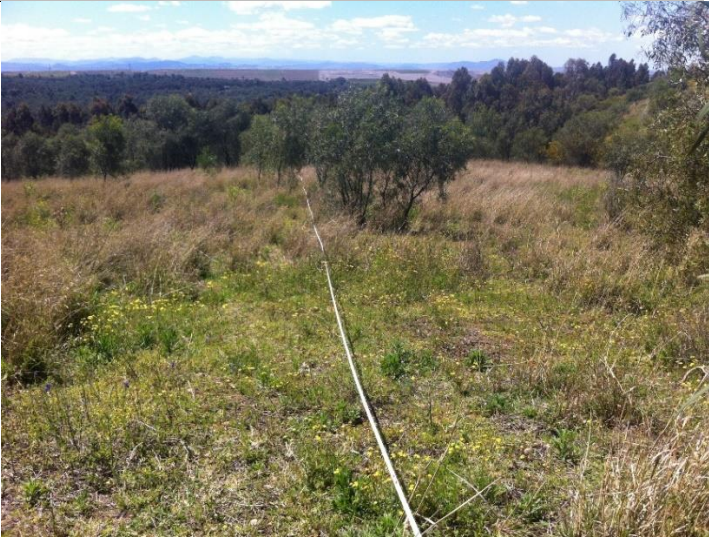
Transect	Notes	Photograph
7R	<p>Transect is a mixture of grassy patches, tussocks and exotic herbs. The locally native <i>Acacia salicina</i> (Willow Wattle) is colonising rehabilitation in this area.</p>

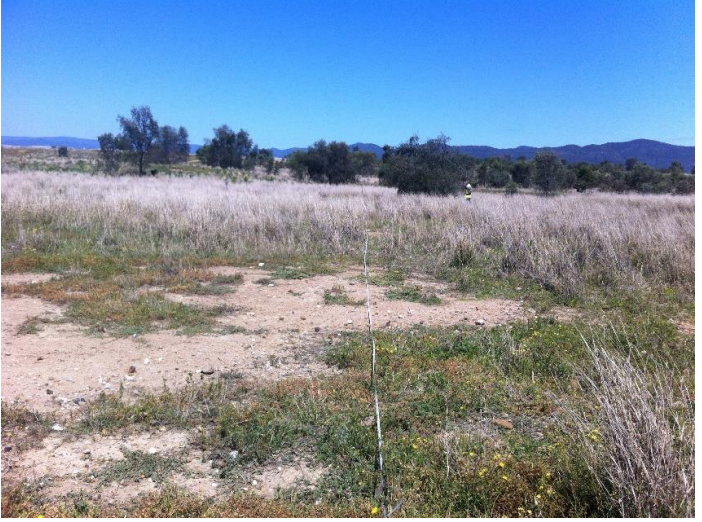
9R	<p>Clumps of <i>Galenia pubescens</i> are common around a large soil scald within this transect. Large clumps of <i>C. gayana</i> are the dominant feature for the remainder of the plot</p>

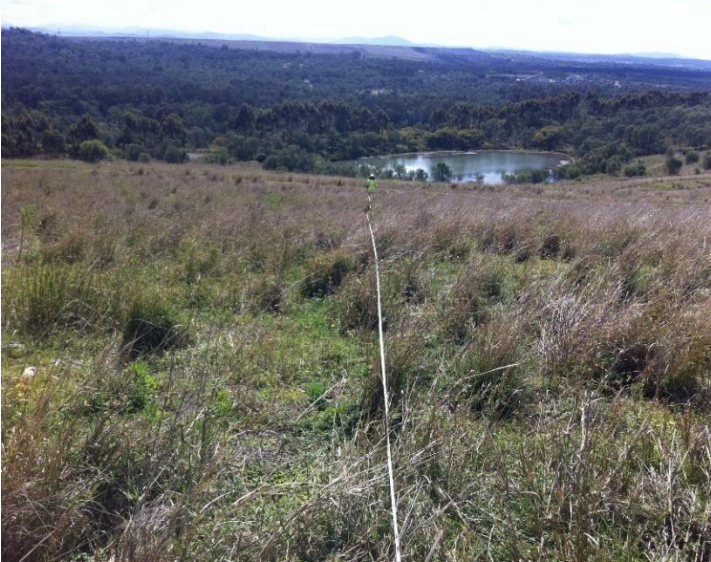
Transect	Notes	Photograph
33R	Transect primarily composed dense tussocks of <i>C. gayana</i> with dead grass leaf litter, low grass and patches of exotic herbs

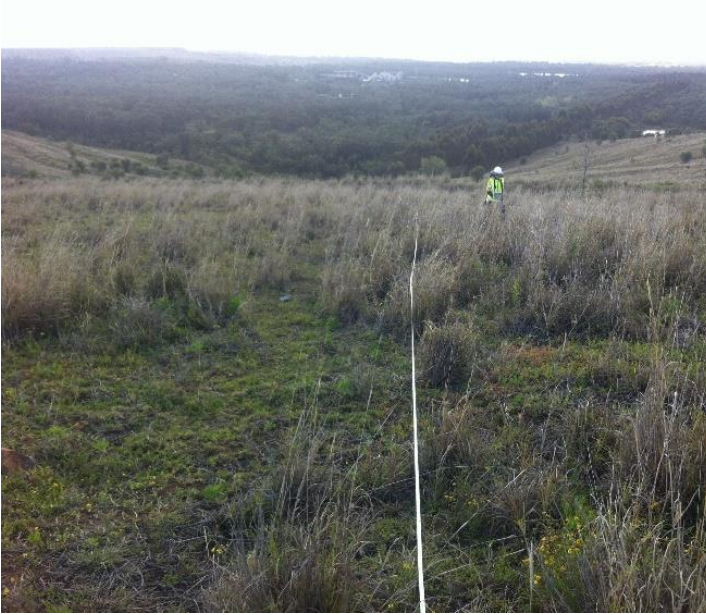
Transect	Notes	Photograph
34R	Transect primarily composed dense tussocks of <i>C. gayana</i> with dead grass leaf litter, low grass and patches of exotic herbs
