**WAMBO COAL PTY LTD
2016 ANNUAL REVIEW**

1 January – 31 December 2016

Name of operation	Wambo Coal Mine
Name of operator	Wambo Coal Pty Ltd
Development consent /Project Approval #	DA305-7-2003, DA177-8-2004, EPBC 2003/1138
Name of holder of development consent	Wambo Coal Pty Ltd
Title/Mining lease #	CL365, CL374, CL397, CCL743, ML1402, ML1572, ML1594, A444, EL7211
Name of holder of mining lease	Wambo Coal Pty Ltd
Water licence #	As per Table 3
Name of holder of water licence	Wambo Coal Pty Ltd
MOP start date	31 March 2015
MOP end date	30 March 2020
Annual Review start date	1 January 2016
Annual Review end date	31 December 2016
<p>I, Steven Peart, certify that this audit report is a true and accurate record of the compliance status of Wambo Coal Mine for the period 1 January 2016 to 31 December 2016 and that I am authorised to make this statement on behalf of Wambo Coal Pty Ltd</p> <p><i>Note.</i></p> <p>a) <i>The Annual Review is an ‘environmental audit’ for the purposes of section 122B(2) of the Environmental Planning and Assessment Act 1979. Section 122E provides that a person must not include false or misleading information (or provide information for inclusion in) an audit r

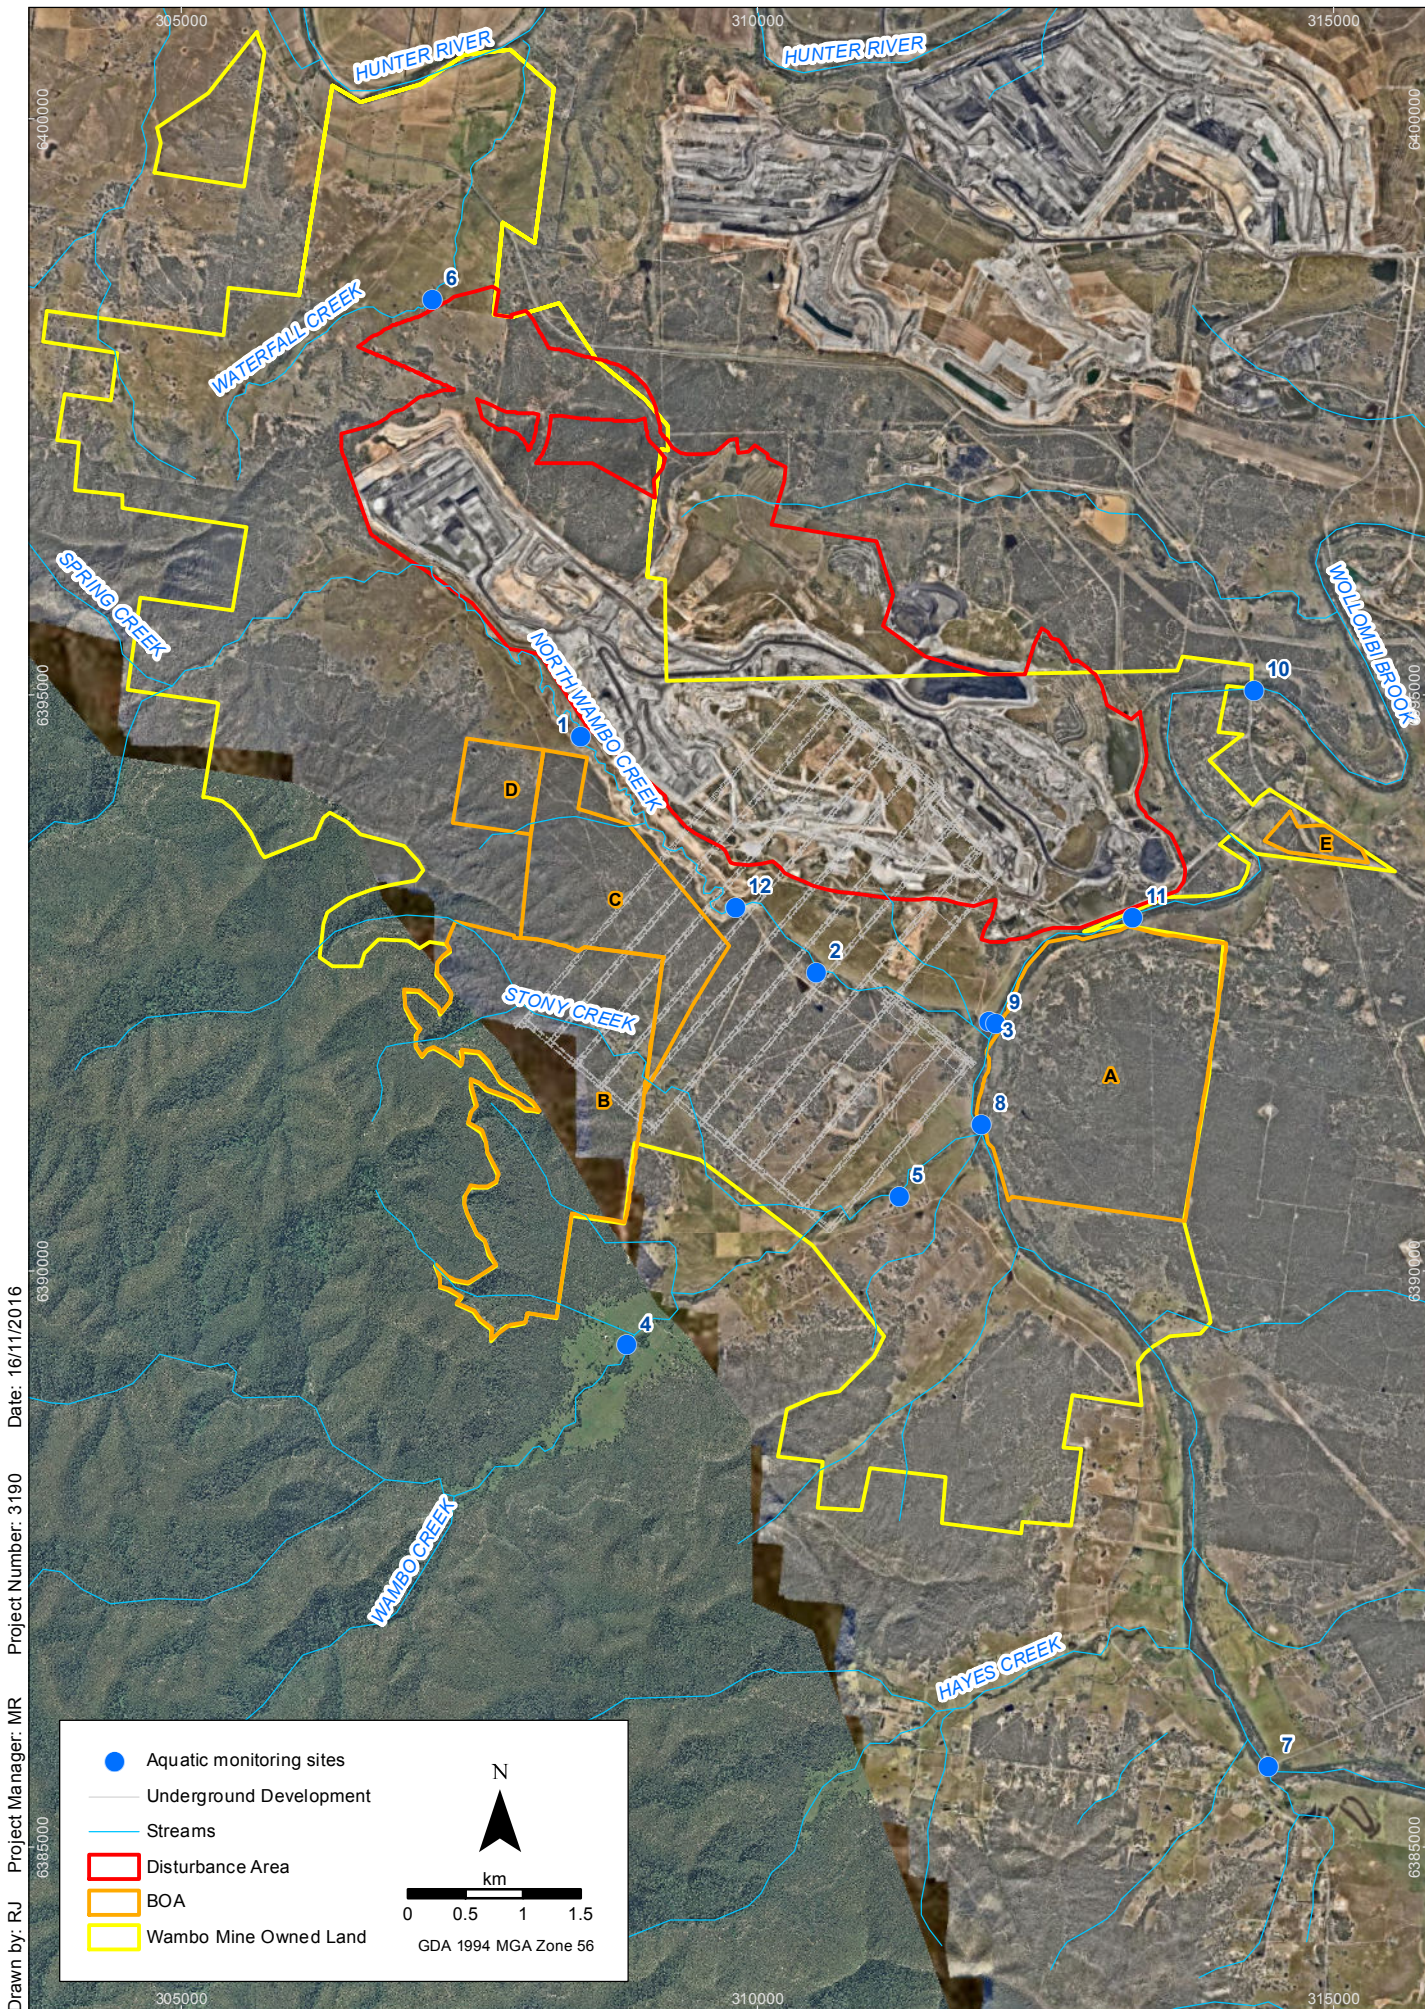
Location of monitoring sites
Wambo Coal 2016 aquatic monitoring

The location of monitoring sites are shown in Figure 1. Four sites were located in pool habitats on North Wambo Creek, one site on Waterfall Creek, two sites on South Wambo Creek, and five sites on Wollombi Brook (Table 1, Figure 1). Effort was made to ensure site independence and appropriate representation of habitat types observed within the catchment. The locations selected were constrained by access and water availability.

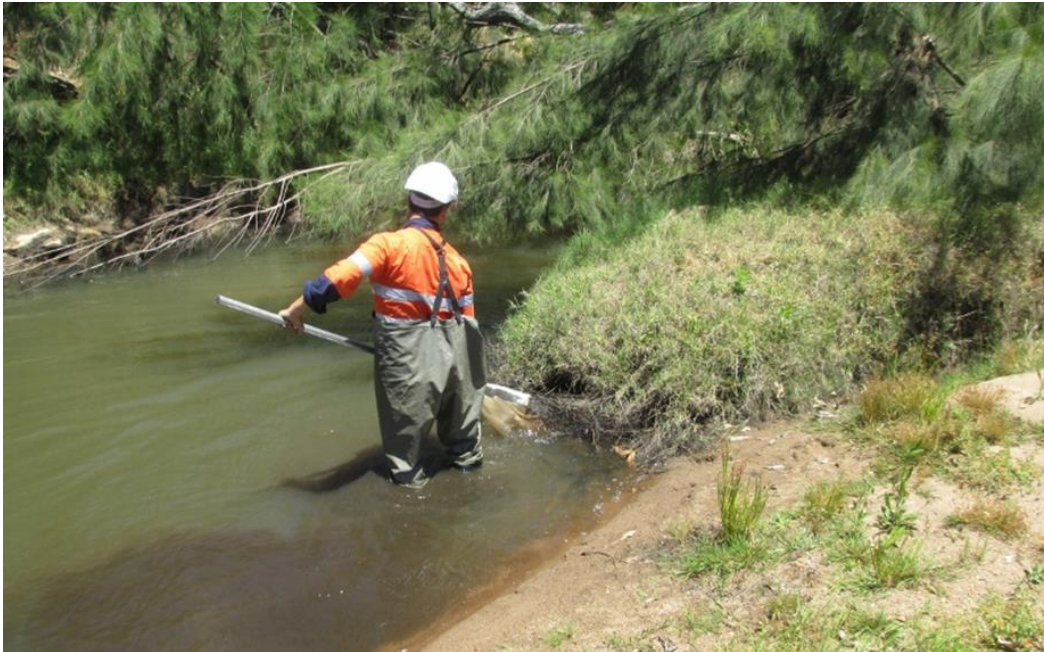
Plate 1 AUSRIVAS sampling method

conspicuous or slow. The animals collected at each site were placed into a labelled jar containing 70% ethanol.

The chemical and physical variables required for running the AUSRIVAS predictive model were recorded. These included alkalinity, modal depth and width of the river, percentage bedrock, boulder or cobble and latitude and longitude. Distance from source, altitude, land-slope and rainfall were also calculated.

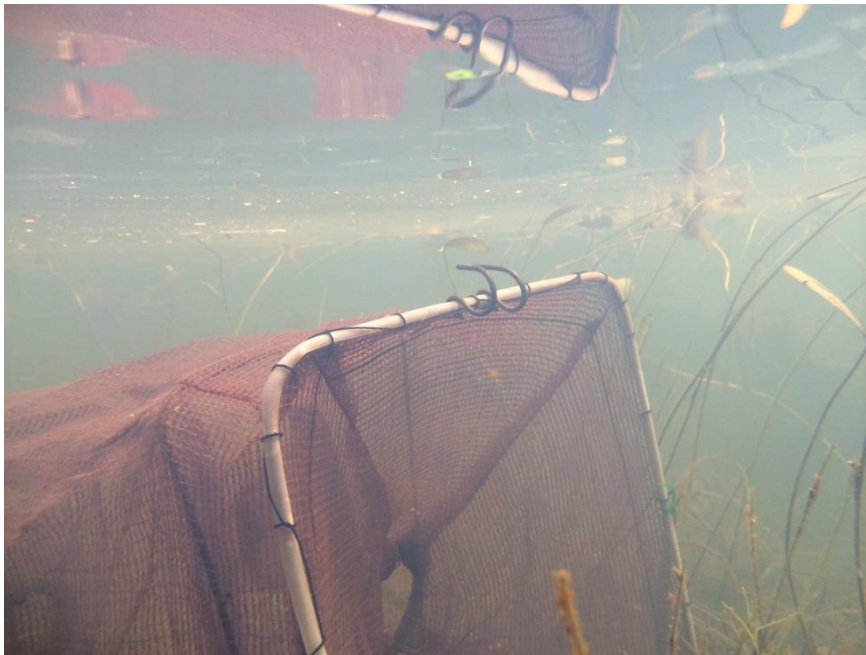
Plate 2 Concertina baitfish trap

Fish collected by dip net sampling techniques as part of the macroinvertebrate sampling were separated from the sample *in situ* and recorded. To further sample the fish assemblage, five concertina type baitfish traps (Plate 2) were set for a minimum of half an hour at each site. The fish were identified and counted and returned to the water. Fish and macroinvertebrate sampling was conducted under Section 37 *Fisheries Management Act 1994*- scientific collection permit number P13/0008-1.1

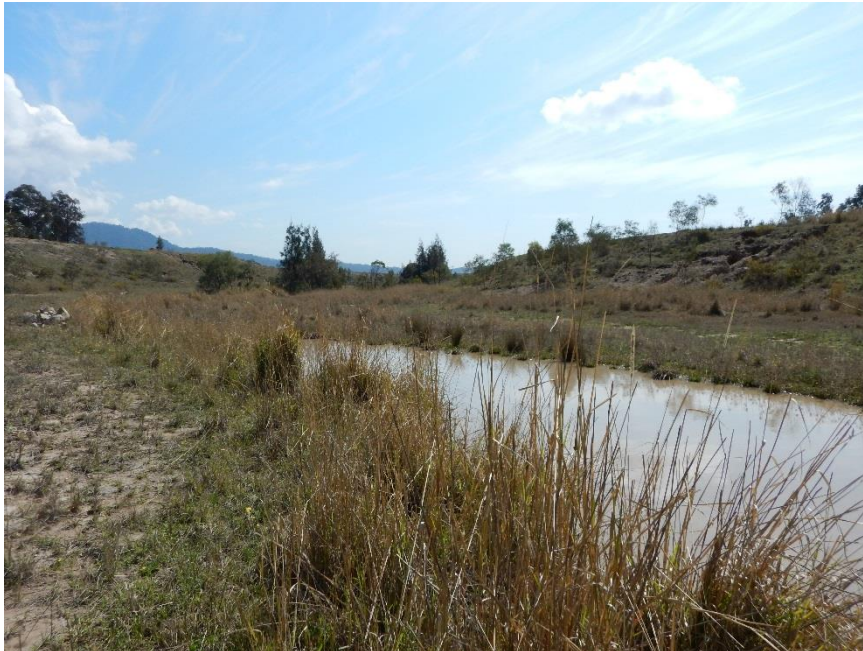
Plate 3 Site 1 North Wambo - Stage 2 (308470E 6394637N)

North Wambo Creek stage 1 diversion shows signs of natural tree/shrub recruitment Plate 3 (i.e. *Casuarina cunninghamiana*, *Eucalyptus punctate* and *Acacia implexa*). Exotic plant cover consistent with the original rehabilitation treatment persists within this riparian environment (i.e. *Chloris gayana*) with no strong evidence indicating the development of a native groundcover stratum.

Shallow turbid pools were present at the location however there was no flow observed. Native emergent macrophytes Umbrella Sedge (*Cyperus eragrostis*) and *Juncus sp.* were present at the site. The substrate consisted of fine silt and there was no shading of the stream.

The fish sampling results are provided in Table 7. No fish were recorded in Site 5 (South Wambo Creek). (Plate 7). Waterfall Creek (Site 6, Plate 8) and North Wambo realignment sites (Site 1 and Site 12) (Plate 3 and Plate 14), contained minimal aquatic habitat and consisted of small shallow isolated pools. No fish were observed at these sites.

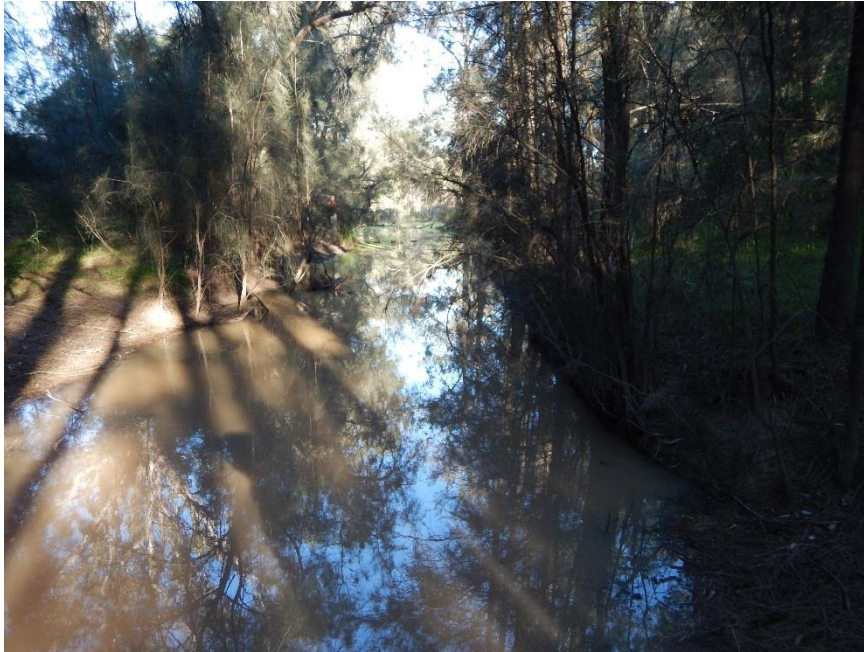
Plate 4 Site 2 North Wambo below diversion (310513E 6392590N)

The condition of the riparian environment at site 2 was fair with visual evidence of moderate disturbance. Disturbance sources include the upstream Stage 2 and 3 diversion, subsidence and the presence of weeds.

The riparian tree canopy was dominated by River Sheoak (*C. cunninghamiana*) with Native Olive (*Notolaea microphylla*) forming a dominant midstorey strata, while Couch (*Cynodon dactylon*) was the dominant native groundcover species (Plate 4).

The stream habitat consisted of a pool (0-1m deep), with 5 m modal width, and the benthos consisted of fine mud and silt. There was no visible flow and a fine green algal scum was present on the water surface. The vegetation provided low shading of the stream.

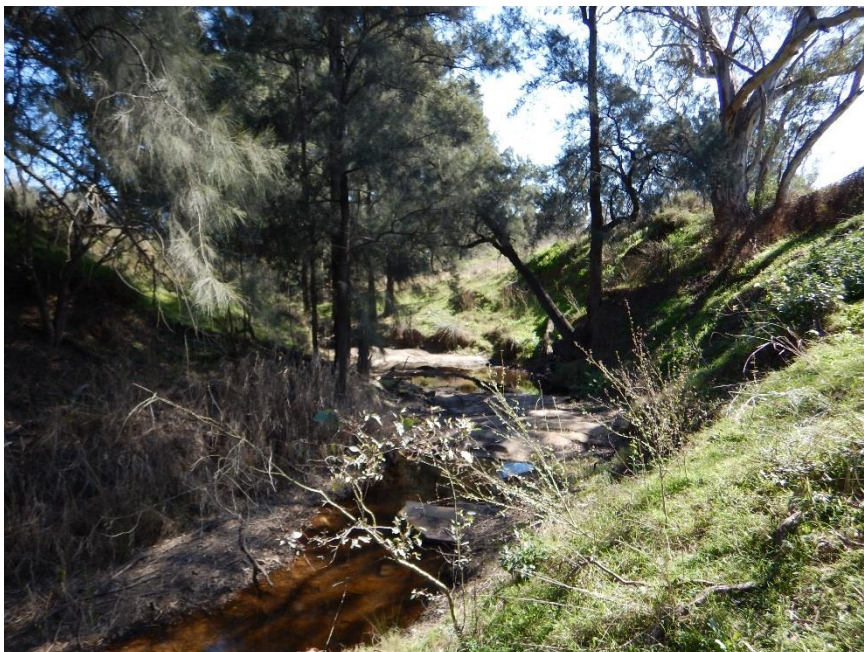
Plate 5 Site 3 North Wambo – pool near Wollombi confluence (312008E 6392169N)

The riparian zone was in fair condition with only moderate disturbance. The riparian canopy was dominated by River Sheoak. Lemon scented Myrtle (*Leptospermum polygalifolia*), Wattle (*Acacia parramattensis*) dominate the midstorey stratum. Couch and Marsh Club-rush (*Bolboschoenus fluviatilis*) are also present as well as exotic species such as Willow (*Salix sp.*) and various pasture weeds.

The site includes a circular pool on the Wollombi Brook flood plain with a mode (10-15m wide) and depth (>1m deep), as well as bedrock dominated creek section flowing in to this pool. Benthos was dominated by silt and clay and the occasion with bedrock and isolated pebbles prominent in the upstream section of this site (Plate 5). Common Rush (*Phragmites australis*) occurs along the pool edge. There was no visible flow at the time of sampling. The canopy provided moderate shading of the river.

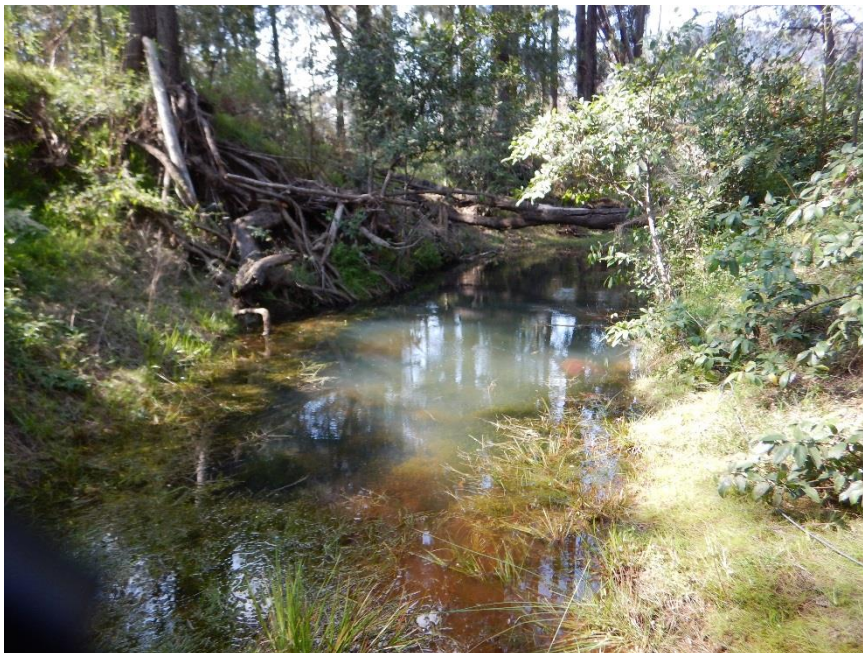
Plate 6 Site 4 South Wambo creek at Max's Farm (308863E 6389360N)

Riparian vegetation was in moderate condition, showing moderate disturbance. There was evidence of cattle crazing in the riparian zone and bank slumping. The canopy was dominated by River Sheoak and midstorey by Sandpaper Fig (*Ficus coronata*), Red Ash (*Alphitonia excelsa*), White Cedar (*Melia azedarach*), Snake Vine (*Stephania japonica*). The groundcover stratum consisted of Weeping Grass (*Microlaena stipoides*) and Bracken Fern (*Pteridium esculentum*). The riparian vegetation provided moderate to high shading of the river (Plate 6).

The stream pools were narrow (modal width 3m) and shallow (<1m deep). Stream benthos consisted of mixture of silt, sand, gravel, pebbles and cobbles substrates. Macrophytes were present in 90% of the reach and included Common Starwort (*Callitriche stagnalis*), *Lipilaena australis* and *Juncus sp.* There was some flow visible connecting pools. Algae also covered the benthos.

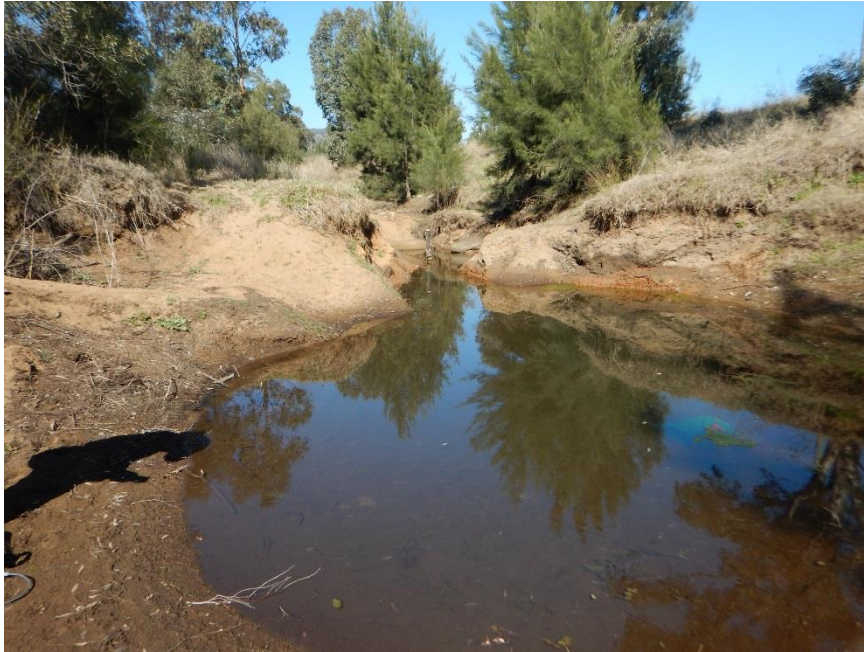
Plate 7 Site 5 South Wambo Creek at gauge (311227E 6390652N)

A small isolated pool was the only available aquatic habitat in this section of stream. The riparian zone, as shown in Plate 7, was in poor condition showing high disturbance such as bank degradation, evidence of cattle use and the presence of weeds. The canopy was dominated by River Sheoak. There was no mid storey present and ground cover was dominated by Kikuyu (*Pennisetium clandestinum*), Couch and Bamboo Grass (*Austrostipa ramosissima*). The vegetation provided little shading of the river.

The pool at this site was mostly shallow (<1 depth) with 1m modal width. Stream benthos consisted of sand and silt. There were no macrophytes present at this site and no visible flow was evident at the time of sampling.

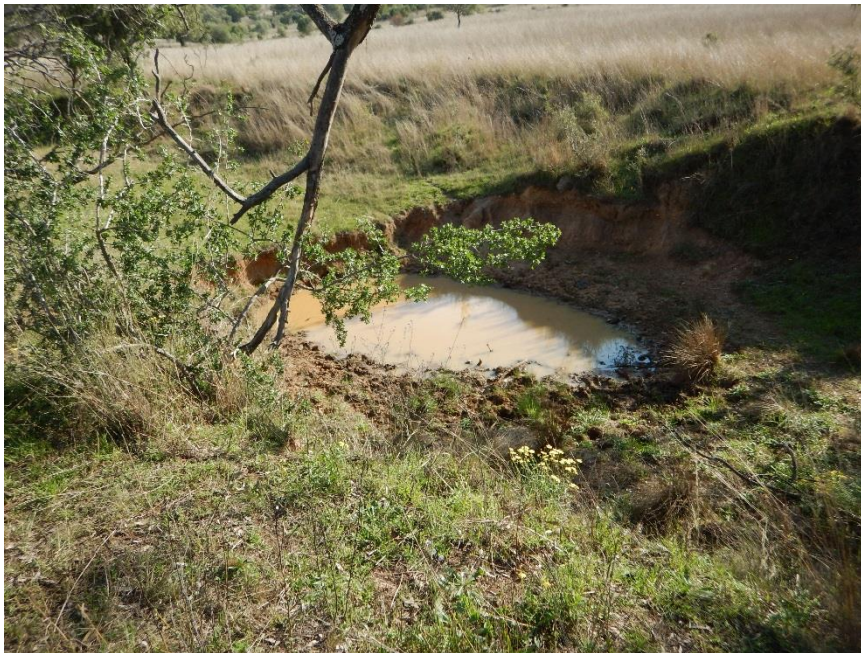
Plate 8 Site 6 Waterfall Creek (307175E 6398438N)

Aquatic habitat was limited at the sampling location, with few isolated pools within the site reach. The riparian zone was in poor condition showing high disturbance from cattle accessing the stream, rubbish and erosion on adjacent banks (Plate 8). The canopy consists of Narrow-leaved Ironbark (*E. crebra*), while the mid story was dominated by Cooba Wattle (*A. salicina*) and Peppercorn Tree (*Schinus areira*). The riparian zone was made up predominately of Couch, *Bothriochloa decipiens* and *Aristida vagans*; typical vegetation found in drainages of grazing systems. The riparian vegetation provided low shading of the creek. Pools present were shallow, turbid, and had a silt dominated benthos.

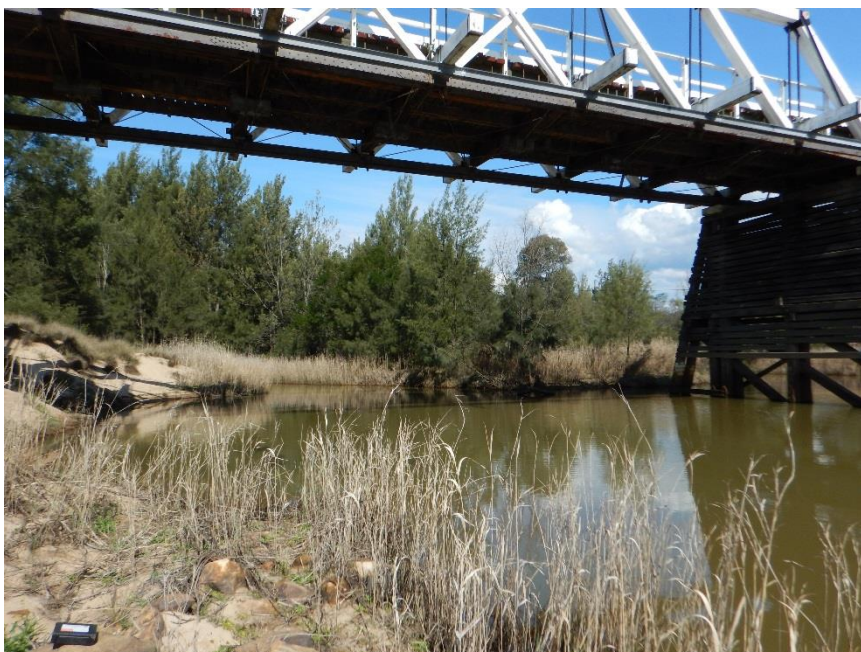
Plate 9 Site 7 Wollombi Brook at Bulga bridge (314433E 6385703N)

The riparian zone showed moderate disturbance (Plate 9). Canopy vegetation was dominated by River Sheoak, which was also the most abundant midstorey species. Vegetation provided no shading of the river.

The pool depth was relatively deep (>1m) and wide (modal width 10m). Benthos was homogeneous consisting entirely of sand sized particles. Macrophytes such as Common Rush and Marsh Club-rush were abundant in this reach.

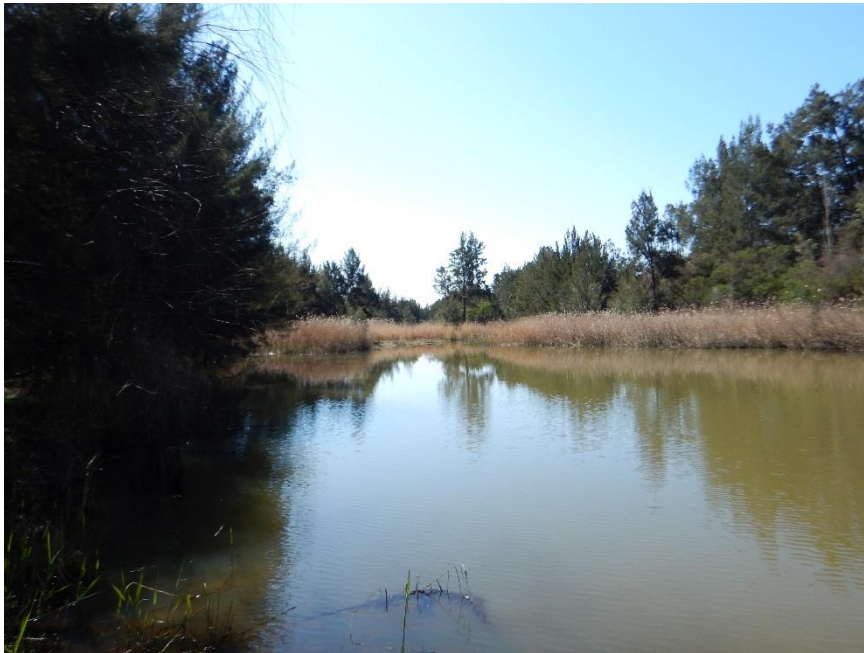
Plate 10 Site 8 Wollombi Brook at South Wambo confluence (311939E 6391268N)

The riparian zone was in good condition with only little visual evidence of disturbance as shown in Plate 10. Riparian canopy was dominated by River Sheoak, while the understory consisted of River Club-rush

(*Scirpus validus*) and Common Rush, while Couch was the dominant grass. There were few weeds present. Vegetation cover provided moderate shading to the river.

The pool was relatively deep in places (>1m) and wide (modal width 12m). The benthos consisted entirely of sand sized particles.

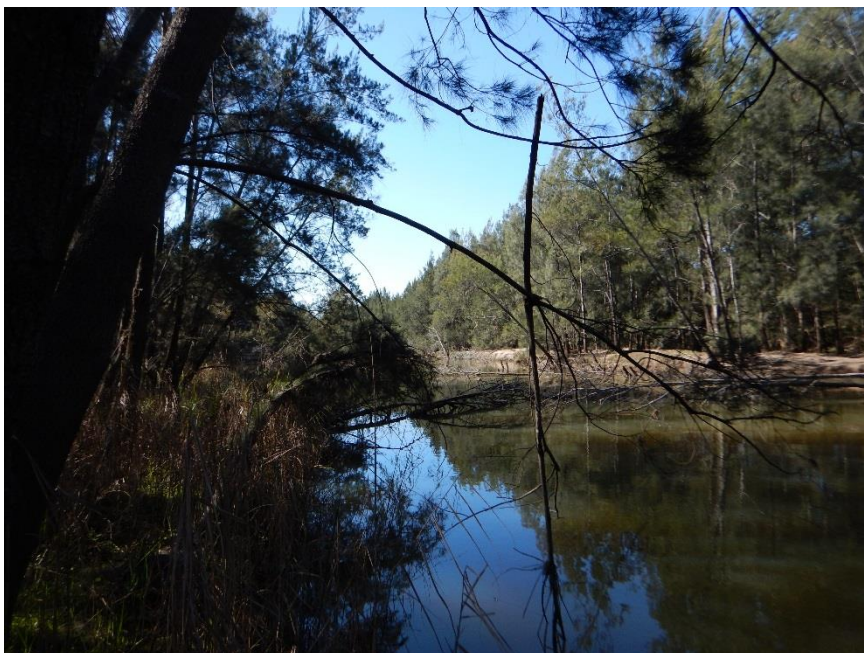
Plate 11 Site 9 Wollombi Brook at North Wambo Creek (312063E 6392151N)

The riparian zone was in fair condition showing moderate disturbance (Plate 11). The canopy was dominated by River Sheoak, with the understorey consisting of Willow, Common Rush and Slender Knotweed (*Persicaria sp.*). Weeping Grass was the dominant groundcover species. Exotic weeds were present. The vegetation cover provided low -moderate shading to the river.

The pool was relatively deep in places (>1m) and wide (modal width 7-10m). The benthos consisted entirely of sand sized particles.

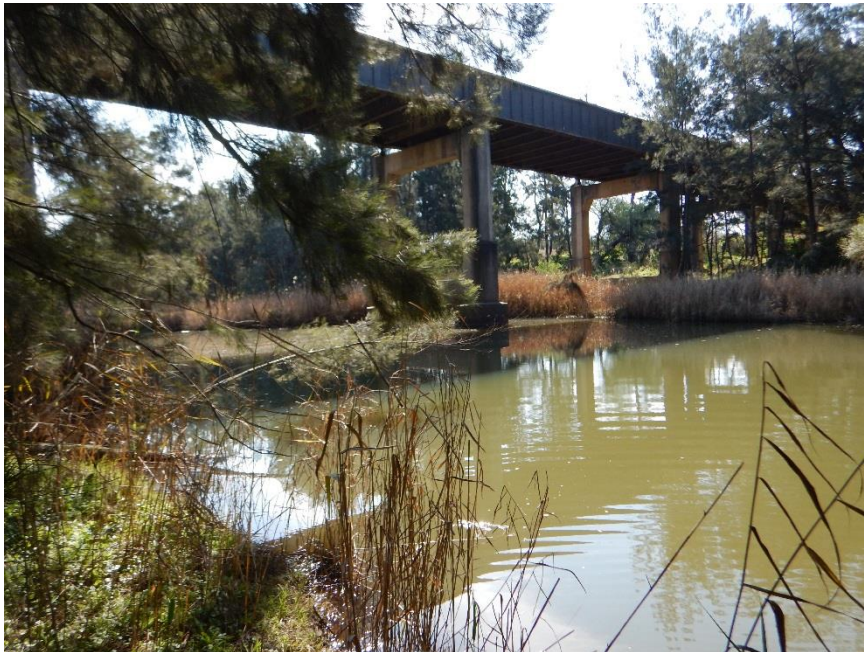
Plate 12 Site 10 Wollombi Brook at downstream bridge (Golden Highway) (314308E 6395036N)

The riparian zone was in fair condition showing moderate disturbance (Plate 12). The canopy was dominated by River Sheoak, with the midstorey consisting of Willow and smaller River Sheoak. Tall groundcover species included Common Rush and Fleabane (*Conyza sp.*). Weeping Grass, Snake Vine and *Centella asiatica* characterised the groundcover stratum below 1 metre. Exotic weeds were present. Riparian vegetation cover provided low to moderate shading of the river. Common Rush was common along pool edges as was Marsh Club Rush.

The pool was relatively deep in places (>1m) and wide (modal width 15m). River benthos consisted entirely of sand sized particles.

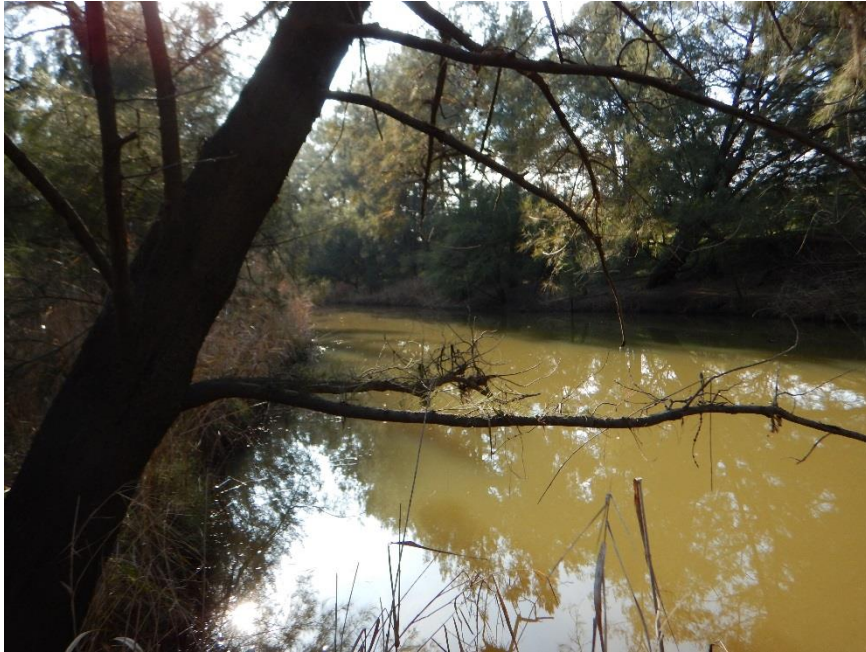
Plate 13 Site 11 Wollombi Brook at mine discharge (313248E 6393066N)

The riparian zone was in fair condition showing moderate disturbance such as the presence of weeds (Plate 13). The canopy was dominated by River Sheoak, with the midstorey consisting of Willow and smaller River Sheoak. Tall groundcover species included Common Rush and Marsh Club-rush. Hydrocotyle characterised the groundcover stratum below 1 metre. Exotic weeds were present. Vegetation cover provided a low - moderate shading to the river.

The pool was relatively deep in places (>1m) and wide (modal width 15m). The benthos consisted entirely of sand sized particles with few gravels.

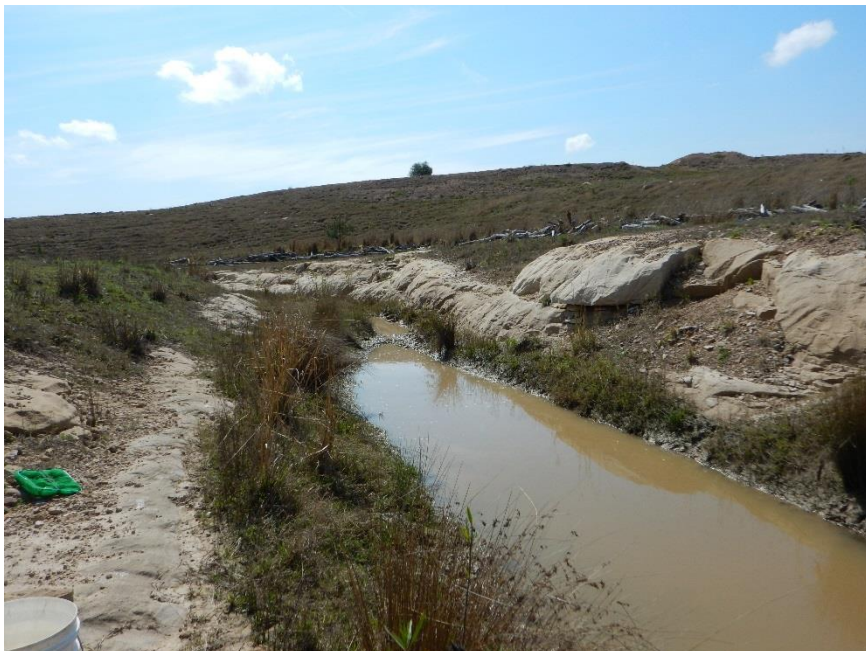
Plate 14 North Wambo Creek Stage 3 (309808E 6393160N)

The riparian zone was in poor condition showing high disturbance, including lack of riparian vegetation, and exhibiting some erosion and siltation (Plate 14). There was no canopy or midstorey present. Groundcover species included weeds *Galenia pubescens* and *Senecio madagascariensis*. Soil was exposed on the banks of the stream. Emergent macrophyte (*Juncus sp.*), and Umbrella Sedge were present within the stream reach. Vegetation cover provided no shading to the river. The pool was very shallow (<.5m) and narrow (modal width 1m) with benthos consisted entirely of silt with few cobbles.

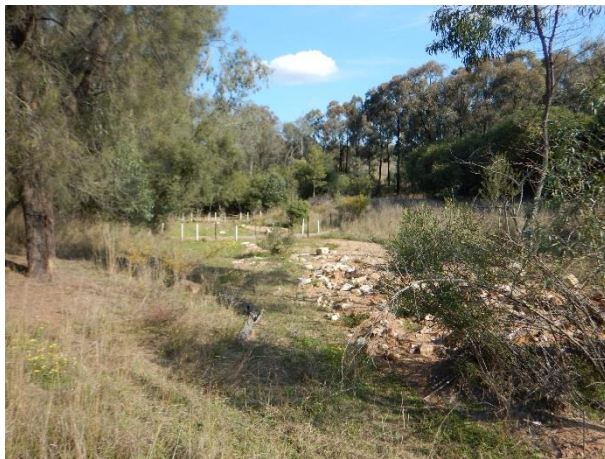
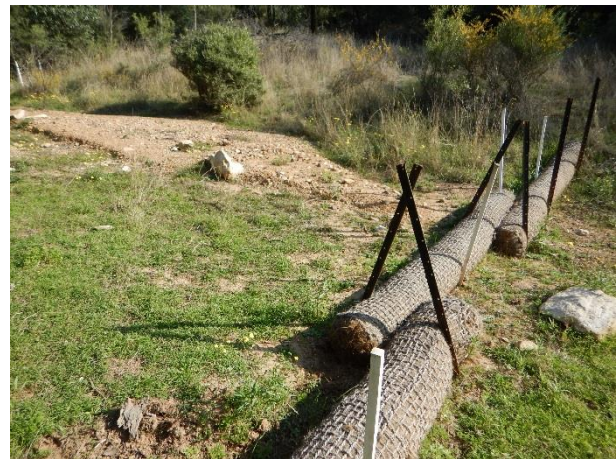
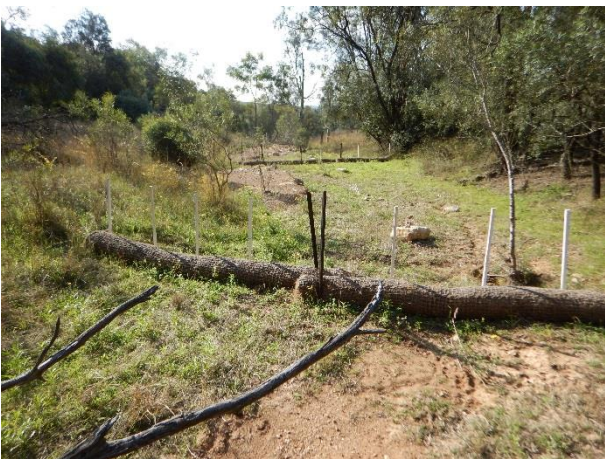
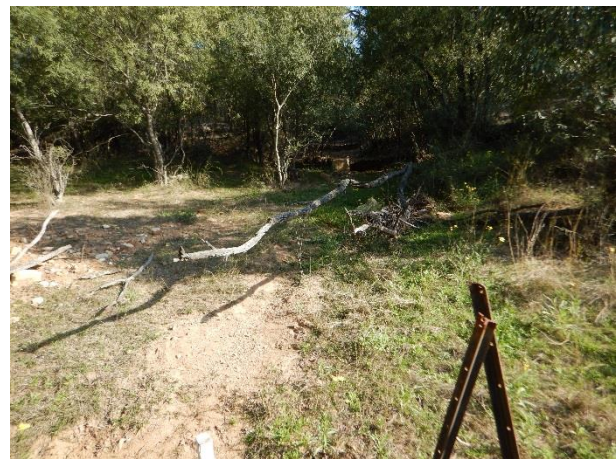
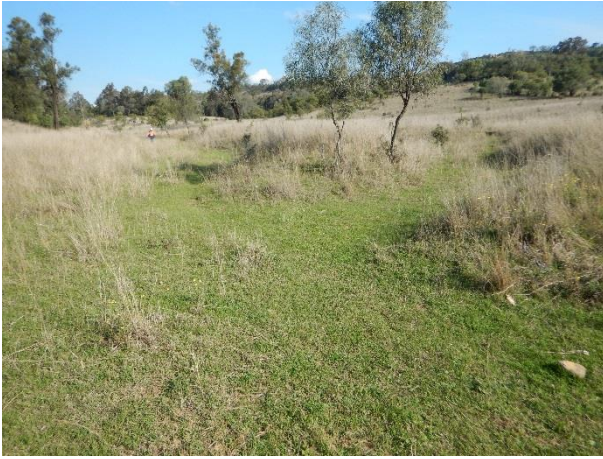
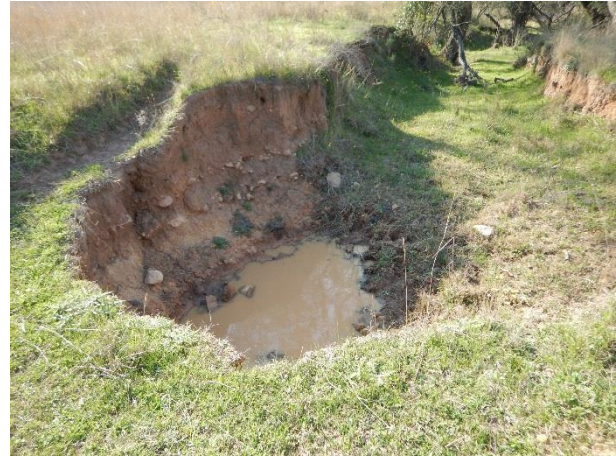
Plate 15 Waterfall Creek tributary downstream of dam showing sediment deposition, retention devices, and the lack of water in the creek.

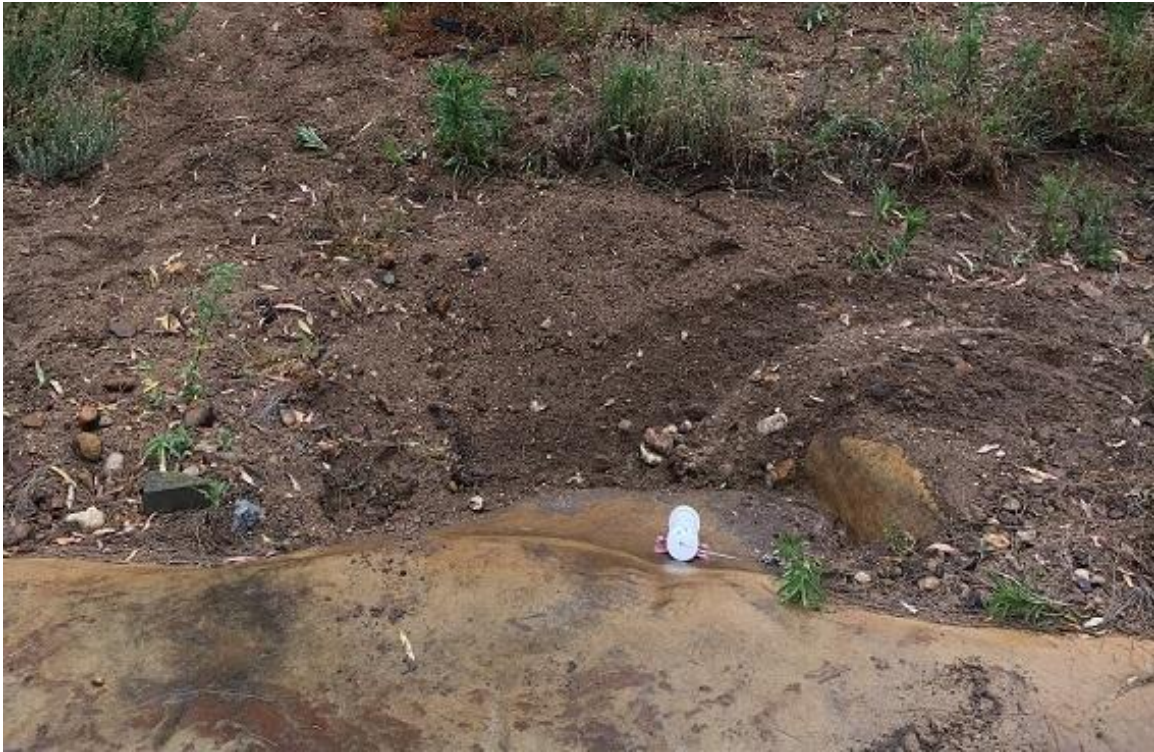
Figure 1 Re-Located Flow Station 5 Sensor in Respect to the Stream Bed – Looking East Across the Stream.

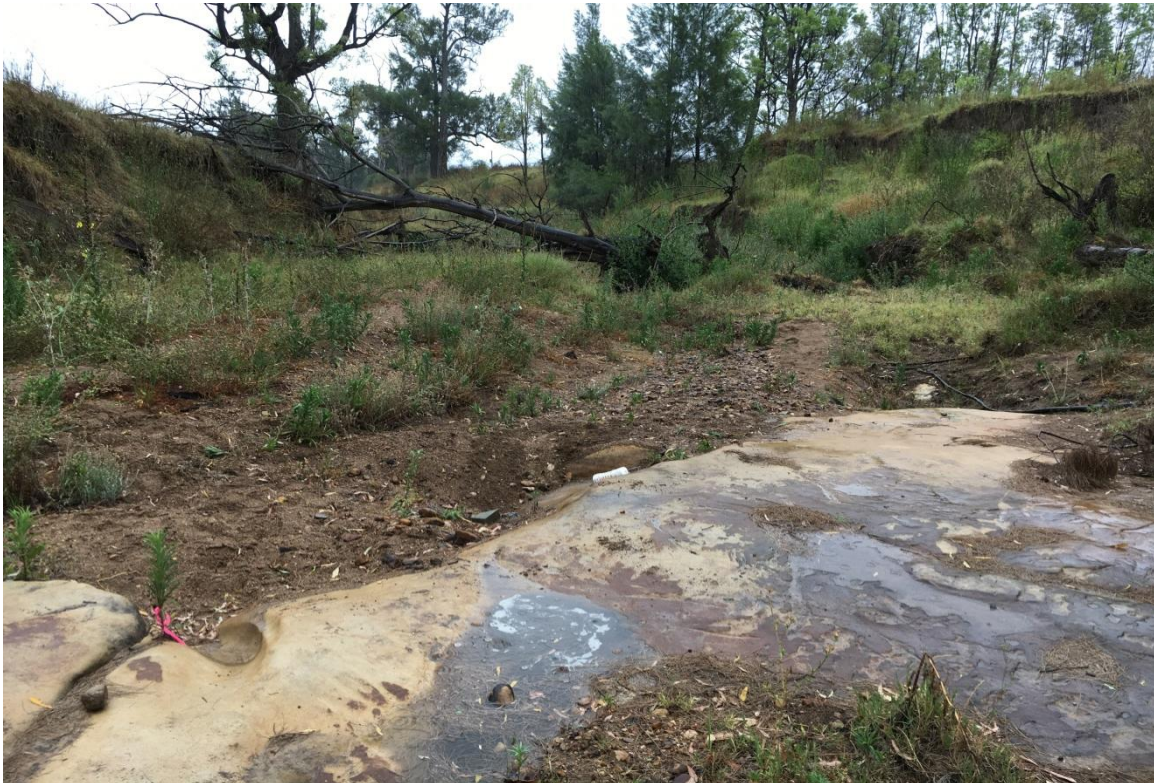
Figure 2 Re-Located Flow Station 5 – Looking Up Stream Past the Sensor.

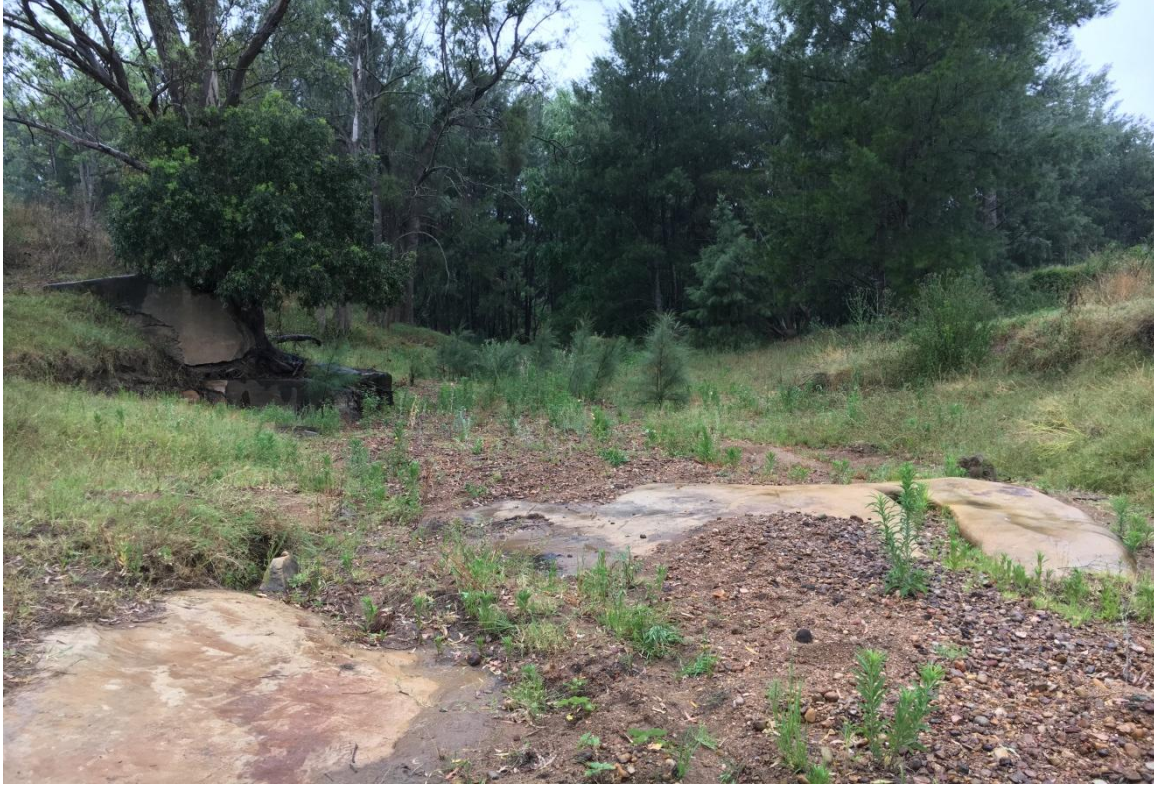
Figure 3 RE-Located Flow Station 5 – Looking Downstream from the Sensor.

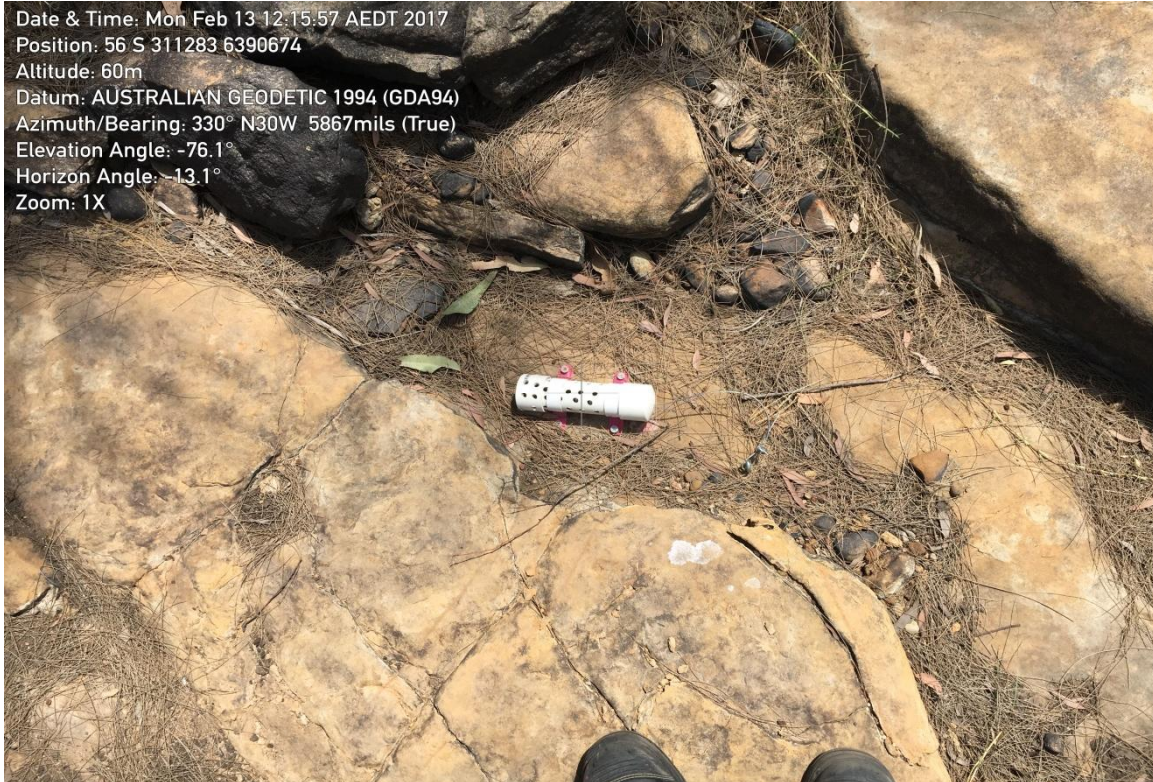
Figure 4 Re-Located Flow Station 6 Sensor in relation to the Stream Bed.

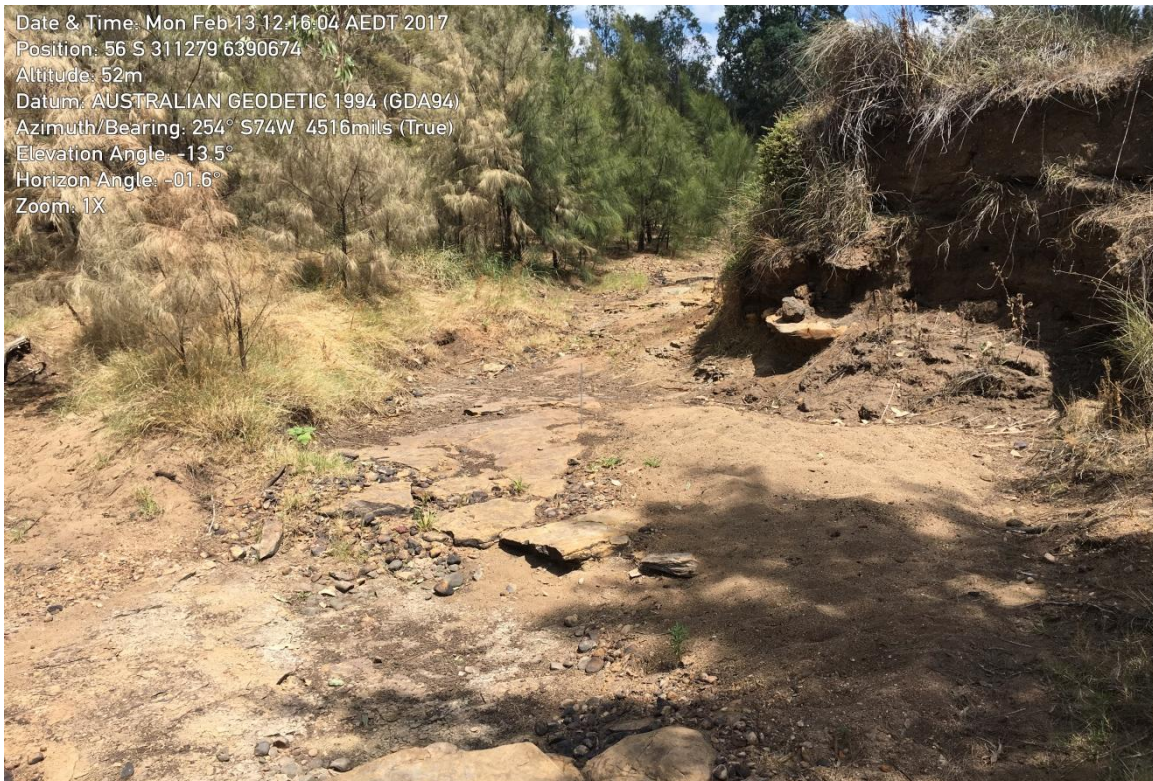
Figure 5 Re-Located Flow Station 6 – Looking Upstream from the Sensor.

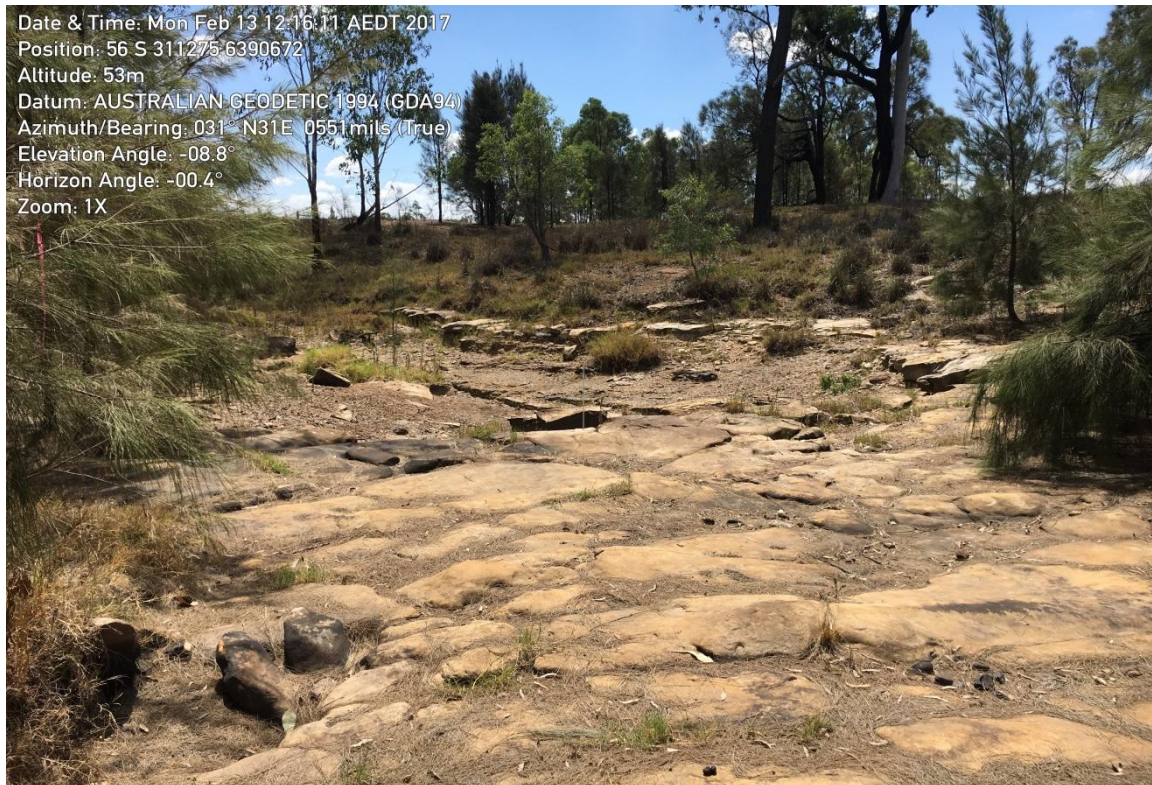
Figure 6 Re-Located Flow Station 6 – Looking Downstream from the Sensor
