# **2021 Annual Review**

**Wilpinjong Coal Mine**

This 2021 Annual Review (AR) (this Report) presents a summary of regulatory compliance, environmental performance and community engagement activities for the *review period* from 1 January 2021 to 31 December 2021.

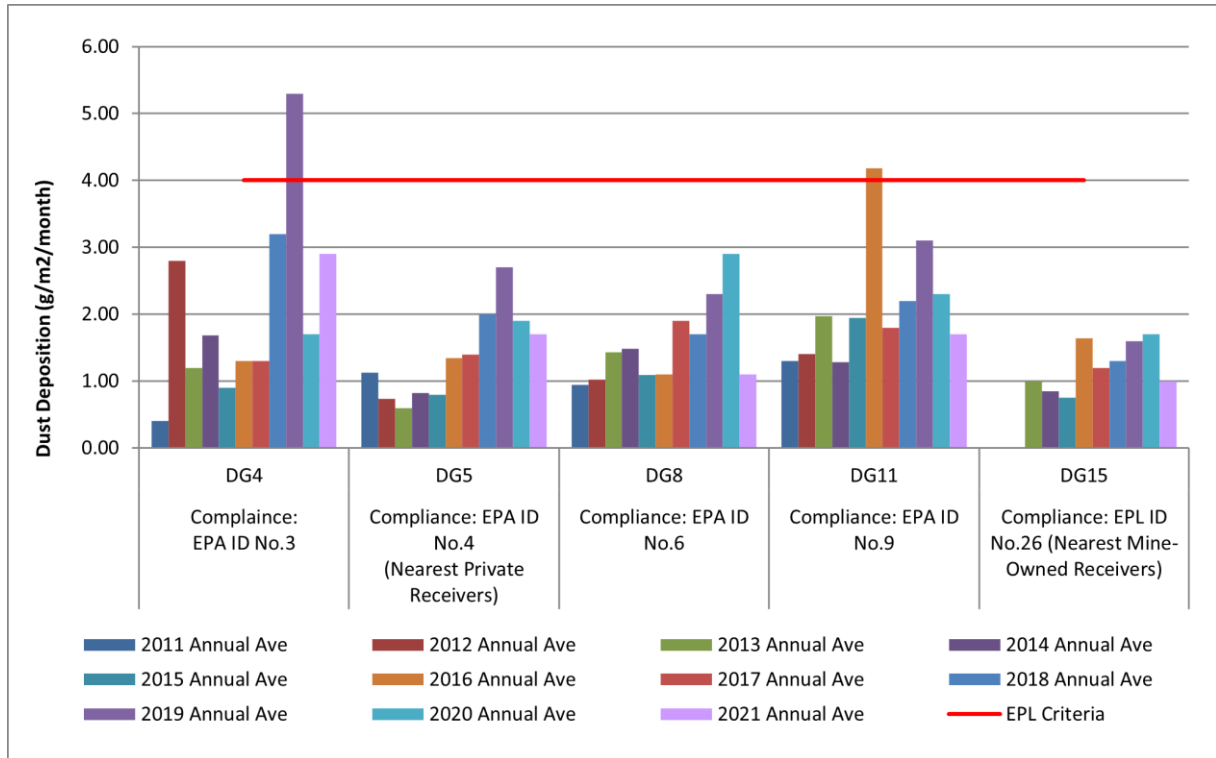
Graph 1 Compliance Annual Average Dust Deposition Results 2011 – 2021

**Notes:** Based on the positioning of the compliance monitors at WCM, it can be assumed that the DG8 monitor is sufficiently away from mining activity and is generally represented of background levels for the area. On this basis, the potential incremental contribution from WCM can be estimated as the level recorded at the compliance monitors minus the level at DG8 (Todoroki, 2019).

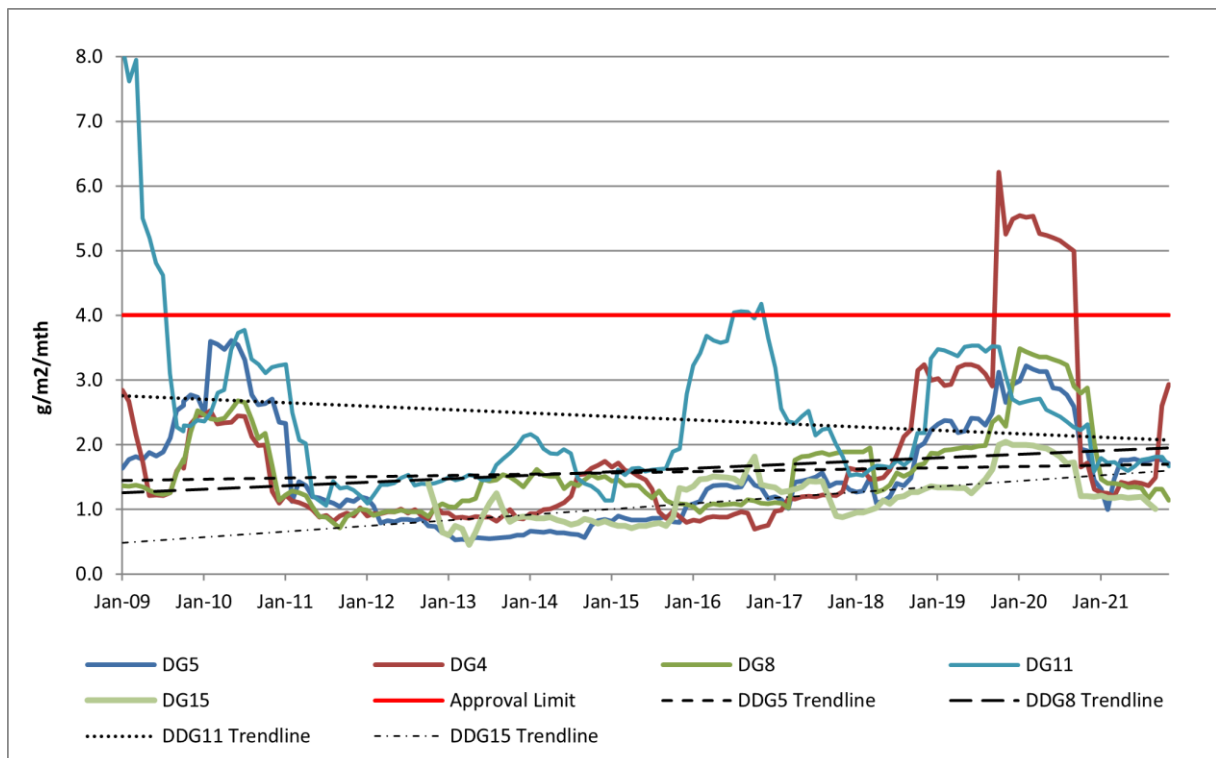
Graph 2 Compliance Dust Deposition Trends (Rolling Averages) 2009-2021

**Notes:** Drought conditions and extraordinary events would have impacted the background deposited dust levels in 2020. Currently, the nearest privately-owned residence to the DG4 monitor is located over 5km away and thus the DG4 monitor is no longer considered to be representative of dust levels at privately owned residences (Todoroski, 2021).

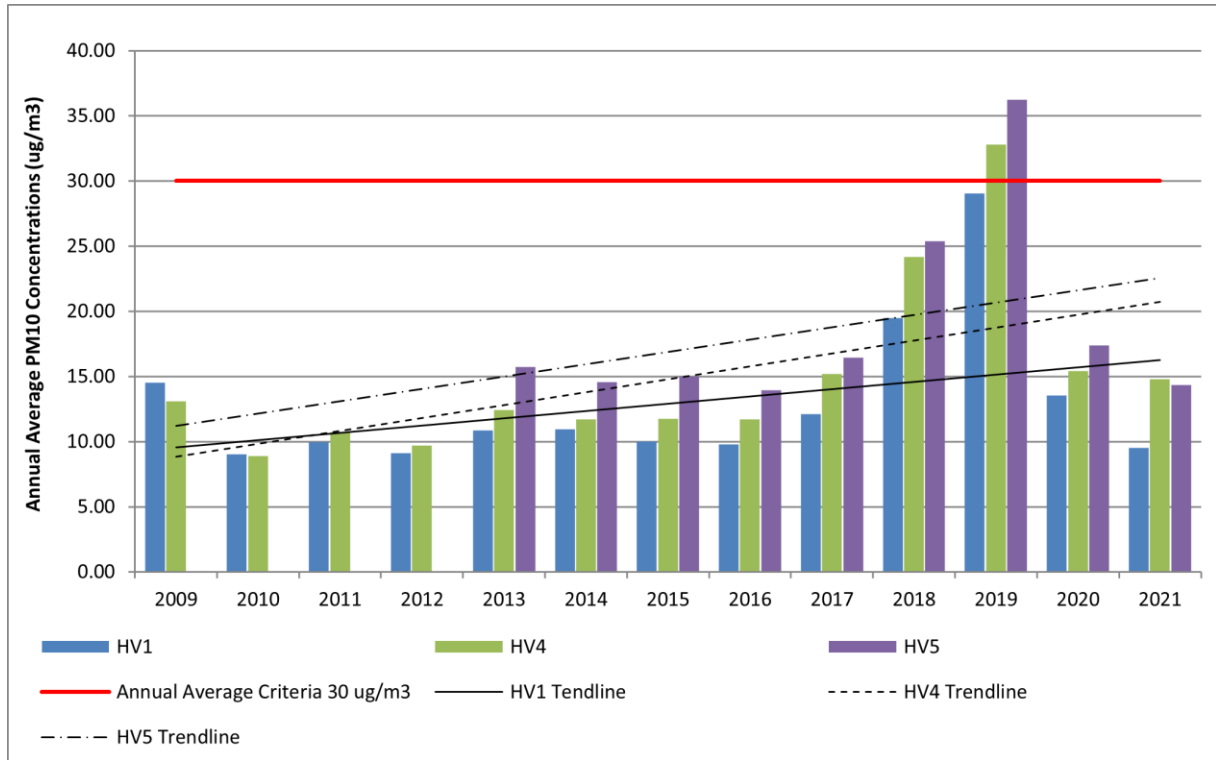
Graph 3 Compliance HVAS Annual Average PM<sub>10</sub> Results and Trends 2009 – 2021

Notes: Elevated results in 2019 were caused by regional extraordinary events as described the 2019 Annual Review.

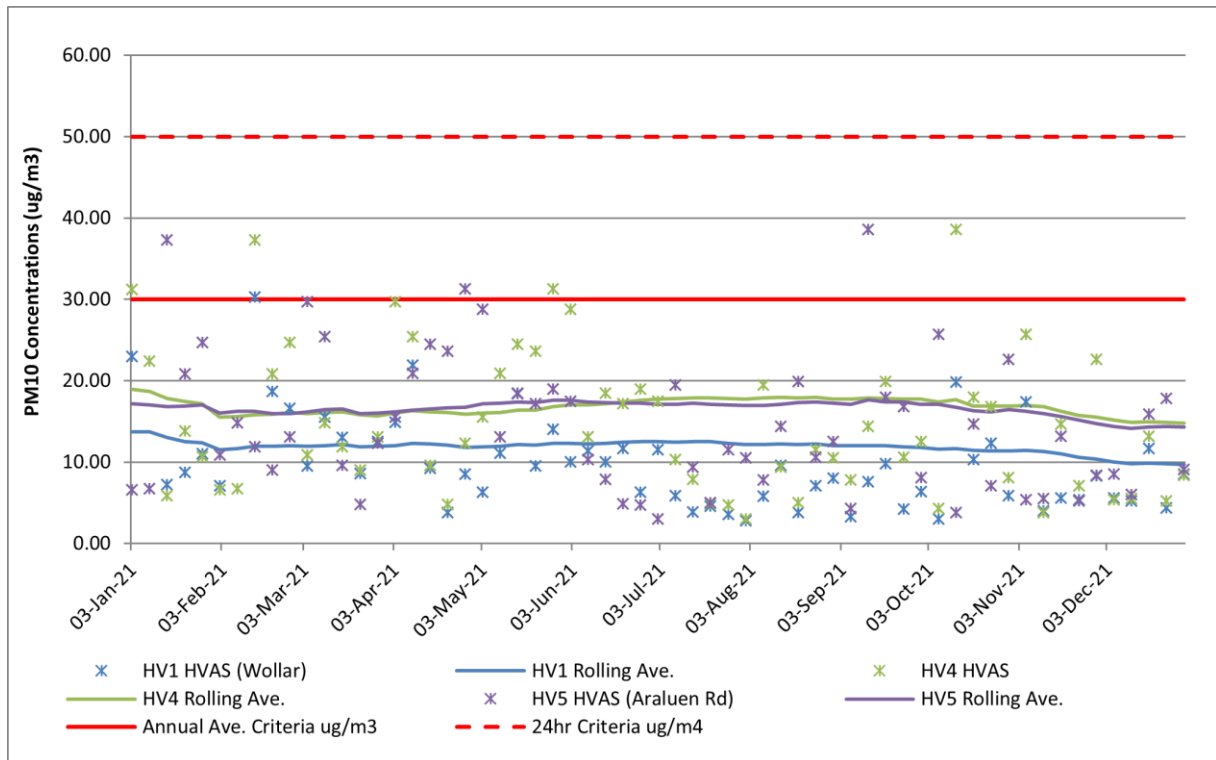
Graph 4 Compliance HVAS (Rolling Averages) Annual Average & 24hr 6-Day Cycle PM<sub>10</sub> Results 2021

Notes: The nearest private residence to the HV4 monitor is located over 5km away from the monitor, the private residency response protocol (which includes an investigation of elevated readings at monitors representative of privately owned residences) is not triggered when elevated levels are recorded at this location as such, it may be more appropriate use to use HV4 as a management monitor rather than compliance monitor (Todoroski, 2021).

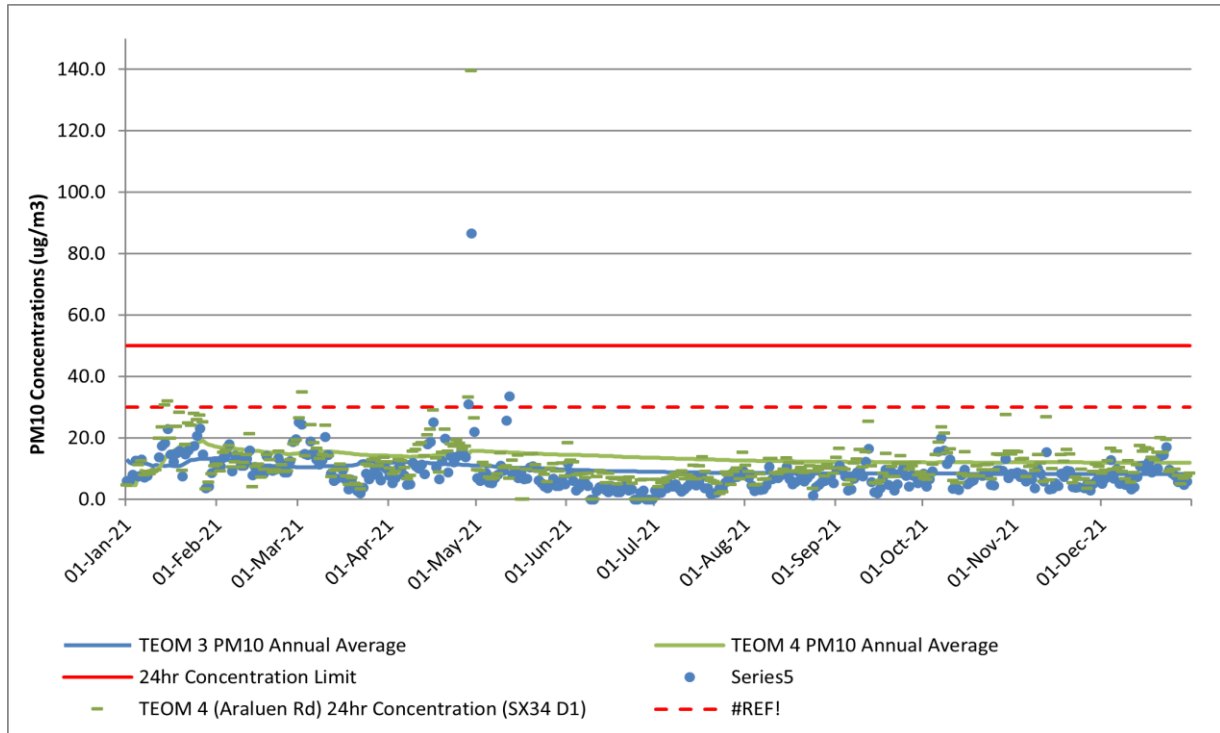
Graph 5 Compliance TEOM 24hr & Annual Average PM<sub>10</sub> Results 2021

**Notes:** It is noted that in 2021 there were two days considered to be “extraordinary events” for WCM, 28/04/2021 and 29/04/2021. These days were considered extraordinary events due to smoke associated with nearby hazard reduction burns (Todoroski, 2022) (Appendix 3B).

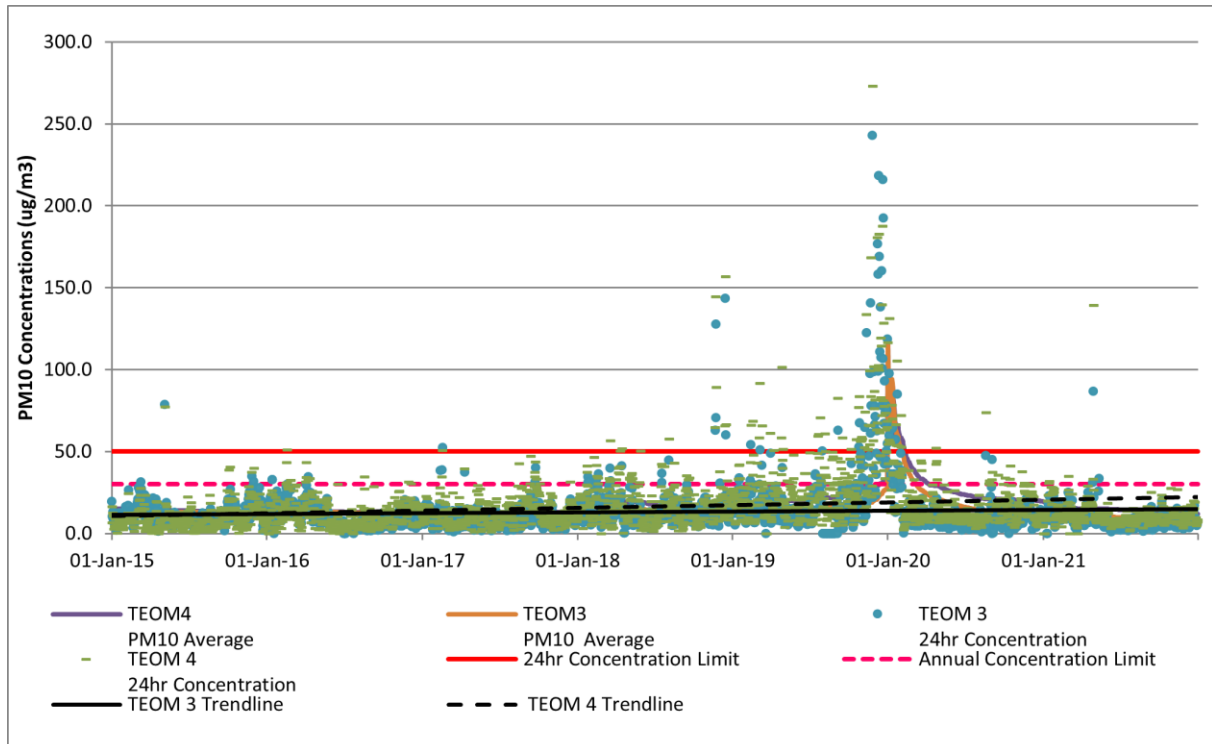
Graph 6 Compliance TEOM PM<sub>10</sub> 24hr Results and Trends (Rolling Averages) 2015-2021

**Notes:** The rolling annual average levels in generally show a trend of increasing levels, with the monitors all showing a sudden increase in levels at the end of 2019 associated with the 2019/2020 NSW bushfires and a sharp drop towards the end of 2020. (Todoroski, 2021). It is noted that in 2021 there were two days considered to be “extraordinary events” for WCM, 28/04/2021 and 29/04/2021. These days were considered extraordinary events due to smoke associated with nearby hazard reduction burns (Todoroski, 2022) (Appendix 3B).

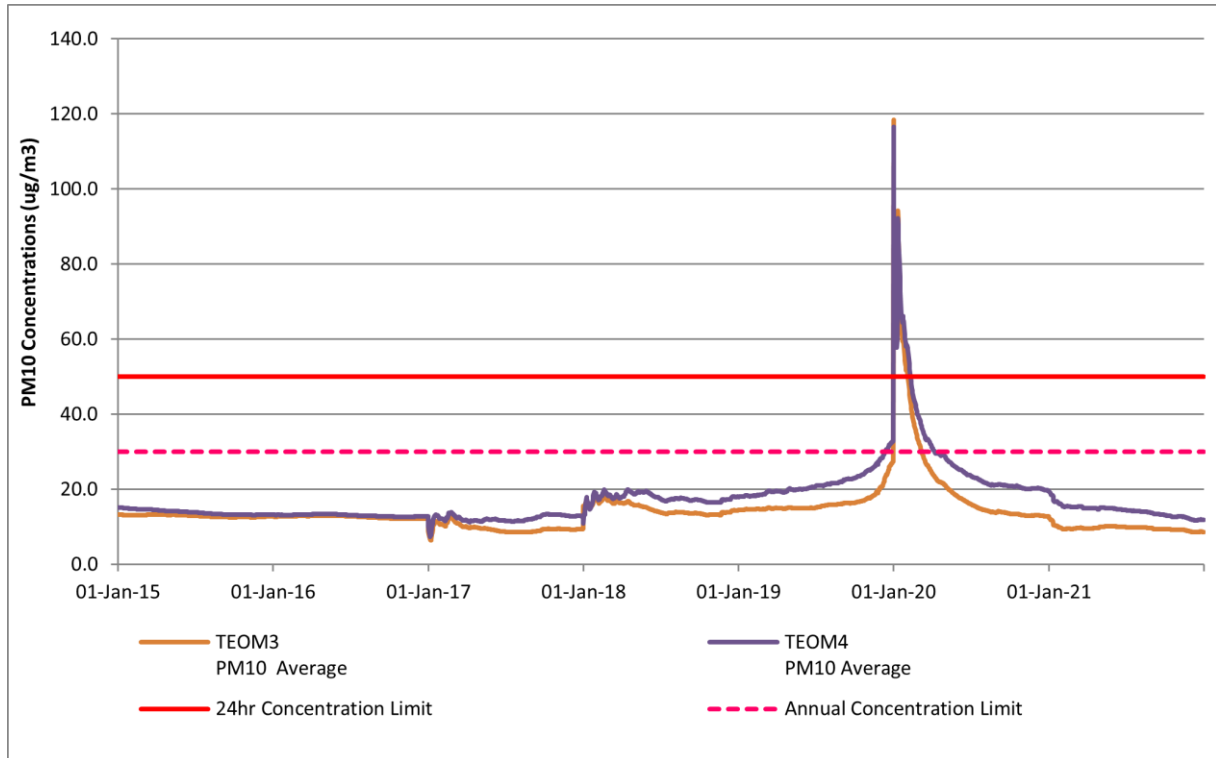
Graph 7 Compliance TEOM PM<sub>10</sub> (Rolling Averages) 2015-2021

**Notes:** The rolling annual average levels in generally show a trend of increasing levels, with the monitors all showing a sudden increase in levels at the end of 2019 associated with the 2019/2020 NSW bushfires and a sharp drop towards the end of 2020 (Todoroski, 2021).

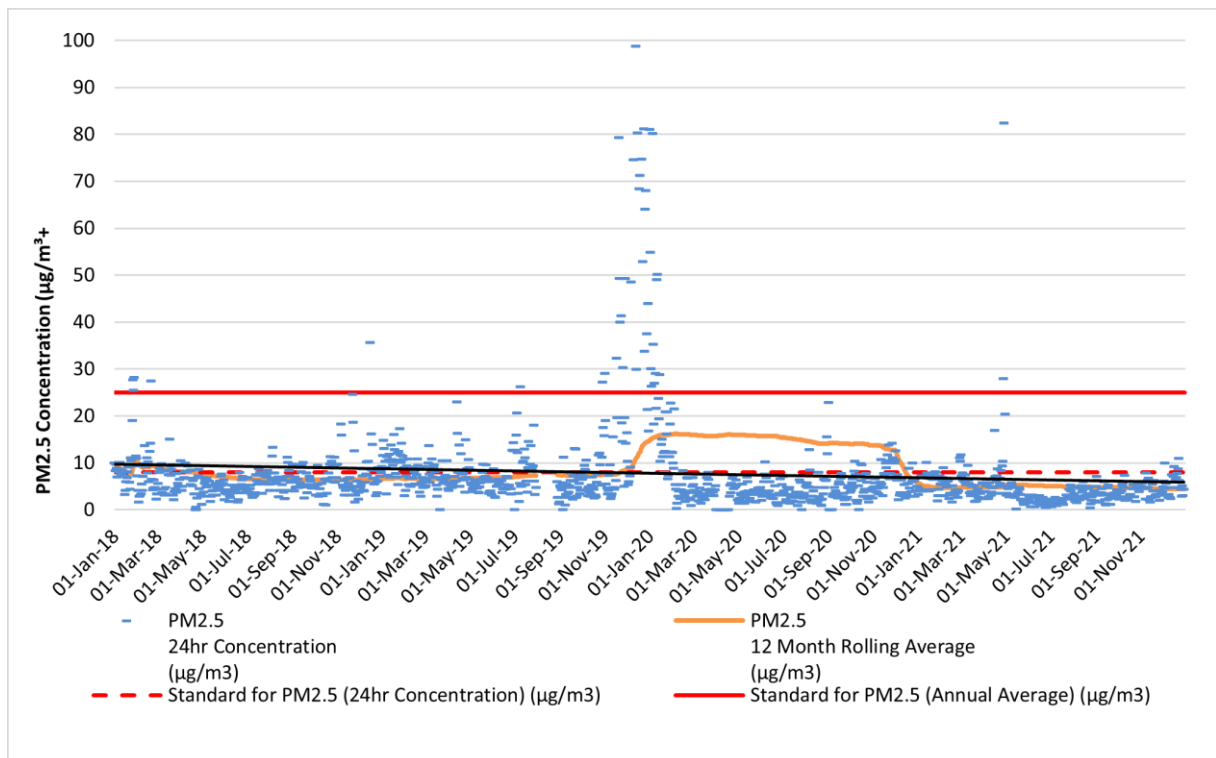
Graph 8 Compliance TEOM PM<sub>2.5</sub> 24hr Results and Trends (Rolling Averages) 2018-2021

**Notes:** PM<sub>2.5</sub> levels at the end of 2019 and start of 2020 are significantly elevated compared with the rest of the data. The levels were affected by bushfire smoke across NSW during the 2019/2020 bushfire season (Todoroski, 2021). It is noted that in 2021 there were two days considered to be “extraordinary events” for WCM, 28/04/2021 and 29/04/2021. These days were considered extraordinary events due to smoke associated with nearby hazard reduction burns (Todoroski, 2022) (**Appendix 3B**).

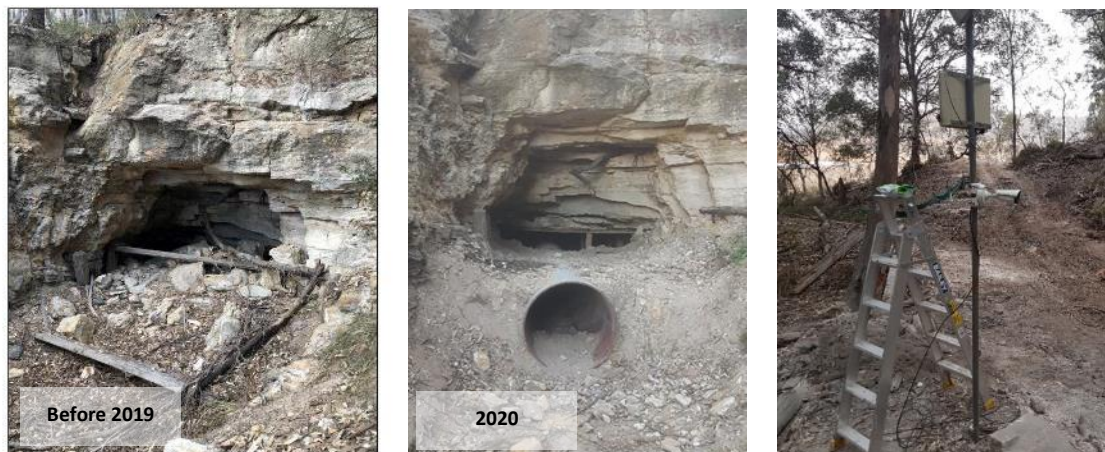
**Photo 1 Culvert Support & Bat Detector with Solar Panel setup 20m in front of Adit**

In accordance with the BMP, Eastern-Bentwing Bat Management Strategies were undertaken in 2019 with the installation of a section of 1000mm diameter steel pipe culvert inserted into the adit to ensure access/egress for microbat species. To mitigate the potential for future collapse, rock debris was removed from around the entrance. On further recommendations provided by WCPL's microbat specialist, further

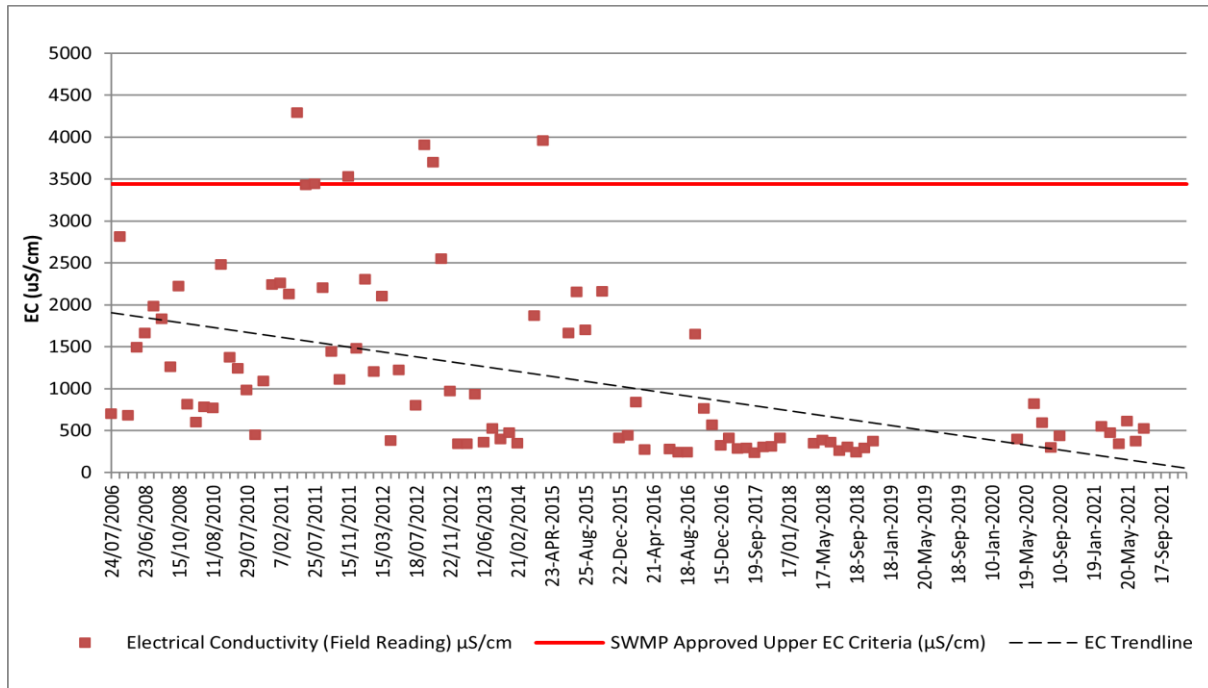
Graph 12 Long-term EC Water Quality Results at WIL\_NC

**Notes:** During the 2021 monitoring period, EC observations at the Wilpinjong Creek Downstream monitoring sites are well below the 80th percentile baseline as well as below the trigger level (3440 µS/cm). Overall, the observations seem to reach equilibrium at around 500 µS/cm as the rainfall trend increases in 2021 and the RO plant is discharged from more continuously (SLR, 2022). No available water samples at WIL\_NC during the 2019 reporting period were available for sampling due to the prolonged drought conditions.

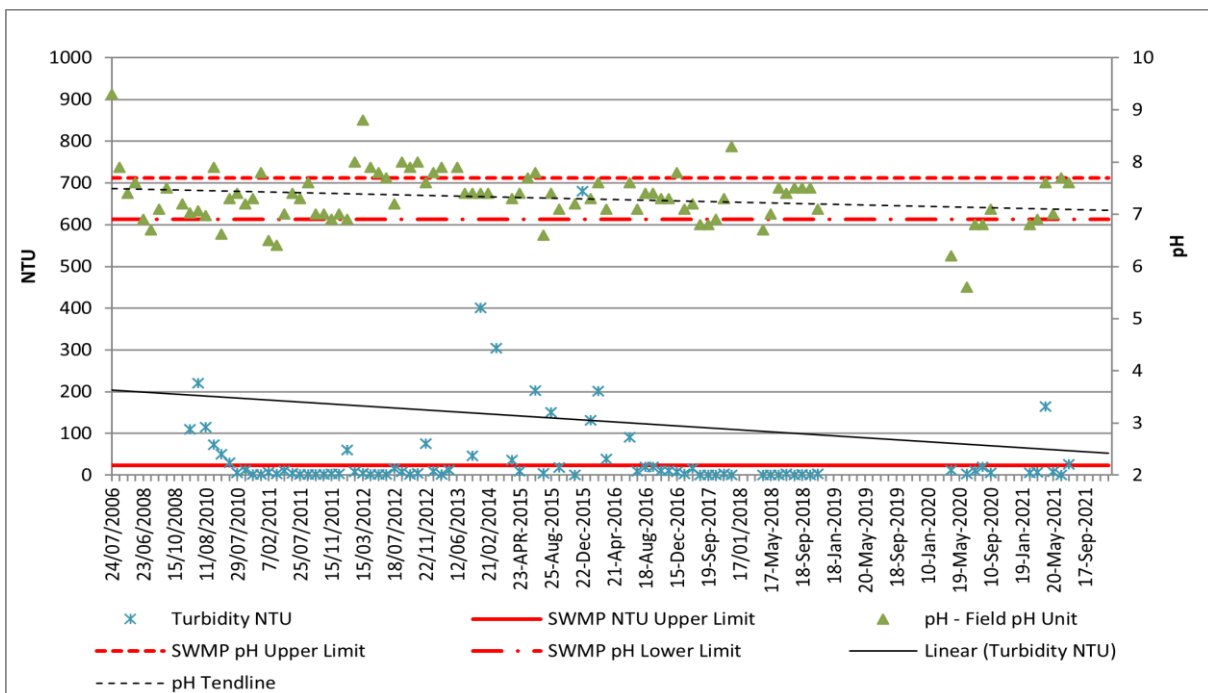
Graph 13 Long-term pH & NTU Water Quality Results at WIL\_NC

**Notes:** Elevated pH results towards trigger values in June and July. No further samples available for August to December 2021 due to safe access issues to water monitoring site. During 2021, turbidity observations generally range from 10 - 200 NTU with few outliers, again showing connectivity of the sites during periods of above average rainfall and flow (SLR, 2022). No available water samples at WIL\_NC during the 2019 reporting period were available for sampling due to the prolonged drought conditions.

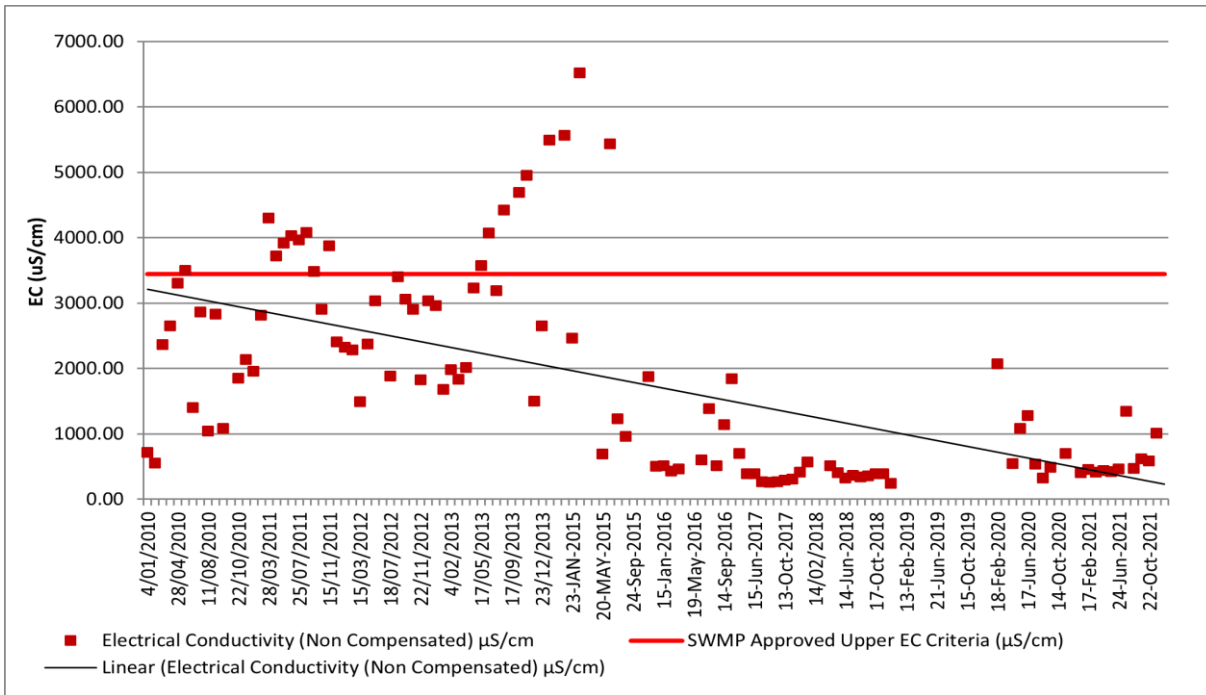
Graph 14 Long-term EC Water Quality Results at WIL\_D2

**Notes:** During the 2021 monitoring period, EC observations at the Wilpinjong Creek Downstream monitoring sites are well below the 80th percentile baseline as well as below the trigger level (3440 µS/cm). Overall, the observations seem to reach equilibrium at around 500 µS/cm as the rainfall trend increases in 2021 and the RO plant is discharged from more continuously (SLR, 2022). No available water samples at WIL\_D2 during the 2019 reporting period were available for sampling due to the prolonged drought conditions.

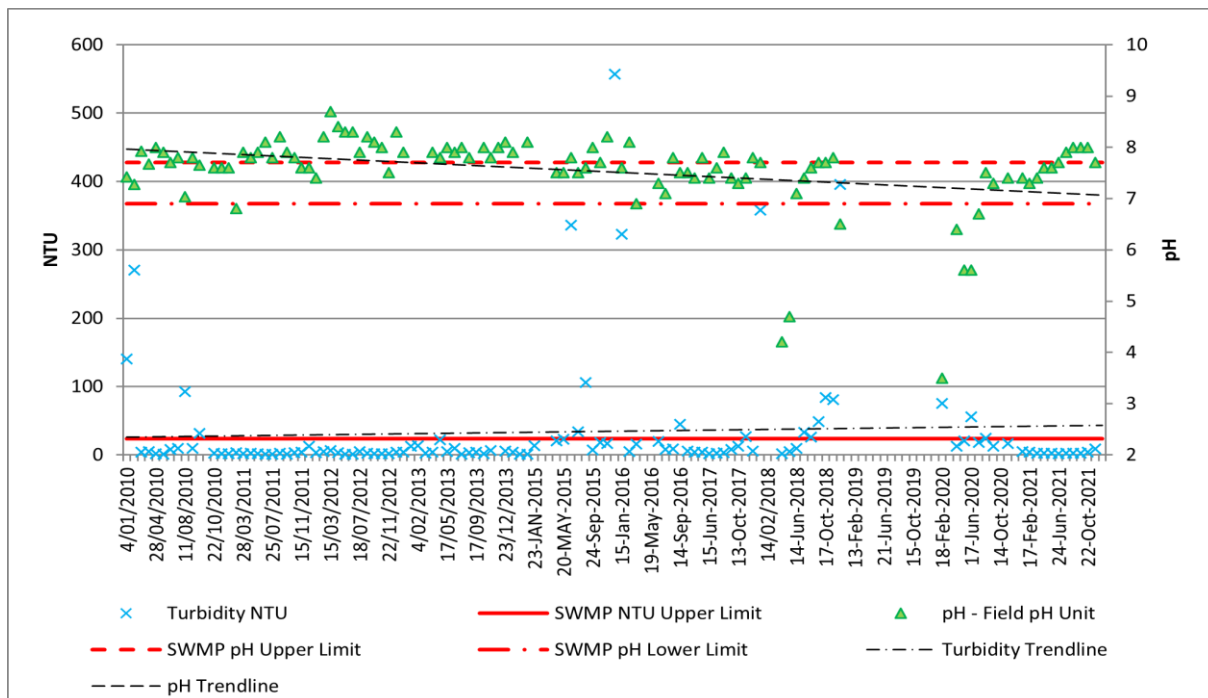
Graph 15 Long-term pH & NTU Water Quality Results at WIL\_D2

**Notes:** During 2021, turbidity observations at Wilpinjong Creek Downstream monitoring sites are generally below the 80th percentile baseline (28 NTU) and trigger level (24 NTU) with 4 outlier observations for WIL-NC and WIL-GS-D above the trigger level in 2021. Three consecutive readings were not observed above the trigger level at any site in 2021 (SLR, 2022).

During 2021, pH observations at Wilpinjong Creek Downstream monitoring sites are within the trigger level bounds at the beginning of the year, before increasing to values above the upper trigger between June and October at both WIL-GS-D and WIL-D2 (four consecutive observations at each site). A similar trend was not observed at Wilpinjong Creek Upstream monitoring sites from June to October (Section 4.1.1.3), therefore breaching the upper pH trigger level as defined in the SWMP (SLR, 2022). No available water samples at WIL\_D2 during the 2019 reporting period were available for sampling due to the prolonged drought conditions.

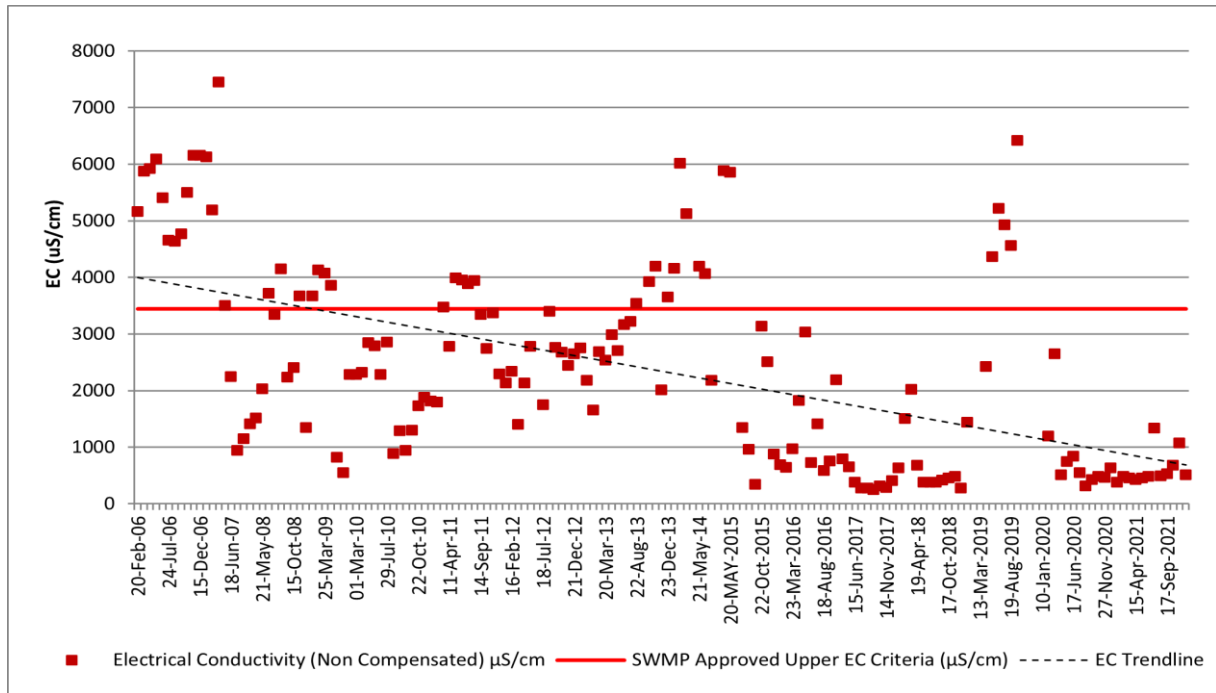
Graph 16 Long-term EC Water Quality Results at WIL\_D

**Notes.** During the 2021 monitoring period, EC observations at the Wilpinjong Creek Downstream monitoring sites are well below the 80th percentile baseline as well as below the trigger level (3440 µS/cm). Overall, the observations seem to reach equilibrium at around 500 µS/cm as the rainfall trend increases in 2021 and the RO plant is discharged from more continuously (SLR, 2022).

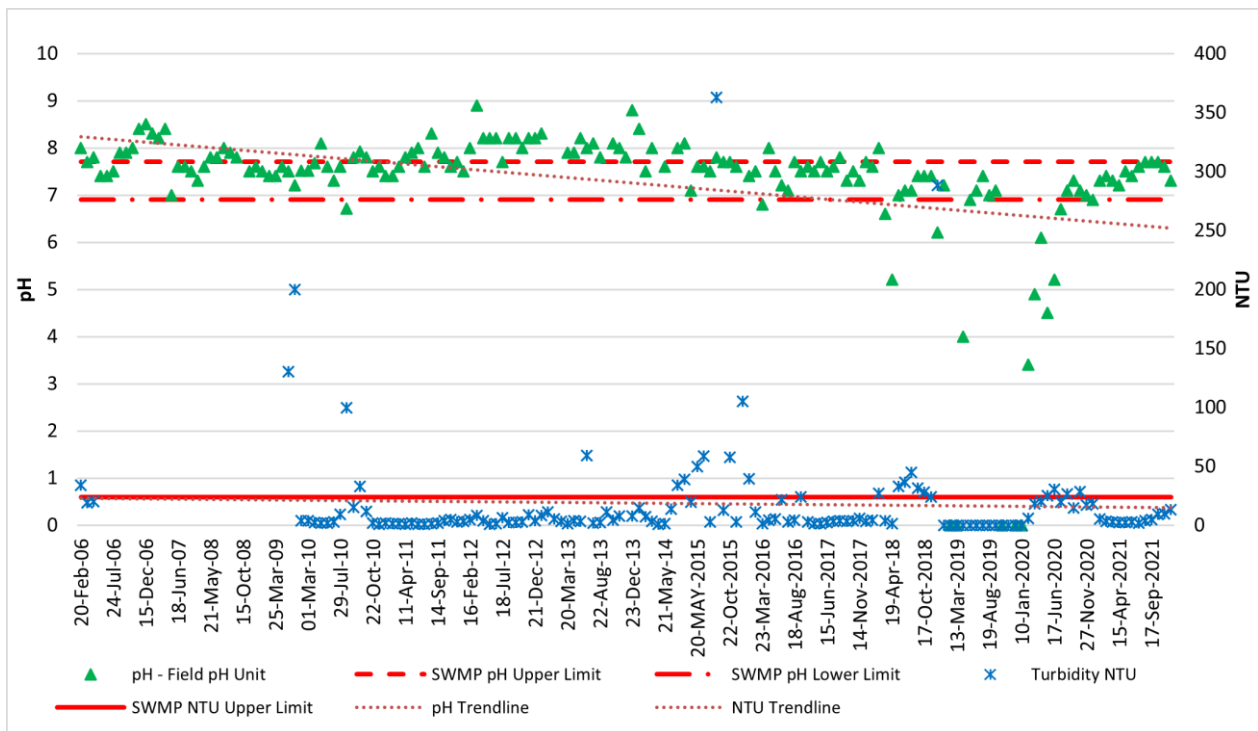
Graph 17 Long-term pH & NTU Water Quality Results at WIL\_D

**Notes:** Elevated pH results towards trigger values in July to October, however no exceedance of pH trigger in 2021.

During 2021, turbidity observations at Wilpinjong Creek Downstream monitoring sites are generally below the 80th percentile baseline (28 NTU) and trigger level (24 NTU) with 4 outlier observations for WIL-NC and WIL-GS-D above the trigger level in 2021. Three consecutive readings were not observed above the trigger level at any site in 2021 (SLR, 2022).

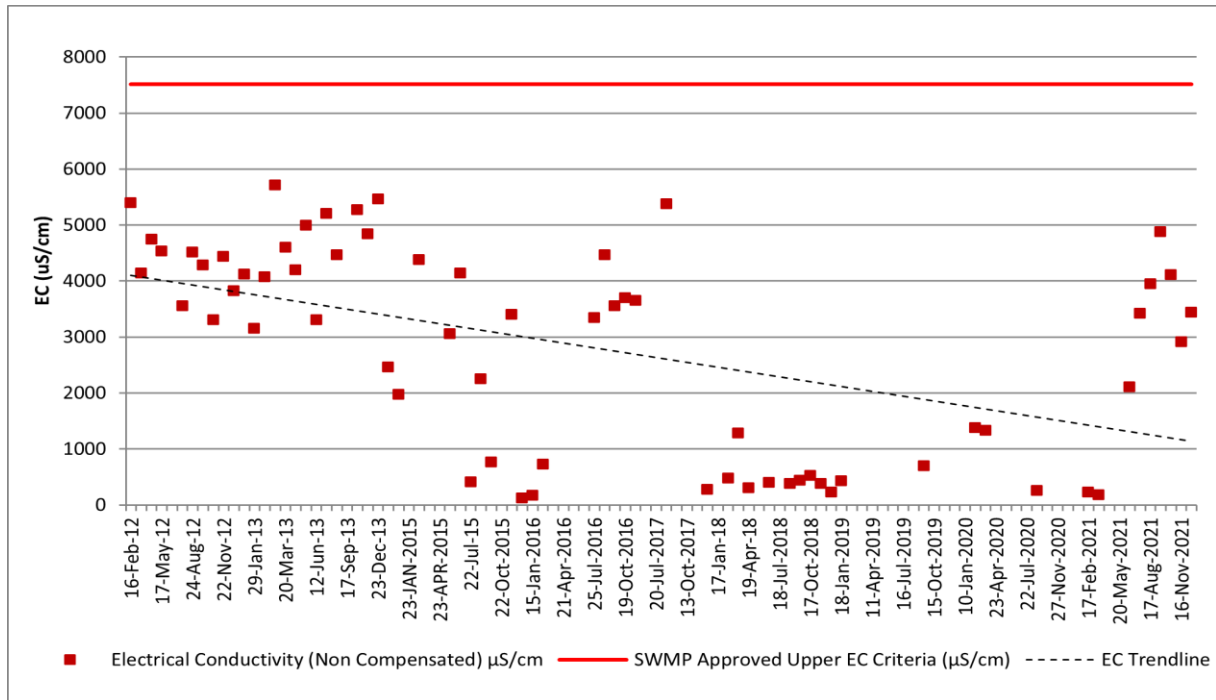
Graph 18 Long-term EC Water Quality Results at CC\_1

**Notes:** During 2021, EC observations at Cumbo Creek Downstream monitoring sites are well below the trigger level (7510 µS/cm) with reading between <1000 and 5000 µS/cm (SLR, 2022).

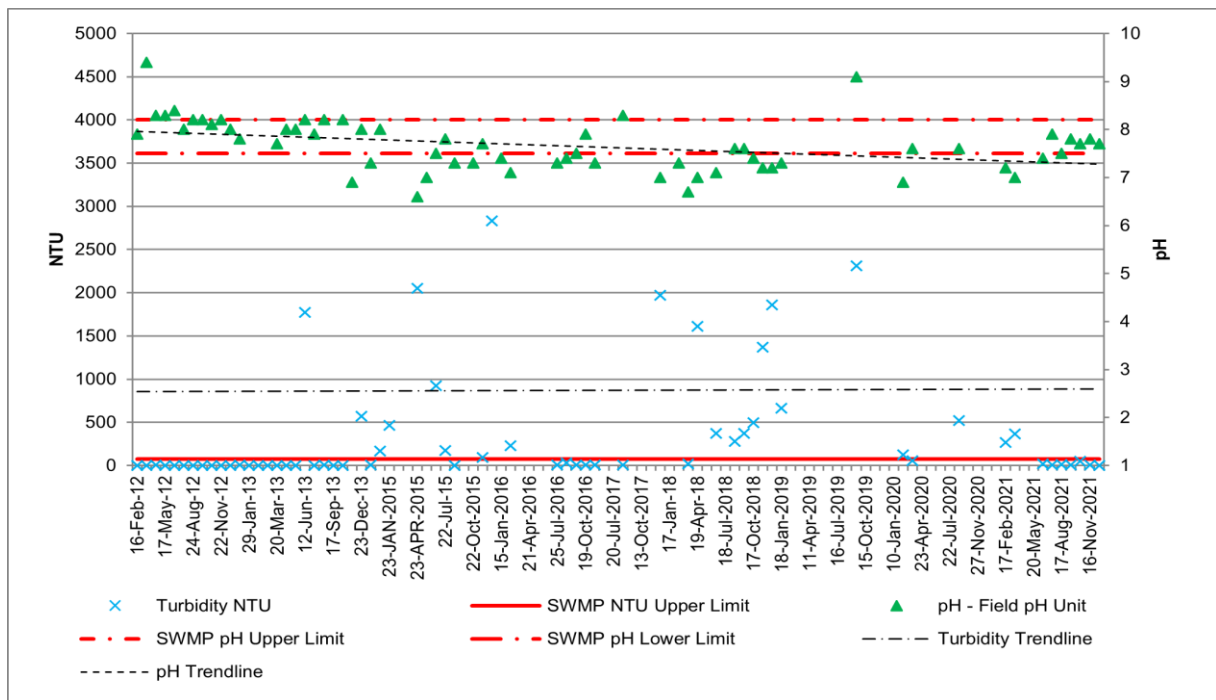
Graph 19 Long-term pH & NTU Water Quality Results at CC\_1

**Notes:** No exceedance of the trigger level was recorded during 2021 as three consecutive observations above the trigger level are required at CC-1. Both Wilpinjong Creek and Wollar Creek downstream sites were generally below 10 NTU during 2021 (SLR, 2022).

Early 2021 (to June) saw all monitoring sites CC-1, CC-1 (30m up) and CC-GS-D below the minimum trigger level at Cumbo Creek downstream sites, consistent with observations from 2014-2020 (approximately pH 7.25). Observations from June to December 2021 indicate an increase of approximately 0.5 pH units to pH 7.75, with a similar increase of approximately 0.5 pH units is observed at Cumbo Creek Upstream sites (from pH 7.75-8.2) from March to June 2021. A pH trigger exceedance was recorded in 2021 as more than three consecutive observations (Feb – June) were below the lower pH trigger level. Observations during this time were pH 7.1-7.4 (SLR, 2022).

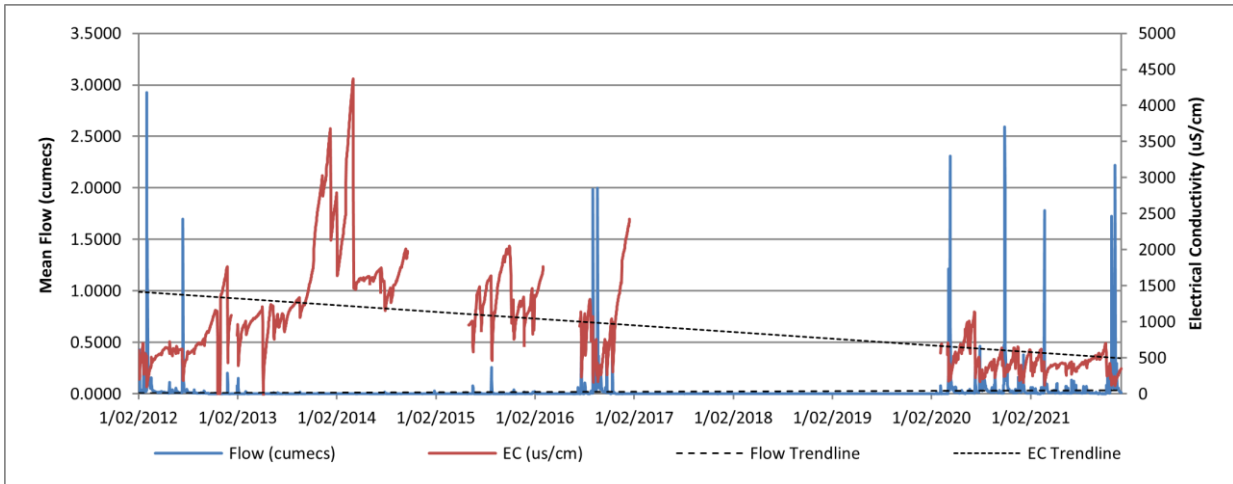
Graph 20 Gauging Station Wilpinjong Creek Upstream Long Term Trends

**Notes:** The flow trend is observed to decline for the period of below average rainfall from mid-2012 to mid-2015 as well as the period of below average flow from early 2017 through to the end of 2019. Response to rainfall events in 2021 is observed at WILGSU, with similar flow volumes and response to rainfall as events observed in 2012 and 2016 (SLR,2022).

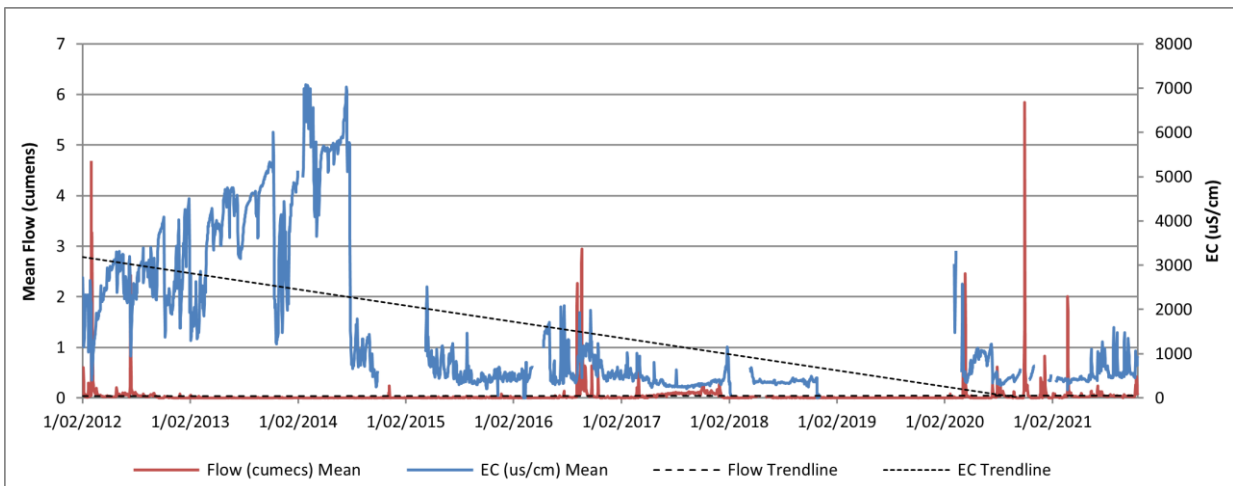
Graph 21 Gauging Station Wilpinjong Creek Downstream Long Term Trends

**Notes:** Above average rainfall conditions and consistent discharge from the RO Plant in 2021 has resulted in consistent above average flow conditions at WILGSD (SLR,2022).

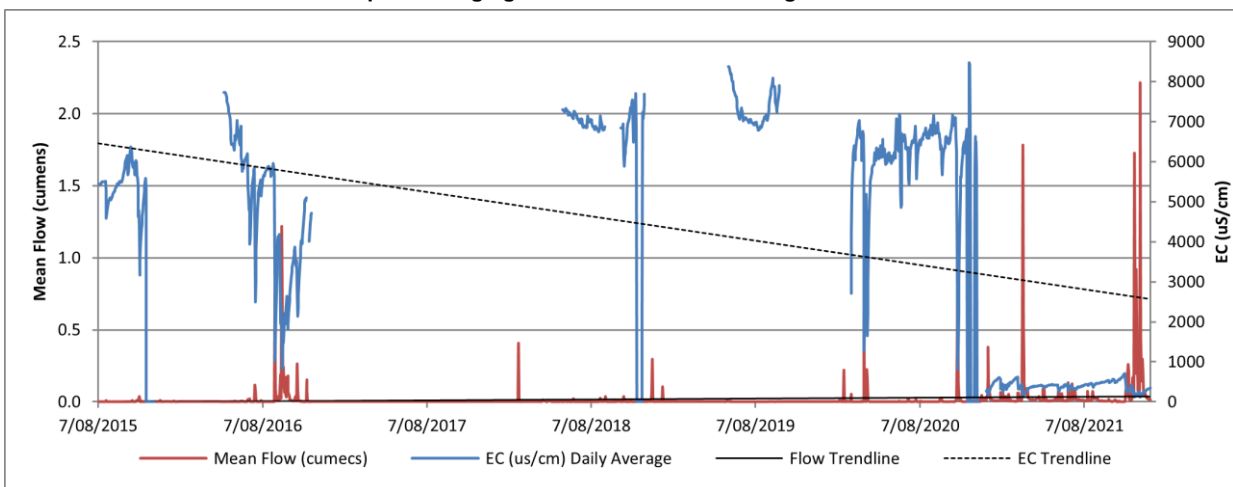
Graph 22 Gauging Station Cumbo Creek Long Term Trends

**Notes:** As identified in the initial flow review, CCGSU shows a good relationship with the rainfall trend for the entire period of record (2015 to 2021) (SLR,2022).

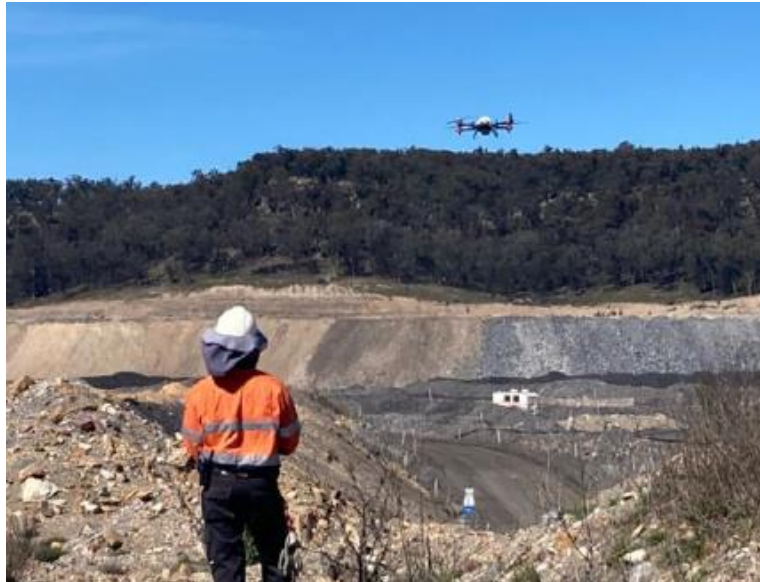
Photo 2 Drone Seeding Dump Batters

WCPL conducted aerial native seeding via drone on an elevated dump in September 2021 (Figure 6). The revegetation works were undertaken to assist in the dumps stabilisation and enhance visual amenity. Approximately 25ha of steep slopes were drone seeded with an array of acacia species. These species were nominally selected due to local availability, quick germination, and establishment with high generation of surface organic matter.

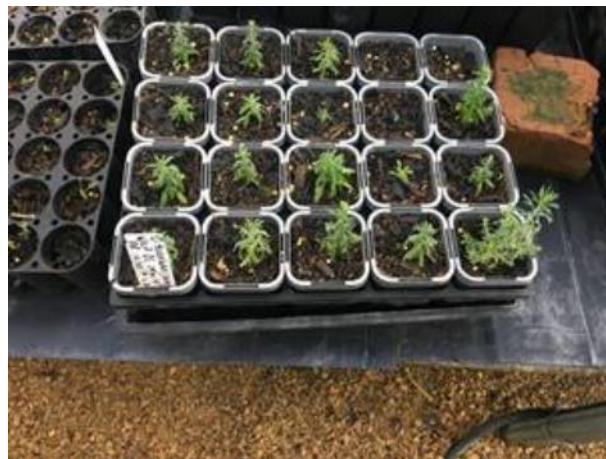
**Photo 3 *Ozothamnus tessellatus* propagated seedlings 2019**

- 3 grams of *Ozothamnus tessellatus* seeds were harvested in 2019;
- 1 gram of *Ozothamnus tessellatus* seeds were sown to grow seedlings in 2019 (**Photo 3**);
- On 26 September 2019, 30 *Ozothamnus tessellatus* seedlings were planted in ECA\_C;
- Grazing pressure from native/feral animals and the ongoing drought resulted in 100% mortality; and
- Seed Collection in 2020 did not occur due to the source plants not flowering or producing a nondetrimental harvestable quantity. Harvesting the small available seed would have been detrimental to the local seed source and such a practice would have been against industry standard and FloraBank guidelines.
- Seed collected in 2019 was stored for propagation and planting trials commenced in 2021
- ~500 grams of *Ozothamnus tessellatus* seeds were harvested in 2021.

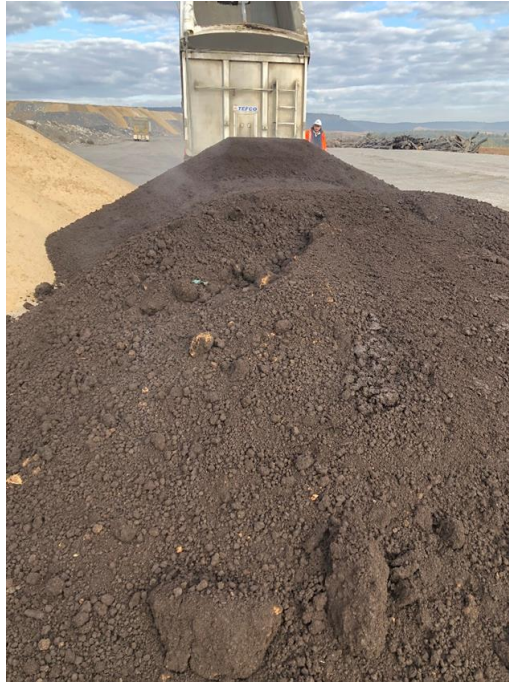
Photo 4 Compost Delivered for Soil Amelioration

Recent soil tests indicate low organic matter and nutrient cycling, to address this WCPL incorporated Vermicasts and Vermi-liquids into the soil amelioration program to enhance and stimulate soil biology and soil structure. The importation of composts were also used and spread across rehabilitation areas to inoculate and increase soil organic matter. The concept of incorporating these products aims to ameliorate the soil and expedite soil system performance and encourage native seed germination and long-term soil stability and structure.

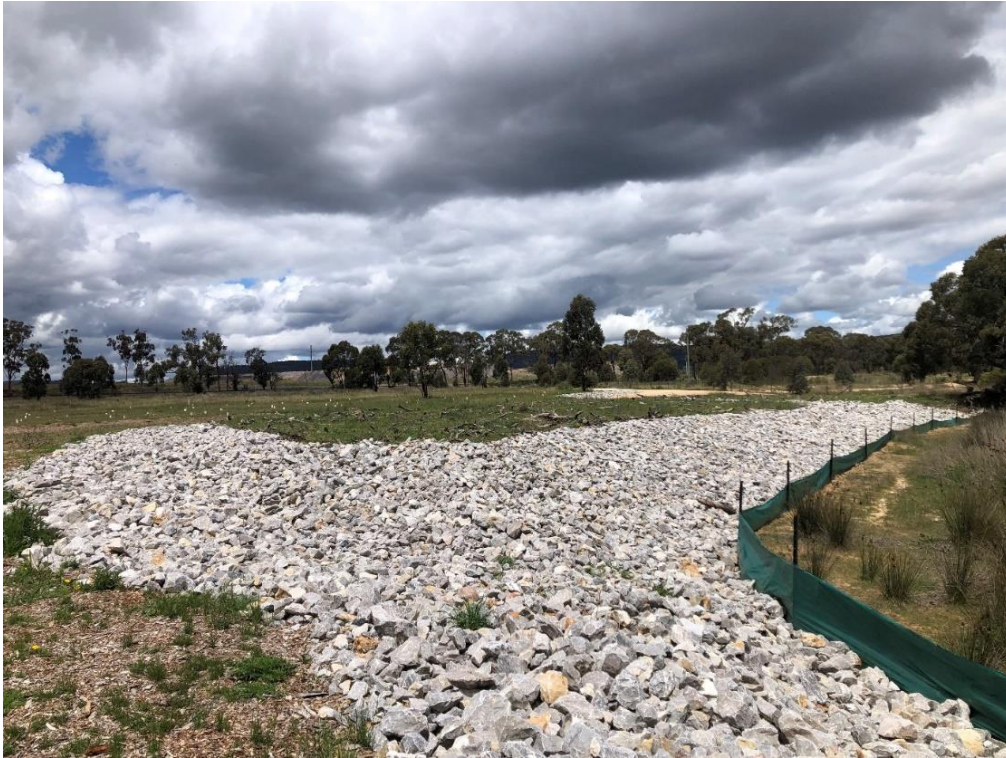
Photo 5 Wilpinjong Creek Stabilisation – Tubestock Planting in 2021

Throughout 2021 a total of 3,629 tubestock were planted across various land management domains (new and replacement), specifically Enhancement and Conservation Areas (ECA) ECA B & Regeneration Area 1. Within and adjacent to ECA B, Wilpinjong Creek stabilisation works occurred in 2021 with re-battering of the creek bank and rock armoring to reduce erosion and cut bank erosion. To complement the physical and mechanical works, tubestock planting and mulching was conducted to enhance the sites ecological, soil and landscape stability and resilience. A total of 500 tubestock were planted in this area (**Photo 5**).

Tubestock were planted adjacent to Wilpinjong Creek in Regeneration Area 1 to enhance landscape stability and to enhance ecological resilience. A collective total of 1.8kms (or 19ha) of creek bank was rehabilitated subsequent to these works throughout 2021(**Figure 7**) & (**Photo 5**). Planting locations aligned with the three-year management schedule as documented within Appendix 6 of the WCPL Biodiversity Management Plan (BMP). Species planted in 2021 included:

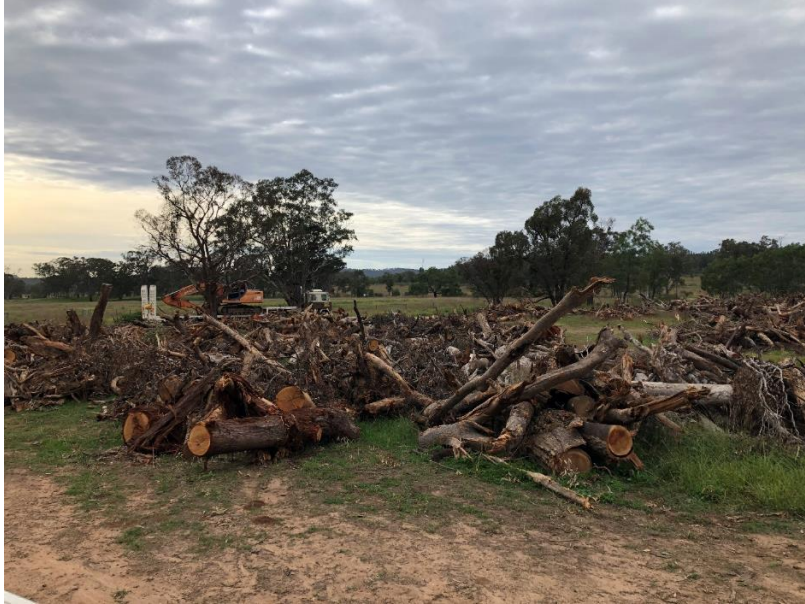
**Photo 7 Log Stockpiles on Site**

To meet the requirements of the BMP, WCPL continued with the relocation of surplus trees removed from the mining footprint for mine site rehabilitation and re-establishment as log habitat. Logs were also imported to site sourced from the Mid-Western Regional Council (MWRC) Wollar /Munghorn Gap Road Upgrade Project.
