# **2021 Annual Review**

**Wilpinjong Coal Mine**

This 2021 Annual Review (AR) (this Report) presents a summary of regulatory compliance, environmental performance and community engagement activities for the *review period* from 1 January 2021 to 31 December 2021.

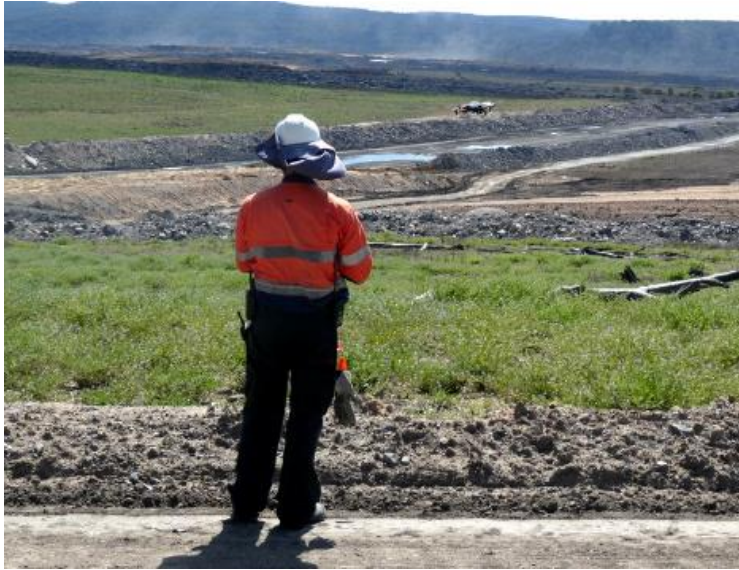
Photo 9 Drone Seeding Trial

A total of 10ha initially aerially seeded by drone with HU732 (Yellowbox Grassy Woodland) understory and grass species were oversown with canopy species in September 2021. Similar to the 2020 drone seeding, the seeds were coated to allow efficient flowability and distribution across the site. The concept of staggered seeding between stratum species was to encourage grass and shrub establishment with reduced competition from canopy species.

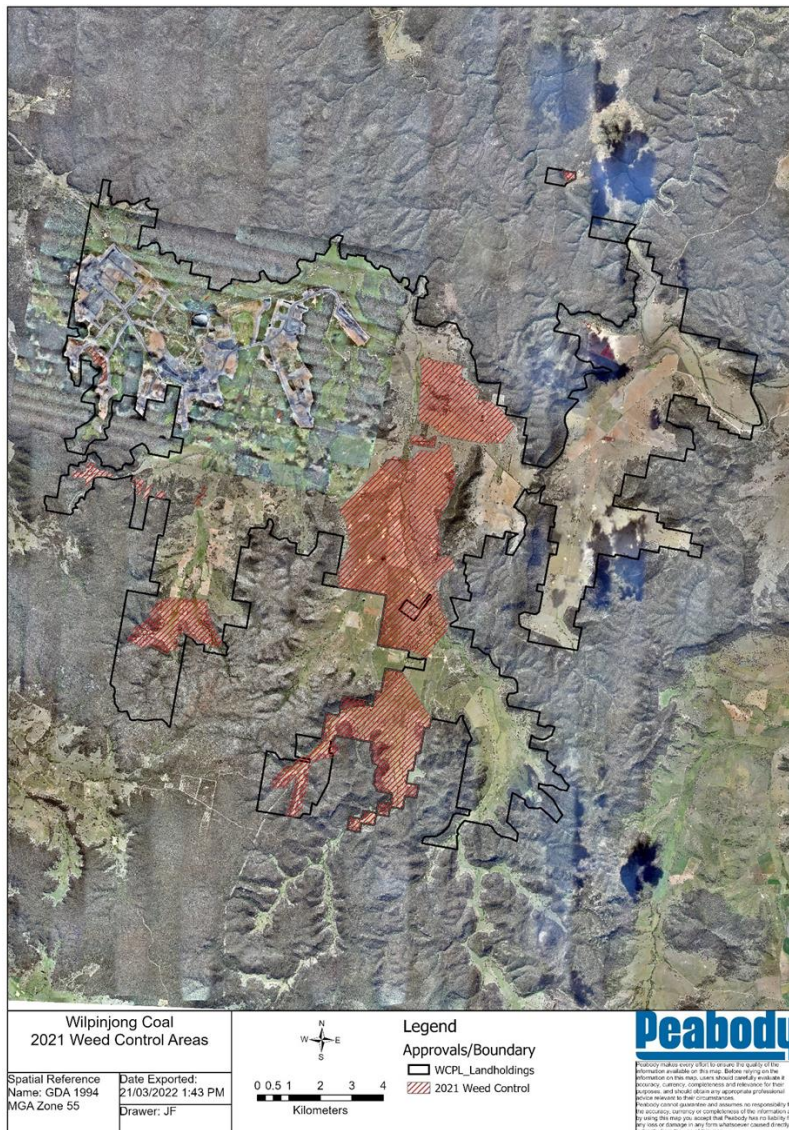
Figure 8 2021 Weed Control Areas

WCPL continued with an extensive weed spraying program throughout 2021 (**Figure 9**) of which incorporated and targeted species and locations identified from the 2020 monitoring program, regular internal inspections and annual MWRC inspections using selective herbicides. Control areas of 2021 were similar to that of 2020 areas. Target weed species included Sweet Briar, Blue Heliotrope, African Boxthorn, Prickly Pear, Paterson’s Curse, Noogoora Burr, St John’s Wort, Tree of Heaven and Blackberry.
