# **2017 Annual Review**

**Wilpinjong Coal Mine**

This 2017 Annual Review (AR) (this Report) presents a summary of regulatory compliance, environmental performance and community engagement activities for the *review period* from 1 January 2017 to 31 December 2017.

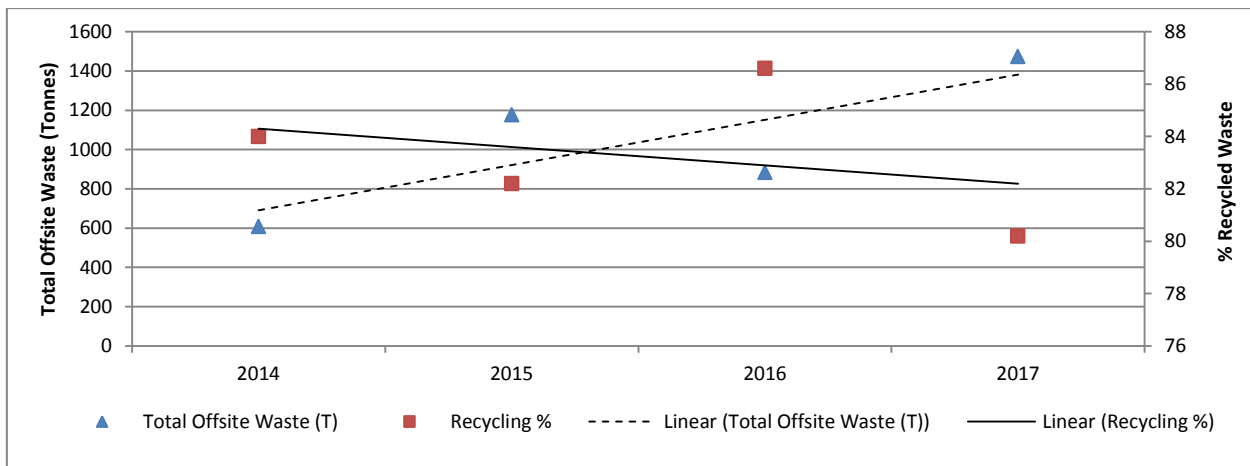
**Graph 10 Waste Statistics and Trends**

Totals	Jan	Feb	Mar	Apr	May	Jun	Jul	Aug	Sept	Oct	Nov	Dec	Totals
<b>Total Offsite Waste (T)</b>	91.6	88.4	101.6	50.3	113.1	406.8	133.4	91.5	87.2	99.1	78.7	132.7	<b>1474.5</b>
<b>Recycled Waste</b>	79.7	74.1	85.6	41.6	98.2	280.1	113.2	70.9	73.9	86.9	60.3	118.6	<b>1183.3</b>
<b>Recycling %</b>	87.0	83.8	84.2	82.6	86.9	68.9	84.9	77.5	84.7	87.7	76.7	89.4	<b>80.2%</b>

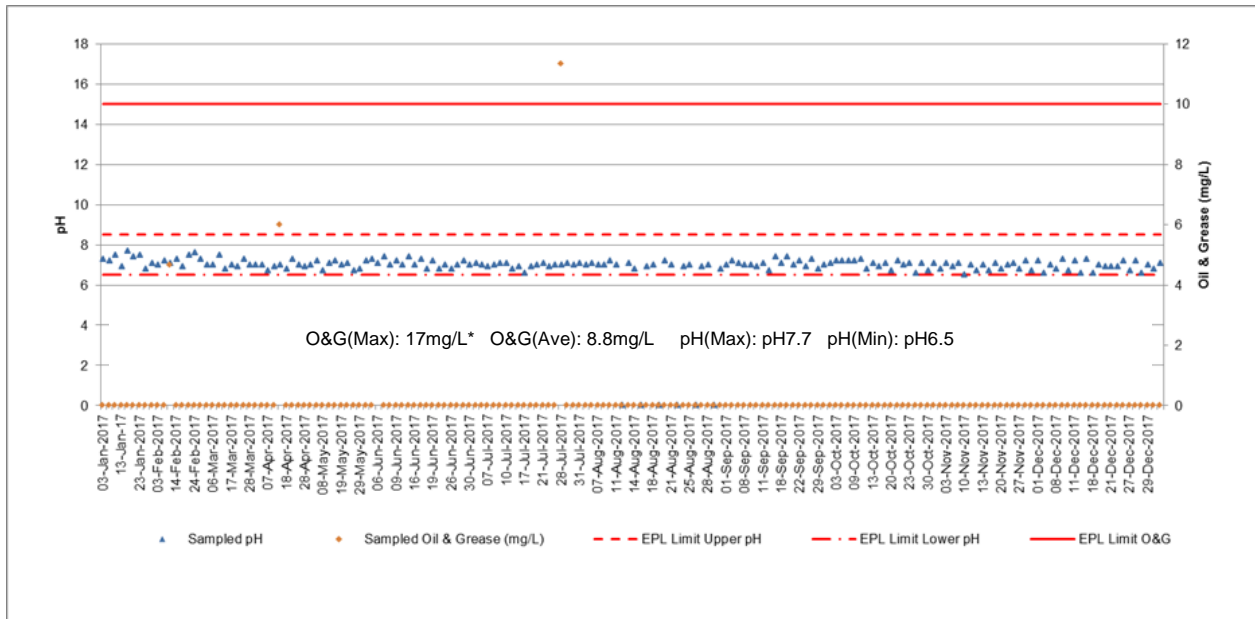
Graph 21 Results for pH & Oil/Grease Discharged During 2017

**Note:\*** Oil & grease result analyses on the 28 July 2017 was 17mg/L. After investigations it was determined the result of laboratory error or interference in the analysis method. Any oil and grease (O&G) in the Reverse Osmosis (RO) feedwater will be rejected at the RO membrane surface. On this basis O&G should not pass into the treated water. After O&G result reported additional water samples taken to confirm any future O&G result reported by laboratory. Since the 28/07/2017 result all water samples (numbering 105) have returned an O&G concentration of <5mg/L.

with the exception of one O&G result of 17mg/L analysed on the 28 July 2017. For further discussions and explanations please refer to footnote provided with **Graph 21**.

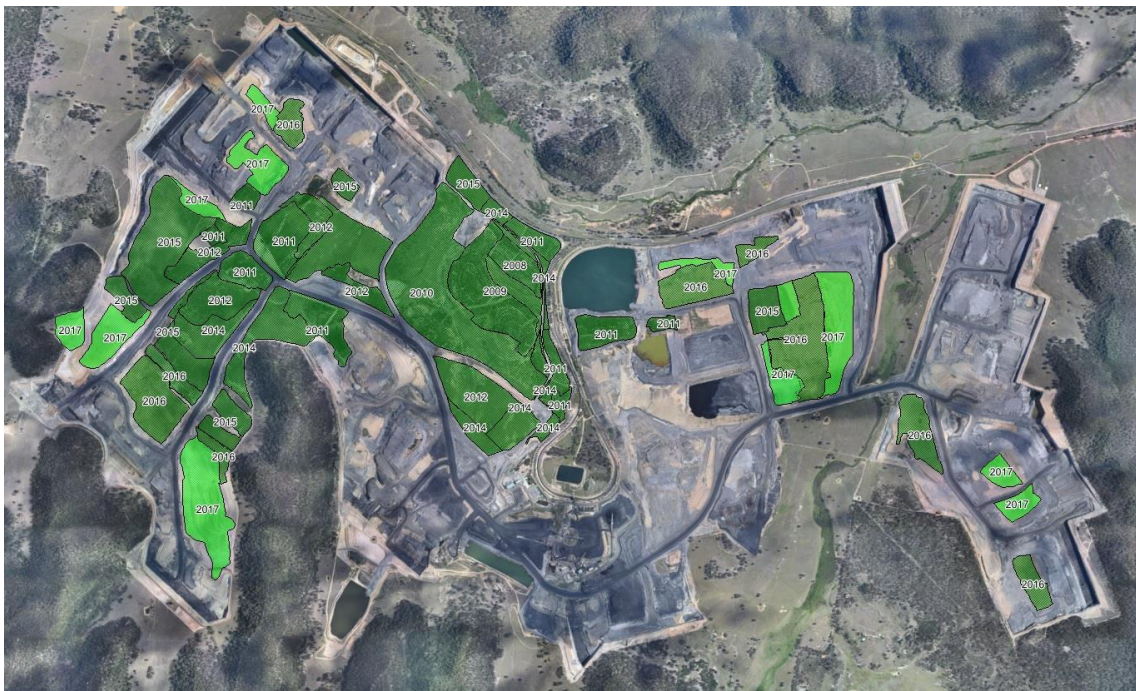
Figure 3 2017 Seeded Areas (light green areas)

During 2017, a combination of approximately 82ha across Domain 5 and Domain 6 were seeded under a summer cover crop (**Figure 4**). The cover crops include various combination of legumes (cow peas, clover), sorghum, millet, sudan grass, oats. Typically combinations and rates are shown in **Table 33** of the different pasture species and rates. Subject to approval in regards to the BVT performance and completion criteria, species to be planted in the rehabilitated landforms will be a mixture of native trees, shrubs and grasses selected to align with the final and approved BVT classifications. WCPL maintains a native seed inventory which was collected from locally native seed sources carried out by suitably qualified personnel which will be used in rehabilitation activities. The progress of the revised rehabilitation strategy will be provided in the next AR.
