**WILPINJONG COAL PTY LTD**

**Environment Protection Licence (EPL) 12425**

**LICENCE MONITORING DATA  
MONTHLY SUMMARY REPORT**

**1 October 2020 to 31 October 2020**

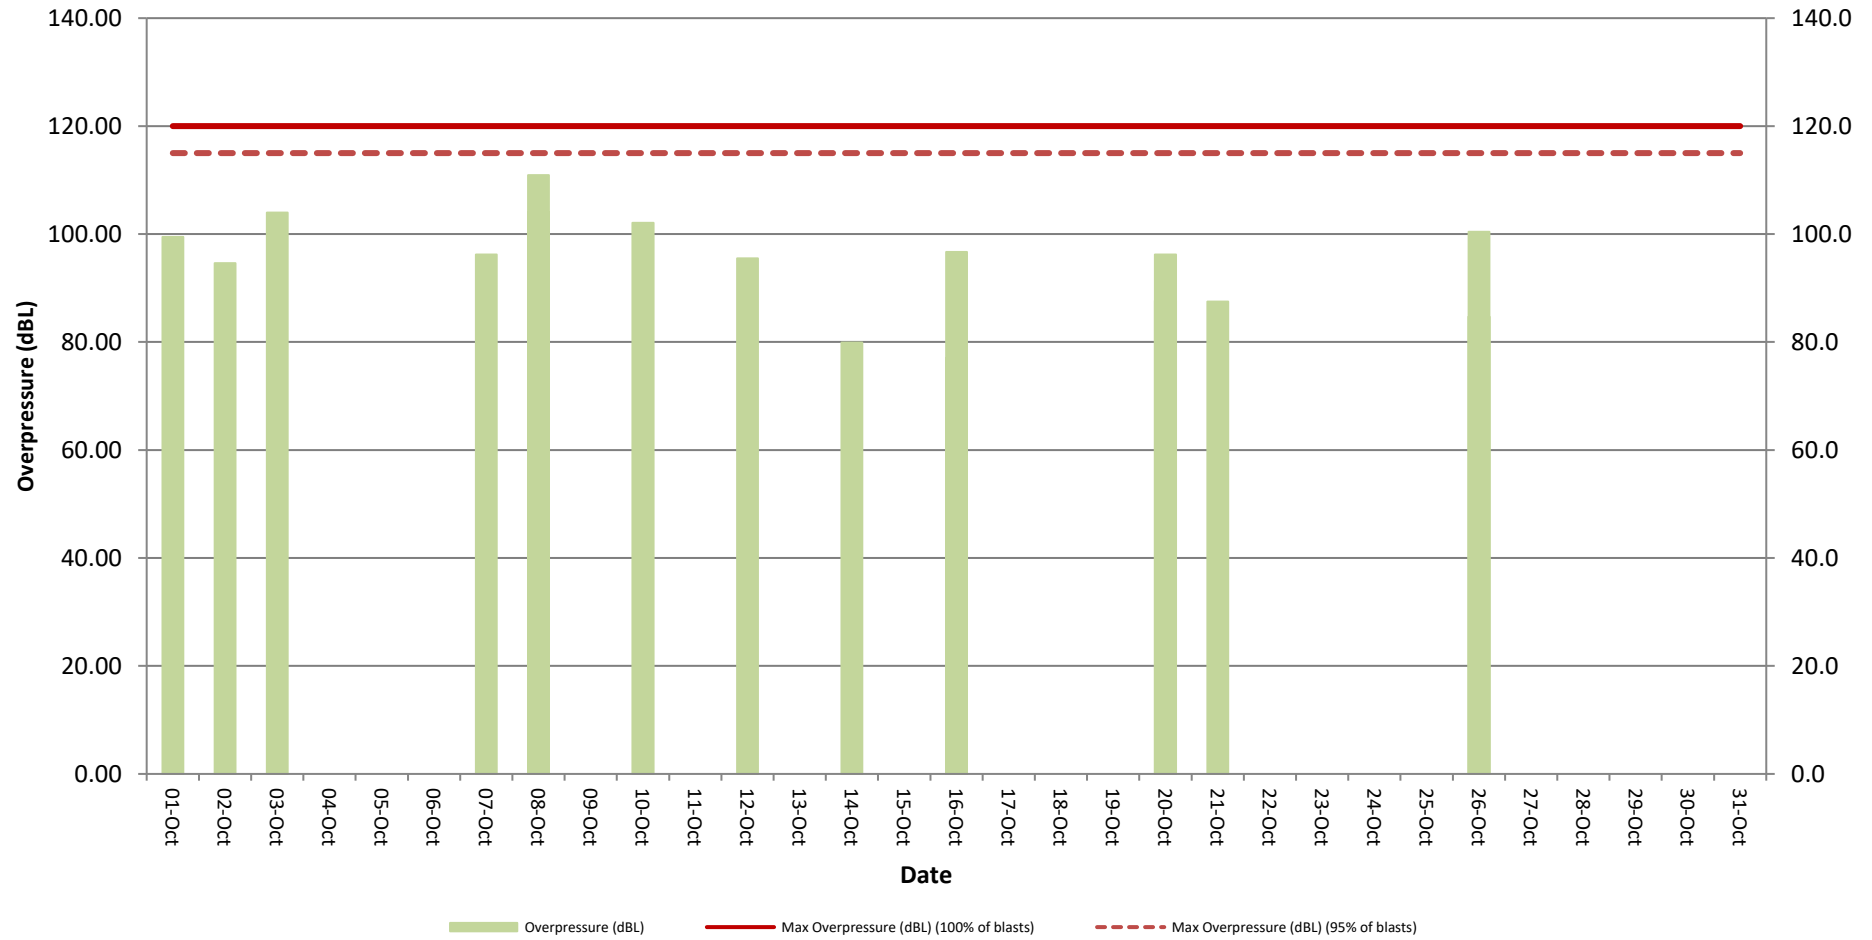
Figure 7. Overpressure (dBL) recorded during Month

Monitoring is carried out near sensitive locations during blasting activities to determine the vibration in the air (overpressure) and earth (ground vibration). A summary of the results of this monitoring, and the limits specified in the EPL, are shown in **Tables 3** and **4**. **Figures 7 & 8** shows the actual overpressure and vibration levels recorded during the month.

Location	Month	Number of Blasts	Minimum overpressure (dB(L))	Maximum overpressure (dB(L))	Mean overpressure (dB(L))	EPL overpressure Limits (dB(L))	Exceedance (yes/no)
Approx. 50m west of the Wollar Public School	October	17	77.0	110.9	94.7	115dB (95% blasts) 120 dB (100% blasts)	no
