CENTURION NORTH

Progressive Rehabilitation and Closure Plan

Prepared by: Peabody Energy Australia Pty Ltd

Version: 001

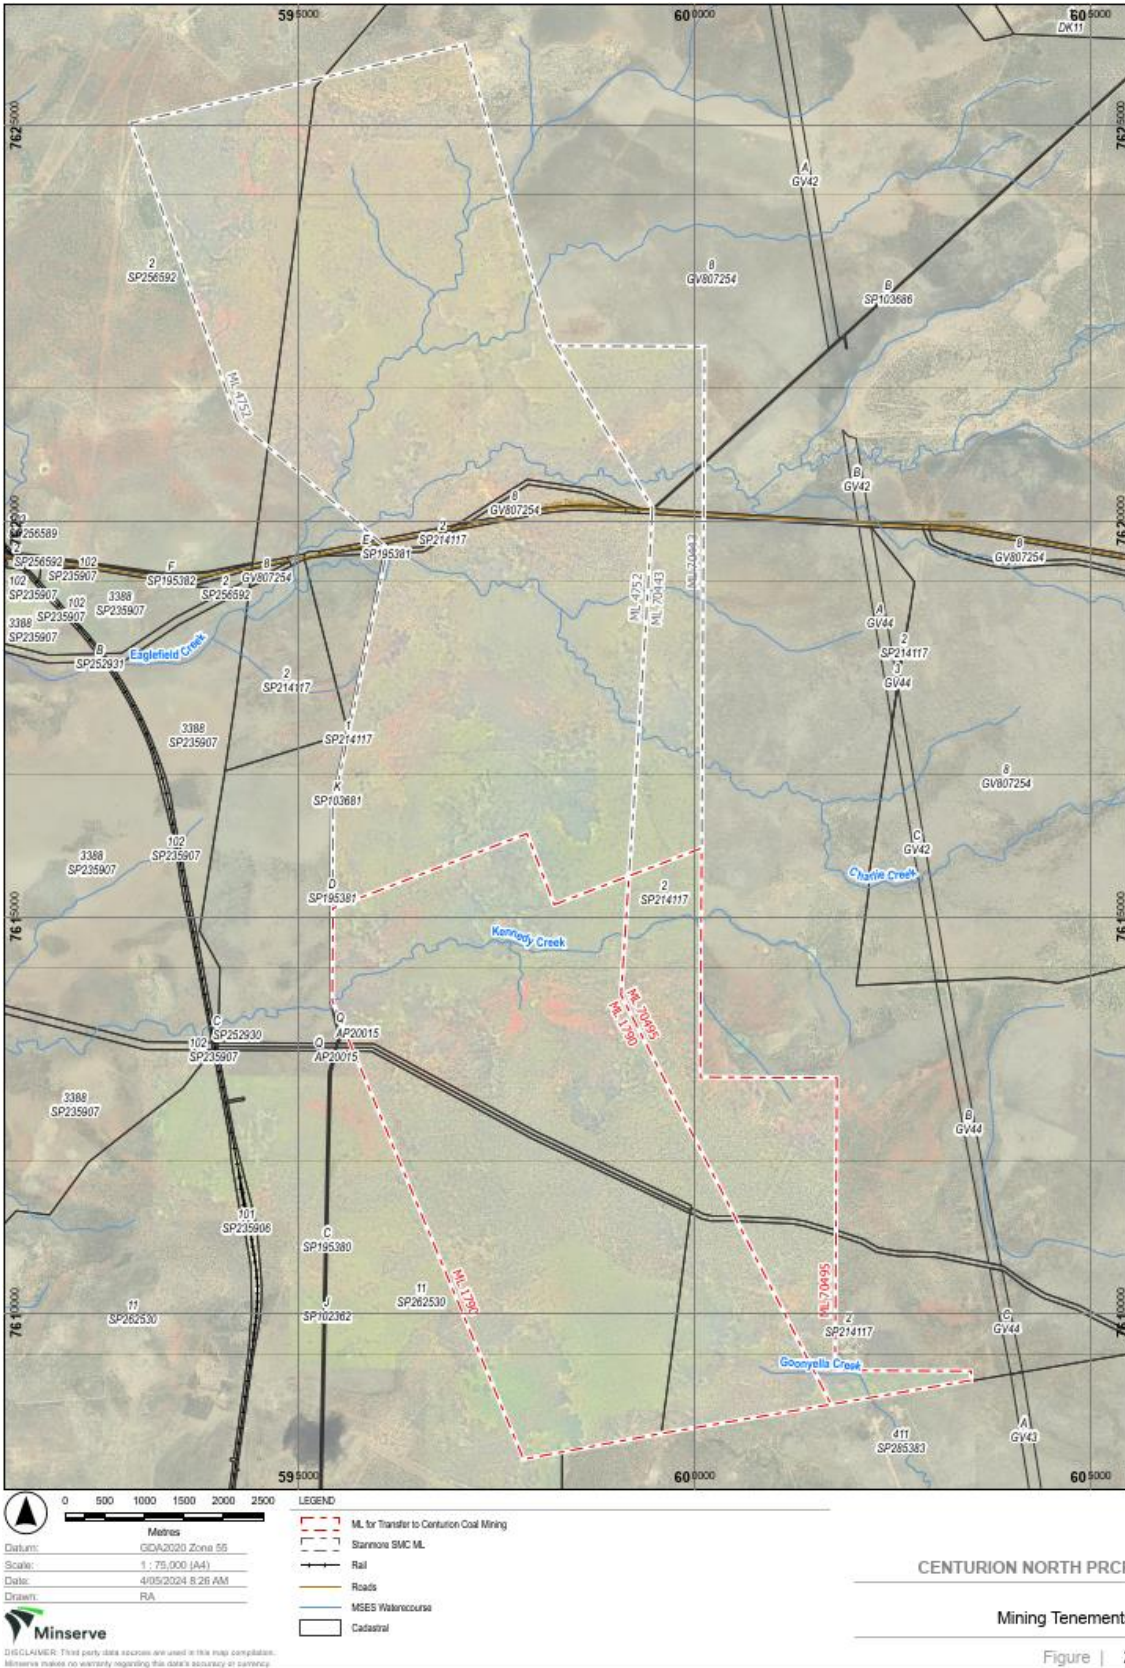
Figure 2 Mining tenements

Details of the Wards Well MLs are provided in **Table 1** along with the location and boundaries of these MLs shown in **Figure 2**.

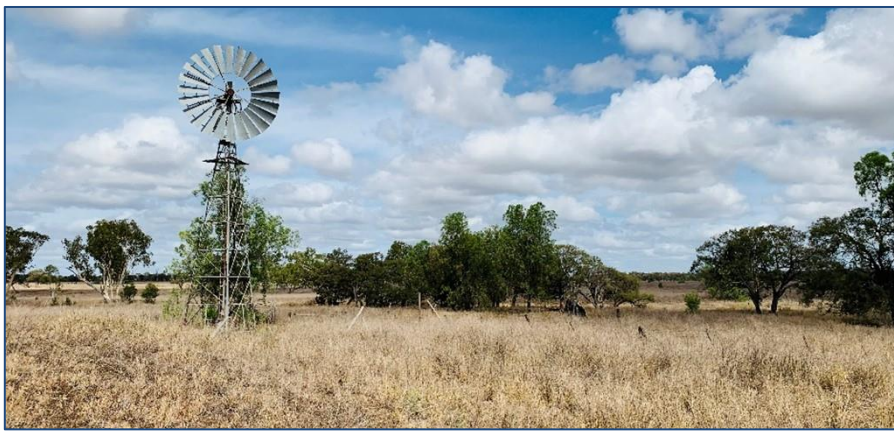
Figure 4 General site topography at Wards Well

The Wards Well MLs topographical features are consistent with the regional landscape and consist of level plains and gently undulating plains and rises. The slope across the majority of the site is between 1-2%, sloping gently towards the southwest (**Figure 4**). Steeper slopes up to 11% exist in the far north and on the south-eastern parts of the site. Within the footprint of the Wards Well area, the highest ground elevations lie within the north-west (about RL380) with the lowest in the middle of the area toward the western boundary (about RL310).

The area encompasses two shallow valleys, associated with Eaglefield Creek (the closest creek to the box-cut area) and Kennedy Creek (located in the southern half of the lease).

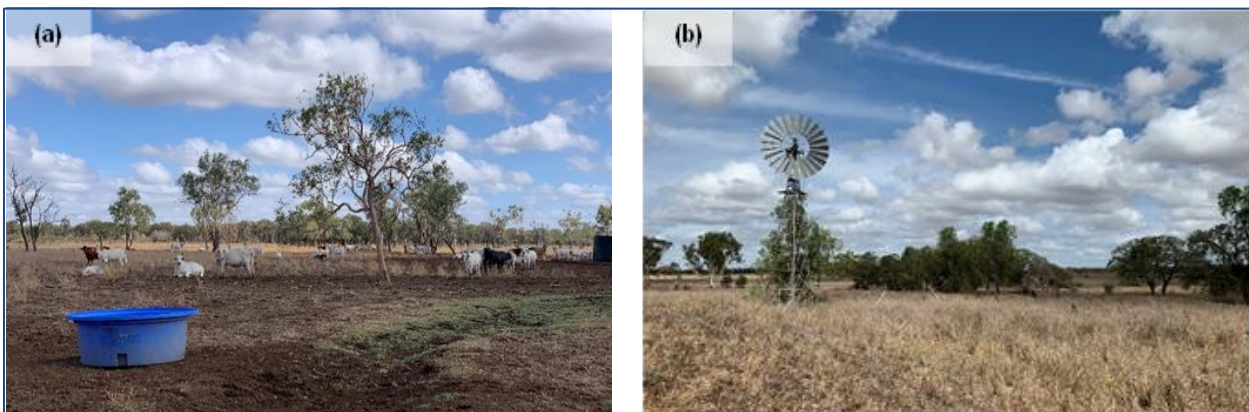
Figure 13 Evidence of existing cattle grazing-related land uses at Wards Well

The pre-mining land use of the area is cattle grazing. Some areas have previously been subject to vegetation clearing. Farm infrastructure such as water tanks, property water pipelines, windmills, bores, water troughs, feed troughs and dams are located throughout the area (**Figure 13**):

- a) cattle and feed stations; and
- b) windmills for livestock watering.

Existing soil erosion is evident across the Wards Well area and is mainly associated with existing land use grazing activities; this includes evidence of historically cleared drainage lines and creeks (i.e. gully erosion) (**Figure 11 (a)** and **13(b)**).

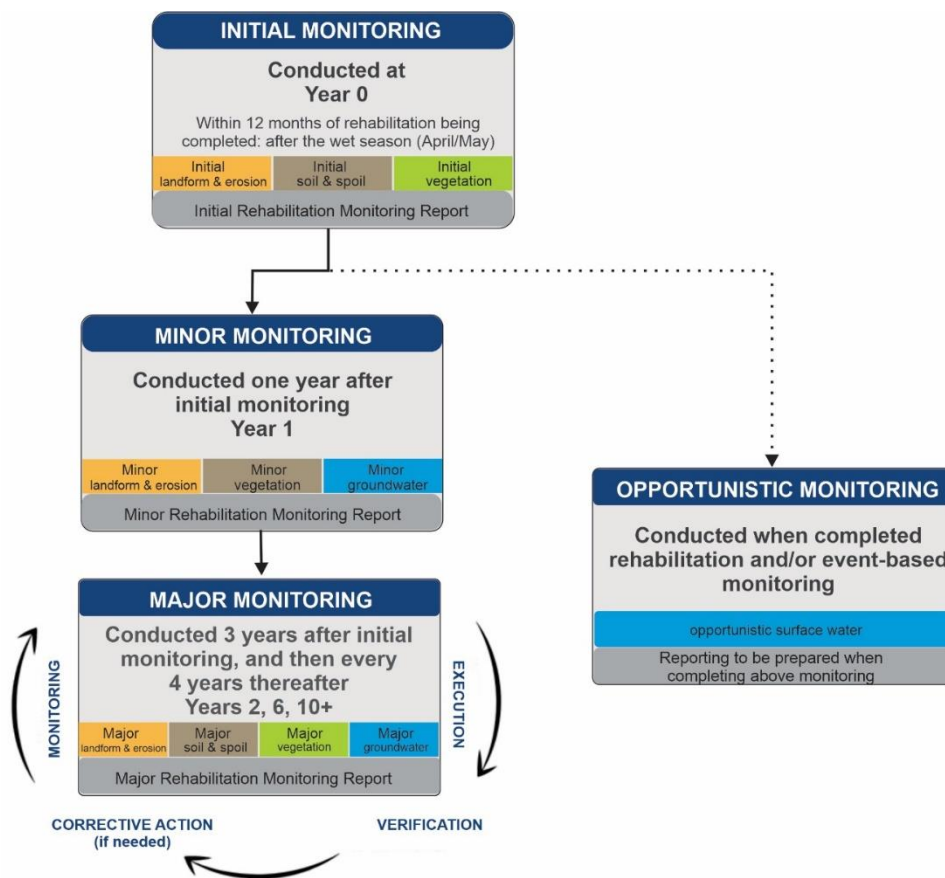
Figure 21 Flow diagram of the Centurion North rehabilitation monitoring program

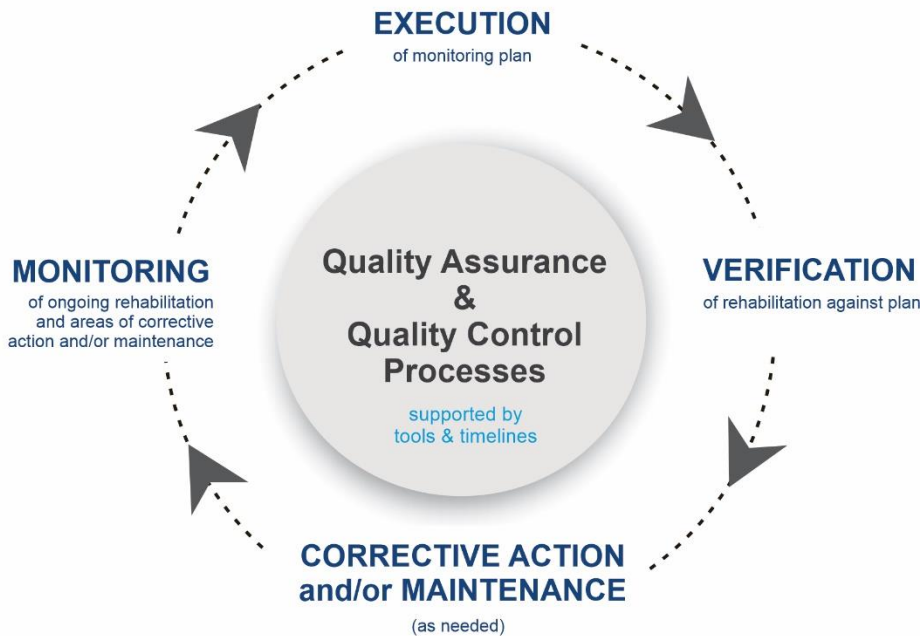
Figure 22 Quality assurance/quality control process to be followed for ongoing rehabilitation monitoring at Centurion North

The quality assurance and quality control (QA/QC) process to be followed as part of Centurion North ongoing rehabilitation monitoring is illustrated in **Figure 22**. The process provides for initial execution of the rehabilitation in accordance with the rehabilitation measures, followed by verification of how this execution was undertaken (again, according to these measures). Based on the verification outcomes, allowance is made for implementation of corrective action and/or maintenance, as needed.

The rehabilitated areas as well as corrected and/or maintenance areas then undergo further rehabilitation monitoring; and subsequent execution of the rehabilitation measures.

This process allows for a repetitive execution-verification-monitoring QA/QC approach, to ensure rehabilitation areas progress on a trajectory towards achievement of milestone criteria and eventual certification.

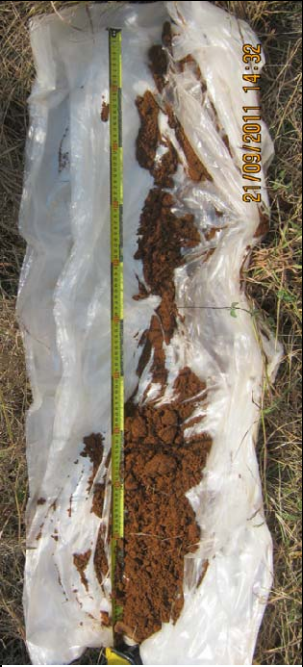
Project: Wards Well	Date: 21/9/2011	Location: 12	Observation Type: P	Coordinates: 599737, 7609528
Job Number: QE9811

Remarks:	ASC Mapped: Kandosol	ASC Ground Truth: Brown Dermosol
-----------------	-----------------------------	---

Depth (mm)	Texture	Coarse Fraction	Munsell Colour	Inclusion	Photograph	Surface Soil Con.	Pedality	Consistence	Drainage	Boundaries	Horizons	Sample
0-350	SL	Nil	7.5YR 3/3	Nil

Sand, firm	Loose, Not Coherent	1	Not recorded	Gradual, Even	A1 ₁	0-100
350-1000+	SCL	Nil	7.5YR 4/4	Some mottles		-	Loose, Not Coherent	1	Not recorded	Gradual Even	A1 ₂	500-600
1000-1100+	SCL	Nil	5YR 5/5	Nil		-	Loose, Weakly Coherent, Massive	1	Not recorded	Base of horizon not encountered	A1 ₃	1000-1100

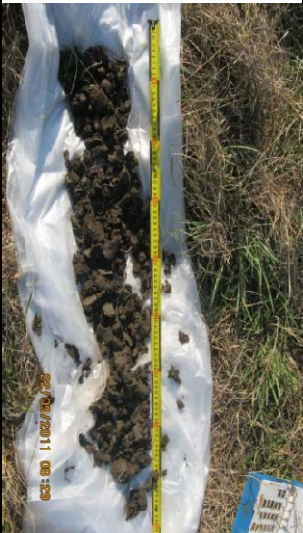
Project: Wards Well	Date: 22/9/2011	Location: 15	Observation Type: A	Coordinates: 598820, 7617662
Job Number: QE9811

Remarks:	ASC Mapped: Vertosol	ASC Ground Truth: Vertosol
-----------------	-----------------------------	-----------------------------------

Depth (mm)	Texture	Coarse Fraction	Munsell Colour	Inclusion	Photograph	Surface Soil Con.	Pedality	Consistence	Drainage	Boundaries	Horizons	Sample
0-50	MC	Nil	10YR 3/1	Nil

Coarse, self-mulching, hard setting	Weak, Coherent, Highly pedal	2	Not recorded	Gradual, Even	A1	No sample
50-200	MC	1-3%	10YR 3/1	Carbonate nodules (white and red)		Weak, Coherent, Highly pedal	2	Not recorded	Gradual, Even	B2 ₁	No sample	
200-1000+	MC	Nil	10YR 3/1	Mottling and carbonate nodules		Sub-angular, blocky	4	Not recorded	Base of horizon not encountered	B2 ₂	No sample

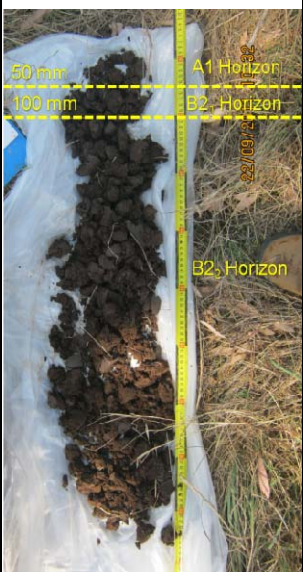
Project: Wards Well	Date: 22/9/2011	Location: 22	Observation Type: A	Coordinates: 598838, 7616587
Job Number: QE9811

Remarks:	ASC Mapped: Vertosol	ASC Ground Truth: Brown Vertosol
-----------------	-----------------------------	---

Depth (mm)	Texture	Coarse Fraction	Munsell Colour	Inclusion	Photograph	Surface Soil Con.	Pedality	Consistence	Drainage	Boundaries	Horizons	Sample
0-50	LC	Nil	5YR 3/2	Carbonate nodules

Self mulching	Weak, Highly Pedal, Coherent	2	Not recorded	Gradual	A1	No sample
50-100	MC	Nil	5YR 3/2	Nil		Firm, Highly Pedal, Coherent	3	Not recorded	Gradual	B2 ₁	No sample	
100-1000	MC	Nil	10YR 4/4	Nil		Very Firm, Highly Pedal, Coherent	4	Not recorded	Base of horizon not encountered	B2 ₂	No sample

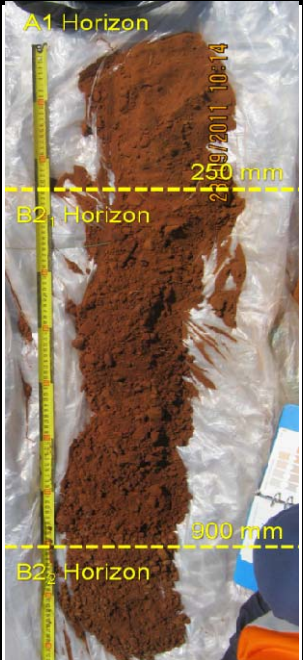
Project: Wards Well	Date: 23/9/2011	Location: 24 Observation Type: A	Coordinates: 594552,7611459
Job Number: QE9811

Remarks:	ASC Mapped: Kandosol	ASC Ground Truth: Kandosol
-----------------	-----------------------------	-----------------------------------

Depth (mm)	Texture	Coarse Fraction	Munsell Colour	Inclusion	Photograph	Surface Soil Con.	Pedality	Consistence	Drainage	Boundaries	Horizons	Sample
0-250	SL	Nil	5YR 4/4	Nil

Hard-setting	Very Weak, Apedal	1	Not recorded	Clear Even	A1	0-100 mm
250-900	FSCL	≤ 5%	5YR 3/4	Drak gray / black mottles		Very Weak, Apedal / Weakly Coherent	1	Not recorded	Gradual Even	B2 ₁	300-400 mm	
900-1000+	FSCL	≤ 80%	5YR 3/4	Nil		Very Weak, Apedal / Weakly Coherent	1	Not recorded	Base of horizon not encountered	B2 ₂	900-1000 mm

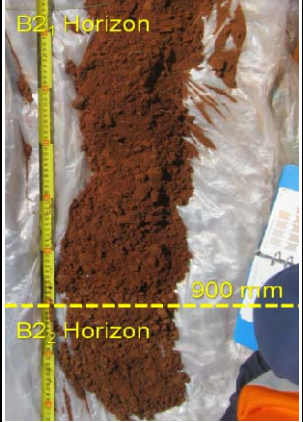
Project: Wards Well	Date: 23/9/2011	Location: 25	Observation Type: A	Coordinates: 594285, 7612574
Job Number: QE9811

Hard packed, hard-setting	Very Weak, Apedal	1	Well	Gradual, Even	A1 _{1P}	No sample
300-900	LC	Nil	5YR 3/6	Nil

-	Very Weak, Apedal / Weakly Coherent	1	Poor	Gradual, Even	B2 ₁	No sample
900+	FSCL	≤ 5%	2.5YR 2.5/4	Some mottling present		-	Very Weak, Apedal / Weakly Coherent	1	Poor	Base of horizon not encountered	B2 ₂	No sample

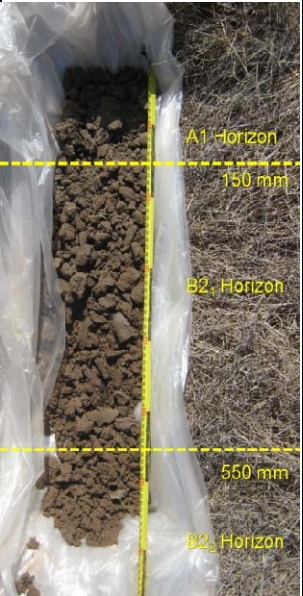
Project: Wards Well	Date: 24/9/2011	Location: 34	Observation Type: A	Coordinates: 597267, 7604679
Job Number: QE9811

Remarks:	ASC Mapped: Vertosol	ASC Ground Truth: Brown Vertosol
-----------------	-----------------------------	---

Depth (mm)	Texture	Coarse Fraction	Munsell Colour	Inclusion	Photograph	Surface Soil Con.	Pedality	Consistence	Drainage	Boundaries	Horizons	Sample
0-150	LC / MC	Nil	10YR 3/2	Nil

Self-mulching cracking clay	Very firm, Highly Pedal, Coherent	4	Not recorded	Diffuse, Even	A1	No sample
150-550	MC	Nil	10YR 3/3	Orange / red mottles		Very firm, Highly Pedal, Coherent	4	Not recorded	Diffuse, Even	B2 ₁	No sample	
550-1000+	MC	Nil	10YR 3/4	Carbonate nodules, Ironstone. Red / orange mottles		Very firm, Highly Pedal, Coherent	4	Not recorded	base of horizon not encountered	B2 ₂	No sample

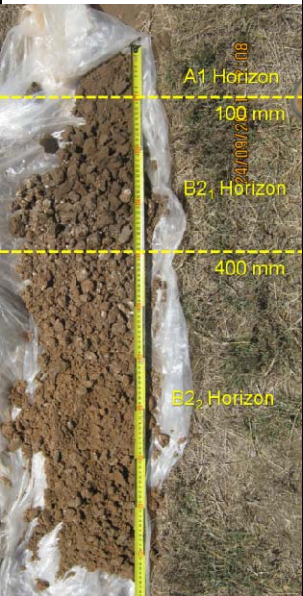
Project: Wards Well	Date: 41	Location: 41	Observation Type: A	Coordinates: 596794, 7609884
Job Number: QE9811

Remarks:	ASC Mapped: Vertosol	ASC Ground Truth: Brown Dermosol
-----------------	-----------------------------	---

Depth (mm)	Texture	Coarse Fraction	Munsell Colour	Inclusion	Photograph	Surface Soil Con.	Pedality	Consistence	Drainage	Boundaries	Horizons	Sample
0-100	SCL	Nil	7.5YR 3/2	Nil

Hard-setting	Firm, Highly Pedal, Coherent	4	Not recorded	Diffuse, Even	A1	0-100 mm
100-400	LC / MC	Nil	7.5Yr 3/2	Carbonate nodules, Ironstone		Firm, Highly Pedal, Coherent	4	Not recorded	Gradual, Even	B2 ₁	200-300 mm	
400-1000+	MC	Nil	7.5YR 4/3	Carbonate nodules		Firm, Highly Pedal, Coherent	3	Not recorded	Base of horizon not encountered	B2 ₂	700-800 mm

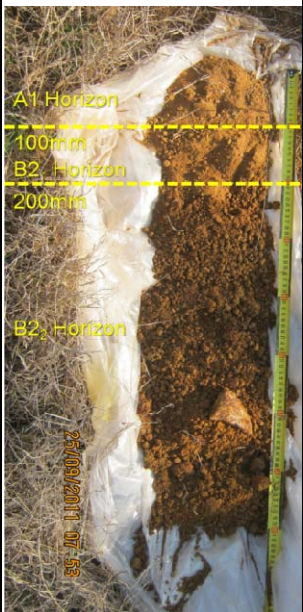
Project: Wards Well	Date: 25/9/2011	Location: 45	Observation Type: A	Coordinates: 601862, 7614637
Job Number: QE9811

Remarks:	ASC Mapped: Vertosol	ASC Ground Truth: Kandosol
-----------------	-----------------------------	-----------------------------------

Depth (mm)	Texture	Coarse Fraction	Munsell Colour	Inclusion	Photograph	Surface Soil Con.	Pedality	Consistence	Drainage	Boundaries	Horizons	Sample
0-100	SL	20-30%	10YR 3/6	Nil

Gravelly, hard-setting	Loose / Very Weak, Apedal	0 / 1	Not recorded	Clear, Even	A1	0-100 mm
100-200	SL	30%	10YR 4/4	Nil		Very Weak, Weakly Pedal	1	Not recorded	Clear, Even	B2 ₁	100-200 mm	
200-800	SCL	80%	10YR 4/6	Yellow mottles		Weak, Highly Pedal, Coherent	1 / 2	Not recorded	Base of Horizon not encountered	B2 ₂	500-600 mm

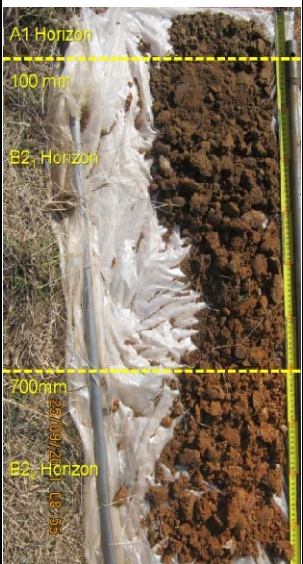
Project: Wards Well	Date: 25/09/11	Location: 49	Observation Type: E	Coordinates: 0601753, 7610328
Job Number: QE9811

Remarks:	ASC Mapped: Kandosol	ASC Ground Truth: Sodosol
-----------------	-----------------------------	----------------------------------

Depth (mm)	Texture	Coarse Fraction	Munsell Colour	Inclusion	Photograph	Surface Soil Con.	Pedality	Consistence	Drainage	Boundaries	Horizons	Sample
0-100	LC	≤ 10%	10YR 3/2	Nil

hard-setting	Firm, Hghly Pedal, Coherent	3	Not recorded	Diffuse, Even	A1	No sample
100-700	MC	≤ 5% Ironstone	10YR 2/2	Ironstone		-	Very Firm, Highly Pedal, Coherent	4	Not recorded	Gradual, Even	B2 ₁	No sample
700-1000+	MC	Nil	7.5YR 6/8	Orange / red / white mottles, Carbonate nodules		-	Very Firm, Highly Pedal, Coherent	4	Not recorded	Base of horizon not encountered	B2 ₂	No sample

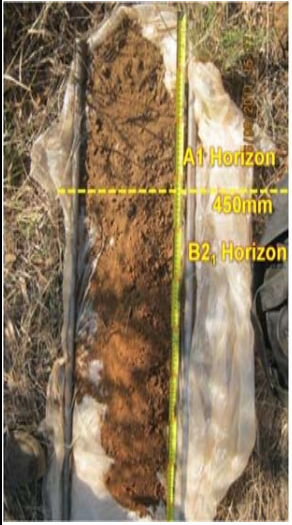
Project: Wards Well	Date: 26/9/2011	Location: 55	Observation Type: A	Coordinates: 597258, 7611552
Job Number: QE9811

Remarks: Brown surface	ASC Mapped: Kandosol	ASC Ground Truth: Kandosol
-------------------------------	-----------------------------	-----------------------------------

Depth (mm)	Texture	Coarse Fraction	Munsell Colour	Inclusion	Photograph	Surface Soil Con.	Pedality	Consistence	Drainage	Boundaries	Horizons	Sample
0-450	MC	Nil	10YR 2/2	Nil

Hard packed	Weak, Non-pedal	2	Not Recorded	Gradual	A1	No sample
450-1000+	SCL	10-20%	7.5YR 3/3	Ironstone		-	Very weak, weakly pedal	1	Not Recorded	Base of horizon not encountered	B2 ₁	No sample

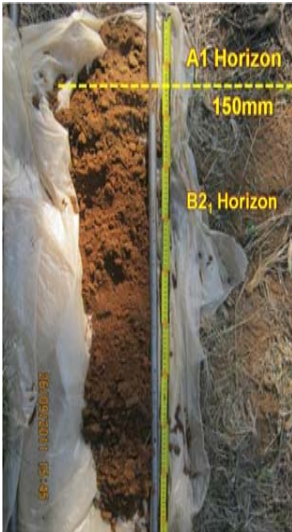
Project: Wards Well	Date: 26/9/2011	Location: 56 Observation Type: P	Coordinates: 0597741, 7611566
Job Number: QE9811

Remarks:	ASC Mapped: Kandosol	ASC Ground Truth: Kandosol
-----------------	-----------------------------	-----------------------------------

Depth (mm)	Texture	Coarse Fraction	Munsell Colour	Inclusion	Photograph	Surface Soil Con.	Pedality	Consistence	Drainage	Boundaries	Horizons	Sample
0-150	SL	Nil	7.5YR 3/4	Nil

Sandy Firm	Very weak, Apedal, Coherent	1	Good	Gradual	A1	No sample
150 - >1000	SCL	Nil	7.5YR 3/4	Black / orange mottles at 950mm		Weak, Weakly pedal, Coherent	1 / 2	Not Recorded	Base of horizon not encountered	B2 ₁	No sample

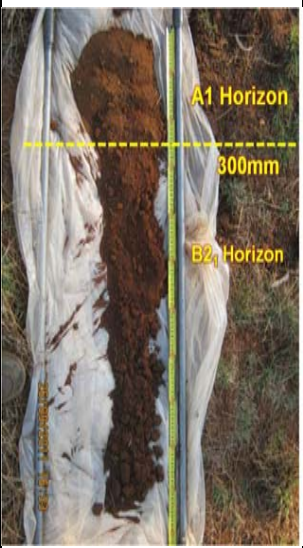
Project: Wards Well	Date: 26/9/2011	Location: 58 Observation Type: A	Coordinates: 597898, 7614327
Job Number: QE9811

Depth (mm)	Texture	Coarse Fraction	Munsell Colour	Inclusion	Photograph	Surface Soil Con.	Pedality	Consistence	Drainage	Boundaries	Horizons	Sample
0-300	LC	Nil	5YR 3/3	Nil

Hard packed	Very weak, Weakly pedal	1	Not recorded	Gradual	A1	No sample
300-1000	LC/MC	Nil	5YR 3/4	Ironstone		Very weak, Weakly pedal	1	Not recorded	Base of horizon not encountered	B2 ₁	No sample

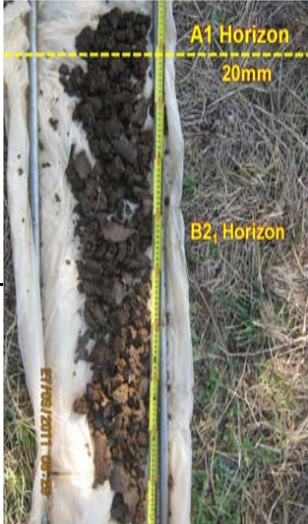
Project: Wards Well	Date: 27/9/2011	Location: 62 Observation Type: A	Coordinates: 0598732, 7615564
Job Number: QE9811

Depth (mm)	Texture	Coarse Fraction	Munsell Colour	Inclusion	Photograph	Surface Soil Con.	Pedality	Consistence	Drainage	Boundaries	Horizons	Sample
0-20	LC	Nil	7.5YR 4/4	Nil

Self Mulching	Firm, Highly pedal	1 / 2	Good	Gradual	A1	No sample
20- >1000	MC	1-2% 15mm	7.5YR 3/4	Orange / white mottles		Firm, Highly pedal	2	Poor	Base of horizon not encountered	B ₂ ₁	No sample

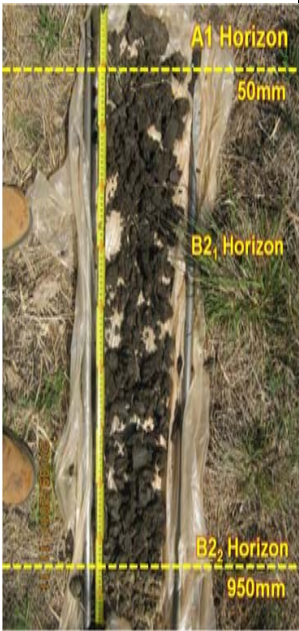
Project: Wards Well	Date: 27/9/2011	Location: 67	Observation Type: A	Coordinates: 0598053, 7617293
Job Number: QE9811

Depth (mm)	Texture	Coarse Fraction	Munsell Colour	Inclusion	Photograph	Surface Soil Con.	Pedality	Consistence	Drainage	Boundaries	Horizons	Sample
0-50	MC	Nil	10 YR 3/2	Nil

Self Mulching, cracking	Very firm, highly pedal	4	Not recorded	Sharp	A1	No sample
50-950	MC	Nil	10YR 3/2	Fine Ironstone gravel (≥ 2 mm)		Very firm, highly pedal	4	Not recorded	Sharp	B2 ₁	No sample	
950- >1000	SiC	50%	10YR 4/3	White/grey mottling		Very weak, weakly pedal	1	Not recorded	Base of horizon not encountered	B2 ₂	No sample

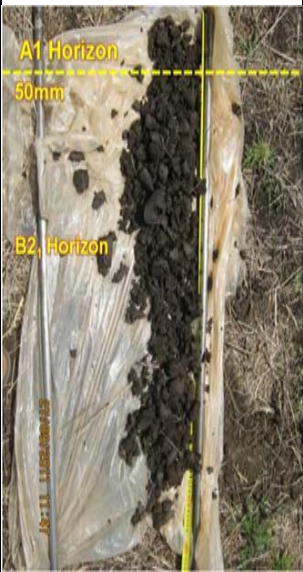
Project: Wards Well	Date: 27/9/2011	Location: 68 Observation Type: A	Coordinates: 0596388, 7617258
Job Number: QE9811

Depth (mm)	Texture	Coarse Fraction	Munsell Colour	Inclusion	Photograph	Surface Soil Con.	Pedality	Consistence	Drainage	Boundaries	Horizons	Sample
0-50	MC	Nil	10YR 3/3	Nil

Self Mulching, cracking	Very firm, highly pedal, massive	4	Poor	Gradual	A1	No sample
50-1000	MC	Nil	10YR 3/3	Orange/black mottles		Very firm, highly pedal, massive	4	Poor	Base of horizon not encountered	B2 ₁	No sample

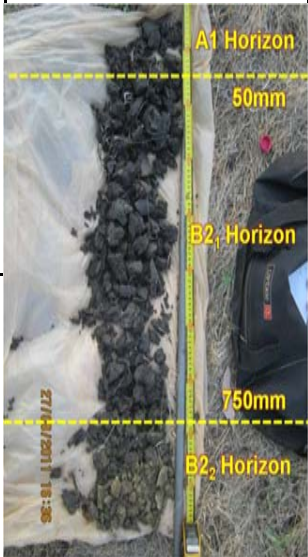
Project: Wards Well	Date: 28/9/2011	Location: 77 Observation Type: A	Coordinates: 0595518, 7624627
Job Number: QE9811

Depth (mm)	Texture	Coarse Fraction	Munsell Colour	Inclusion	Photograph	Surface Soil Con.	Pedality	Consistence	Drainage	Boundaries	Horizons	Sample
0-50	LC	Nil	10YR 4/1	Nil

Self mulching, hard cracking clay	Weak / firm, highly pedal, massive	2-3	Poor	Gradual	A ₁	0-50 mm
50-750	MC	Nil	10YR 4/1	white mottles		Very firm, highly pedal, massive	4	Poor	Sharp	B ₂	400-500 mm	
750 - >1000	LC/MC	Nil	Not recorded	white/grey mottles		Fine, sub-angular, r	3	No recorded	Base of horizon not encountered	B ₂	900-1000 mm

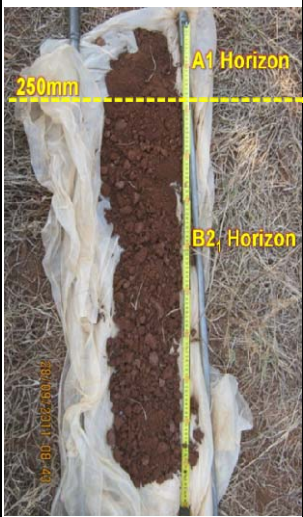
Project: Wards Well	Date: 28/9/2011	Location: 78 Observation Type: A	Coordinates: 0595448, 7625536
Job Number: QE9811

Depth (mm)	Texture	Coarse Fraction	Munsell Colour	Inclusion	Photograph	Surface Soil Con.	Pedality	Consistence	Drainage	Boundaries	Horizons	Sample
0-250	SL	10%	5YR 3/4	Nil

Sandy, firm, non-cracking	Very weak, weakly pedal, massive	1	Good	Sharp	A1 ₁	No sample
250- >1000	SCL	Nil	5YR 3/4	White/black mottles, yellow mottles at 300mm		Very weak, weakly pedal, massive	1	Good	Gradual	B2 ₁	No sample

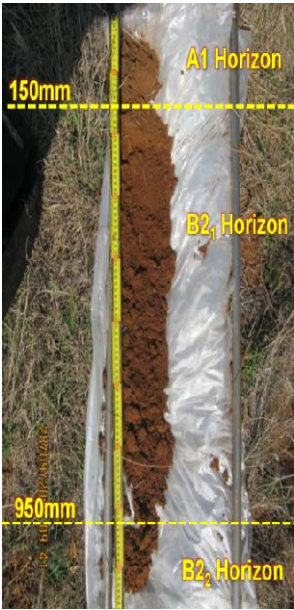
Project: Wards Well	Date: 28/9/2011	Location: 80 Observation Type: P	Coordinates: 0597227, 7626006
Job Number: QE9811

Topography: <1%		Surface Rock % (> 60mm dia): Nil		Erosion: Nil			Drainage: Not recorded					
Remarks: Coarse fraction is black/red when broken				ASC Mapped: Kandasol			ASC Ground Truth: Kandasol					
Depth (mm)	Texture	Coarse Fraction	Munsell Colour	Inclusion	Photograph	Surface Soil Con.	Pedality	Consistence	Drainage	Boundaries	Horizons	Sample
0-150	SL	Nil	5YR 3/3	Nil

Hard packed sandy	Very weak, non-pedal	1	Good	Gradual	A ₁	No sample
150-950	SCL	Nil	2.5YR 4/4	Nil		Very weak, weakly pedal, massive	1	Good	Sharp	B ₂	No sample	
950- >1000	SCL	Nil	5YR 4/4	Ironstone		Very weak, weakly pedal, massive	1	Poor	Base of horizon not encountered	B ₂	No sample

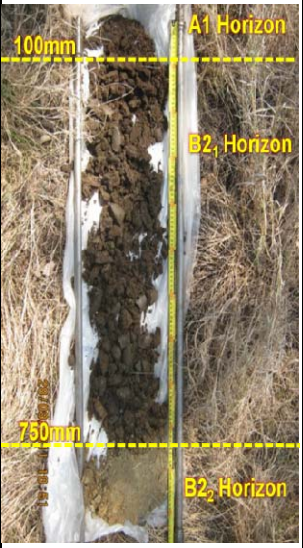
Project: Wards Well	Date: 28/9/2011	Location: 82 Observation Type: P	Coordinates: 0596439, 7624851
Job Number: QE9811

Depth (mm)	Texture	Coarse Fraction	Munsell Colour	Inclusion	Photograph	Surface Soil Con.	Pedality	Consistence	Drainage	Boundaries	Horizons	Sample
0-50	MC	Nil	10YR 3/3	Nil

Hard cracking	Firm, Weakly pedal, Massive	3	Good	Gradual	A ₁	No sample
50-700	MC	Nil	10YR 3/2	Ironstone		-	Firm, Weakly pedal, Massive	3	Poor	Sharp	B ₂ ₁	No sample
700- >1000	SL	Nil	10YR 4/3	White, grey, orange mottles		-	Very weak, Apedal	1	Good	Base of horizon not encountered	B ₂ ₂	No sample

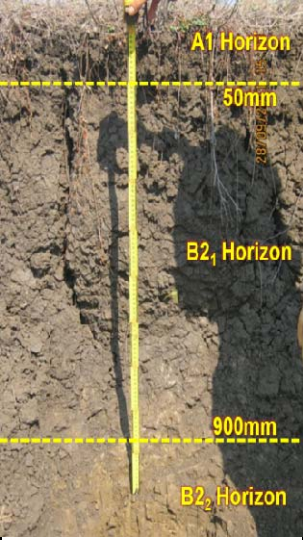
Project: Wards Well	Date: 28/9/2011	Location: 92 Observation Type: P	Coordinates: 0596076, 7621714
Job Number: QE9811

Depth (mm)	Texture	Coarse Fraction	Munsell Colour	Inclusion	Photograph	Surface Soil Con.	Pedality	Consistence	Drainage	Boundaries	Horizons	Sample
0-50	LC	Nil	10YR 4/2	Nil

Hard cracking clay	Firm, strongly pedal, massive	3	Well	Sharp	A1 _{1P}	No sample
50-900	LC/MC	Nil	10YR 4/2	Carbonate, Ironstone, brown maroon gravel		Weak, strongly pedal, massive	2	Poor	Sharp	B2 ₁	No sample	
900 - >1000	MC	Nil	10YR 4/3	Grey gravel, carbonate		Very weak/weak, strongly pedal, massive	1-2	Base of horizon not encountered	B2 ₁	No sample

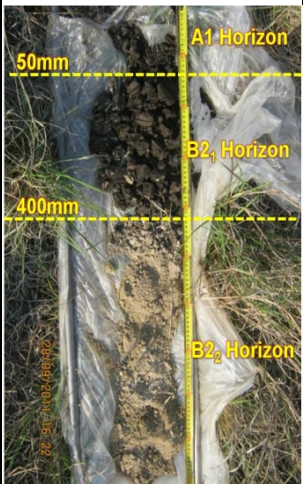
Project: Wards Well	Date: 29/9/2011	Location: 95 Observation Type: E	Coordinates: 0598841, 7620747
Job Number: QE9811

Depth (mm)	Texture	Coarse Fraction	Munsell Colour	Inclusion	Photograph	Surface Soil Con.	Pedality	Consistence	Drainage	Boundaries	Horizons	Sample
0-50	LC	Nil	10YR 3/2	Nil

Self mulching	Weak, strongly pedal	2	Good	Sharp	A ₁	0-50 mm
50-400	MC	Nil	10YR 3/1	Carbonate		Very firm, strongly pedal	4	Poor	Sharp	B ₂	200-300 mm	
400->1000	SL	Nil	10YR 4/1	Carbonate at 400mm		Very weak, non pedal	1	Good	Base of horizon not encountered	B ₂	600-700 mm

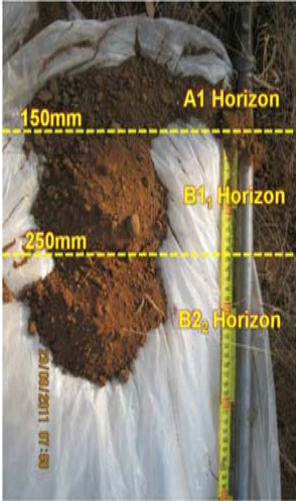
Project: Wards Well	Date: 29/9/2011	Location: 97 Observation Type: A	Coordinates: 0596317, 7619984
Job Number: QE9811

Depth (mm)	Texture	Coarse Fraction	Munsell Colour	Inclusion	Photograph	Surface Soil Con.	Pedality	Consistence	Drainage	Boundaries	Horizons	Sample
0-150	SL	50%	7.5YR 3/4	Black and yellow gravels

Hard packed gravel	Very weak, non pedal	1	Good	Sharp	A ₁	No sample
150-250	SI	50%	5YR 4/4	Ironstone gravel		Very weak, non pedal	1	Good	Sharp	B ₂ ₁	No sample	
250+	Rock								Poor		B ₂ ₂	No sample

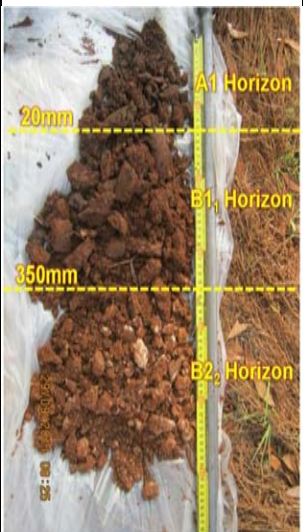
Project: Wards Well	Date: 29/9/2011	Location: 98 Observation Type: A	Coordinates: 0599337, 7620288
Job Number: QE9811

Depth (mm)	Texture	Coarse Fraction	Munsell Colour	Inclusion	Photograph	Surface Soil Con.	Pedality	Consistence	Drainage	Boundaries	Horizons	Sample
0-20	LC-MC	Nil	5YR 3/4	Nil

Firm cracking surface	Very firm, strongly pedal, massive	4	Good	Sharp	A ₁	No sample
20-350	MC	Nil	5YR 4/6	Ironstone & carbonate gravels		Weak/firm, strongly pedal	2-3	Poor	Sharp	B ₂	No sample	
350-600	Sandy clay	70%	5YR 4/6	Carbonate		Very weak, weakly pedal	1	Good	Base of horizon not encountered	B ₂	No sample
