**APPENDIX 3C – SURFACE WATER
MONITORING DATA**

Wilpinjong Coal Mine

2018 Channel Stability Monitoring Report

Prepared for
Wilpinjong Coal Pty Ltd

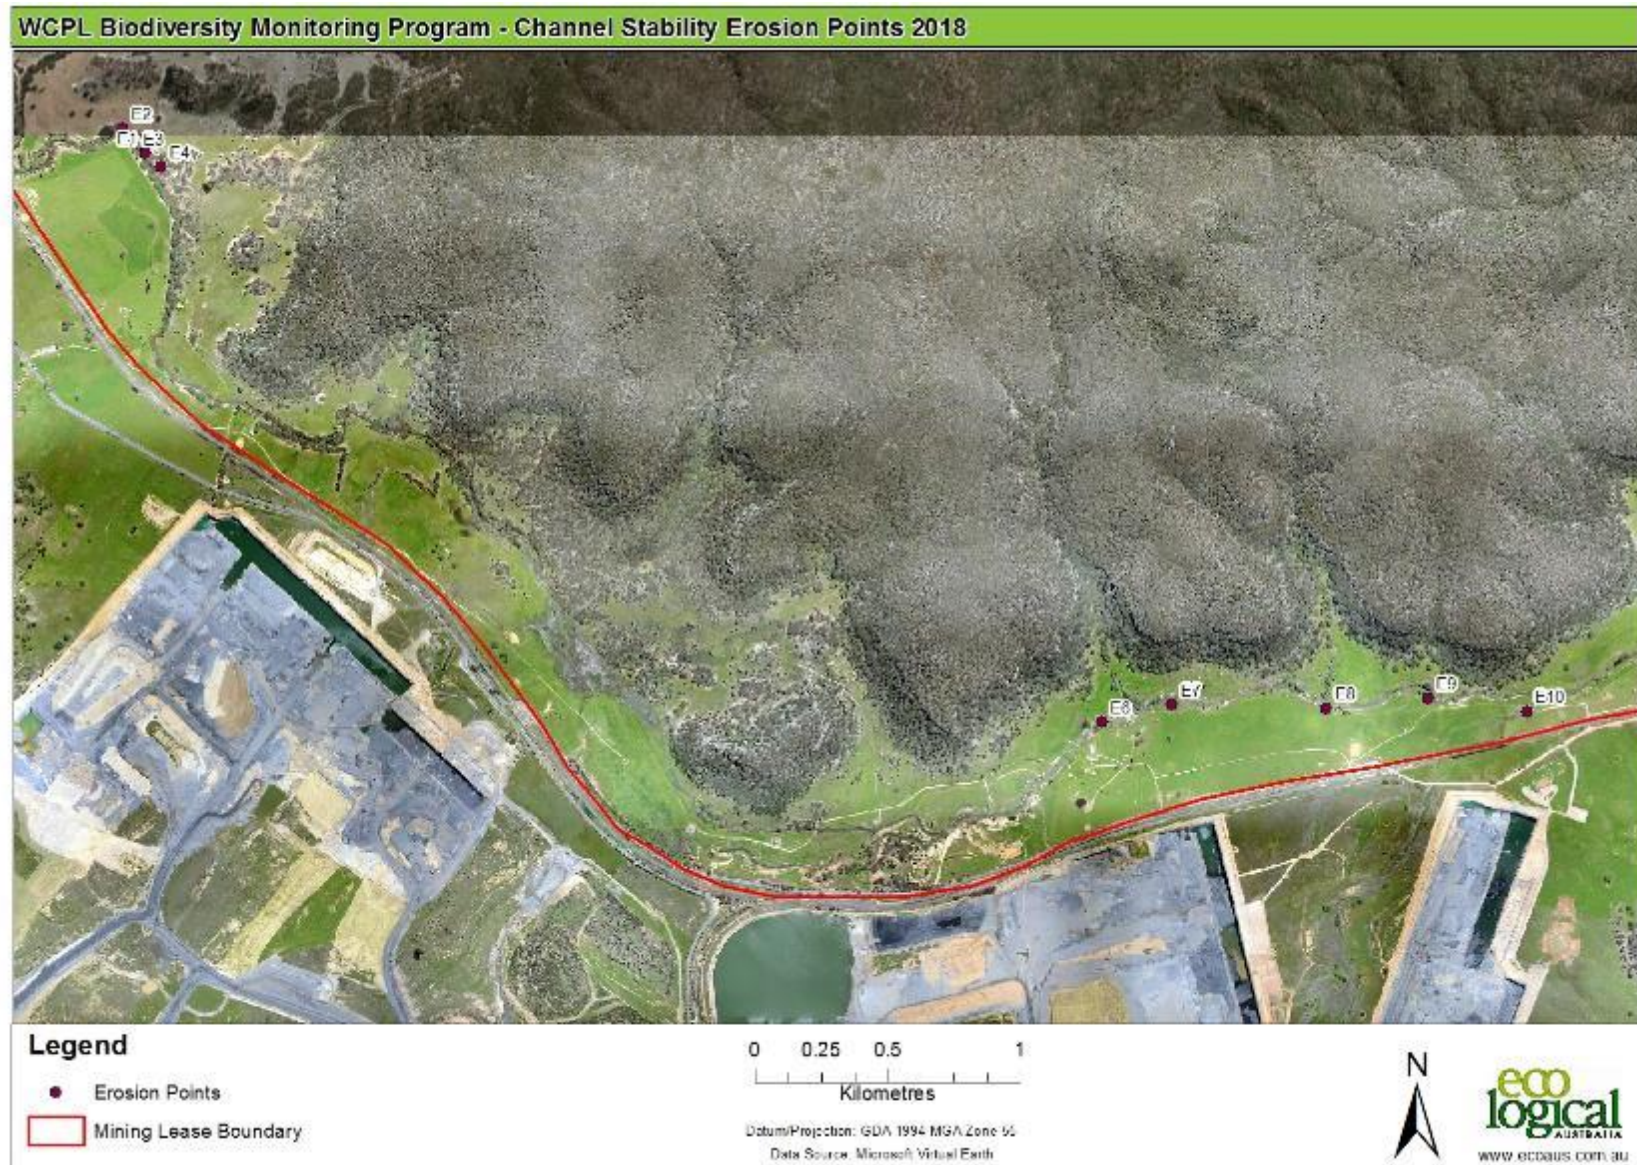
Figure 2-2: Active erosion points assessed in 2018

Previously established erosion points along the Wilpinjong Creek were also assessed (**Figure 2-2**). These are in areas with moderate to severe erosion and are monitored to determine the presence and extent of on-going erosion.

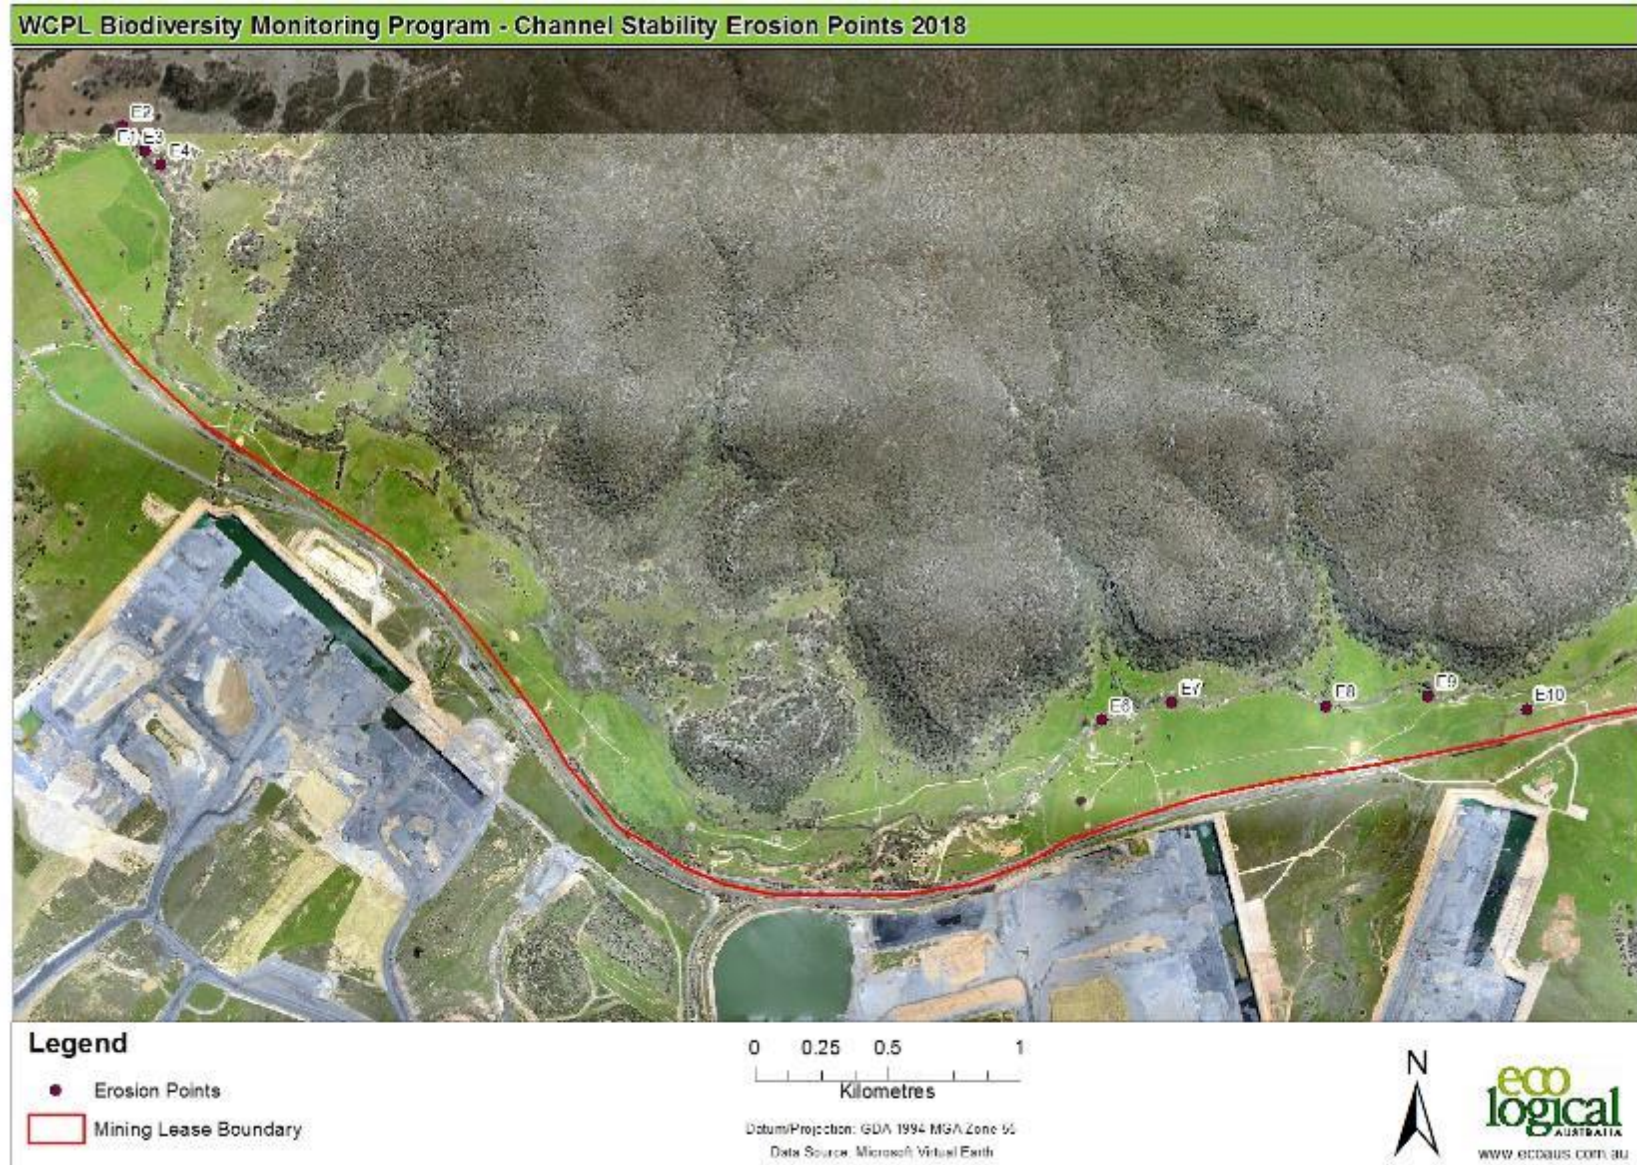
Figure 3-1: Active erosion points assessed in 2018

Table 4-3 provides a photo log of the significant erosion points along Wilpinjong and Cumbo Creeks (see also **Figure 3-1**). These sites were identified as having moderate to severe erosion resulting from historical clearing and agricultural practices and have been recommended for remediation works. Overall, the erosion points appear largely consistent with 2016 and 2017, with no evidence of recent downstream erosion. Given the large areas of bare soil and multiple erosional gullies present at these sites, it is highly likely that lateral erosion would still be occurring during rainfall events, because of increased runoff velocities from the surrounding cleared landscape.

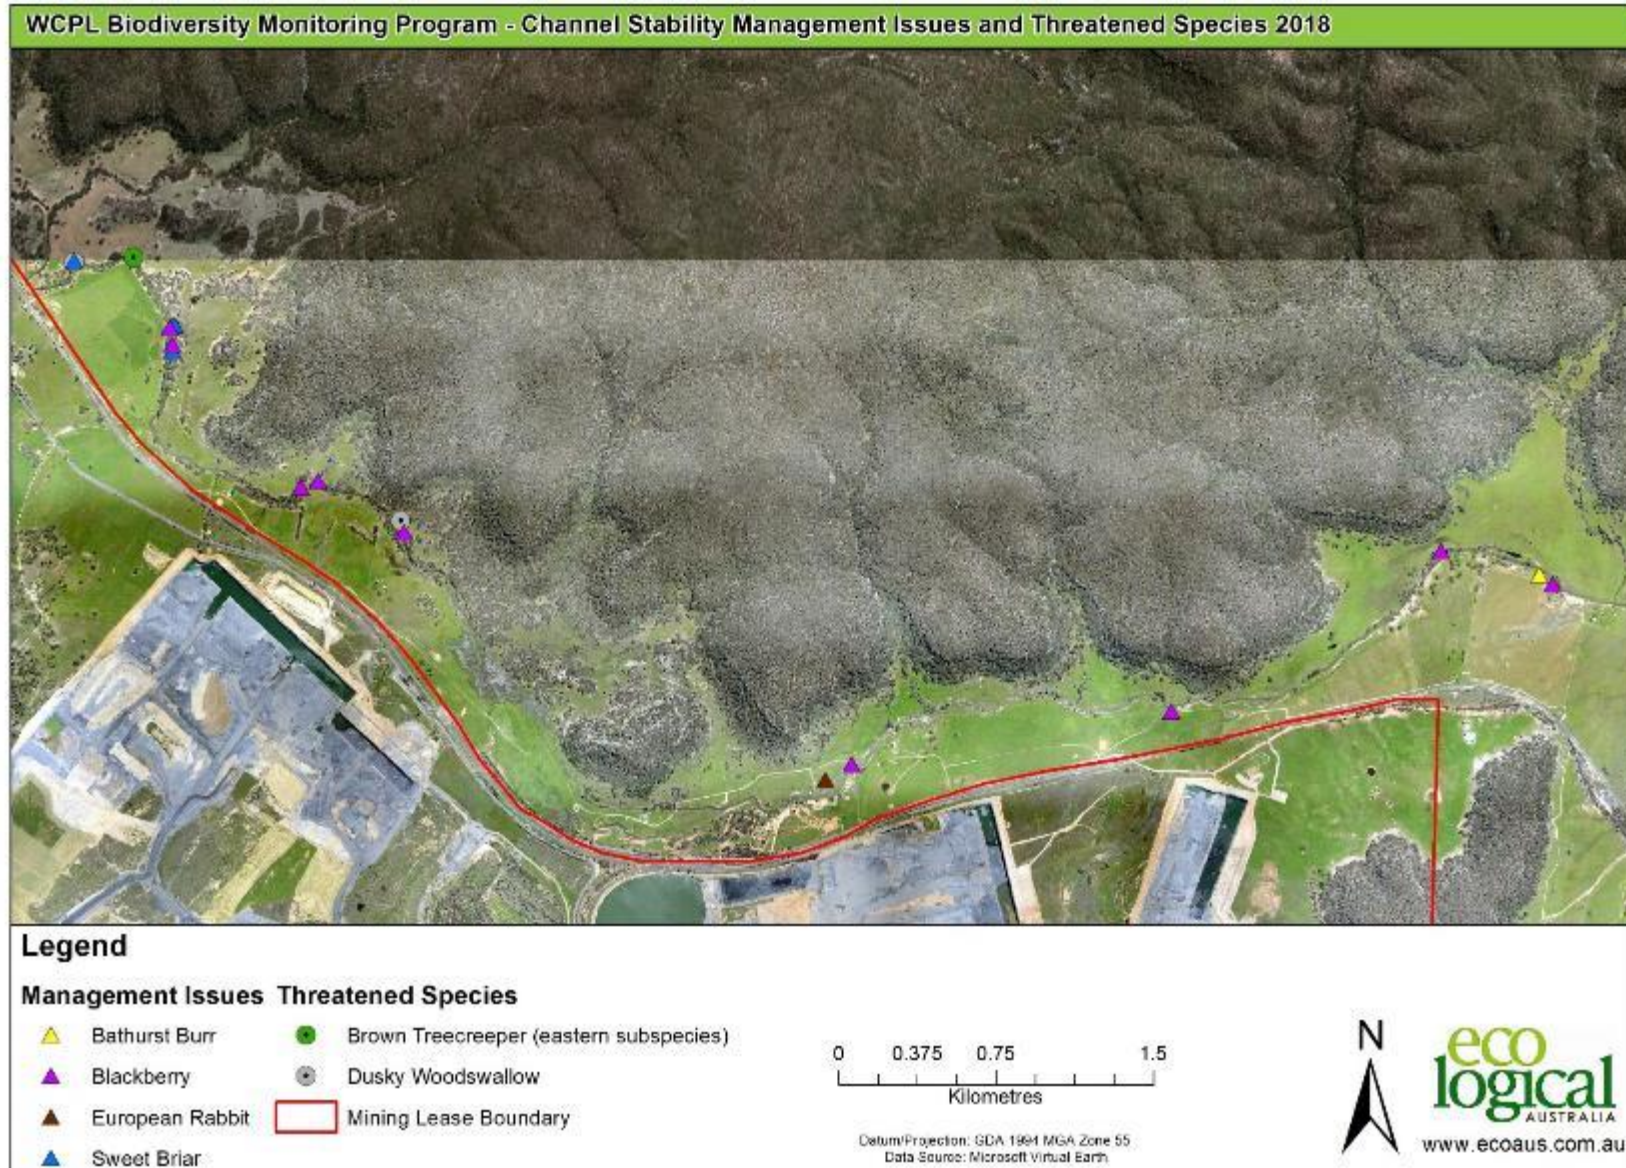
Figure 3-2: Management Issues and Threatened Species

Three species, *Xanthium spinosum* (Bathurst Burr), Blackberry and Sweet Briar, which are classified as regional priority weeds under the Central Tablelands Regional Strategic Weed Management Plan 2017 – 2022, were identified along the Wilpinjong creek. *Climacteris picumnus victoriae* (Brown Treecreeper eastern subspecies) and *Artamus cyanopterus cyanopterus* (Dusky Woodswallow), which are both listed under the BC Act, were also recorded during the monitoring period. These management issues are mapped below, in **Figure 3-2**.

Scattered Regional Priority Weeds were present throughout Wilpinjong Creek and included Blackberry, Sweet Briar and Bathurst Burr (**Figure 3-2**). It was noted that Blackberry has died off since 2017 monitoring at sites WCK2, WCK26 and WCK43, although minor re-growth was also observed at WCK43. The targeted spot spraying of these weeds is recommended in association with remediation works.

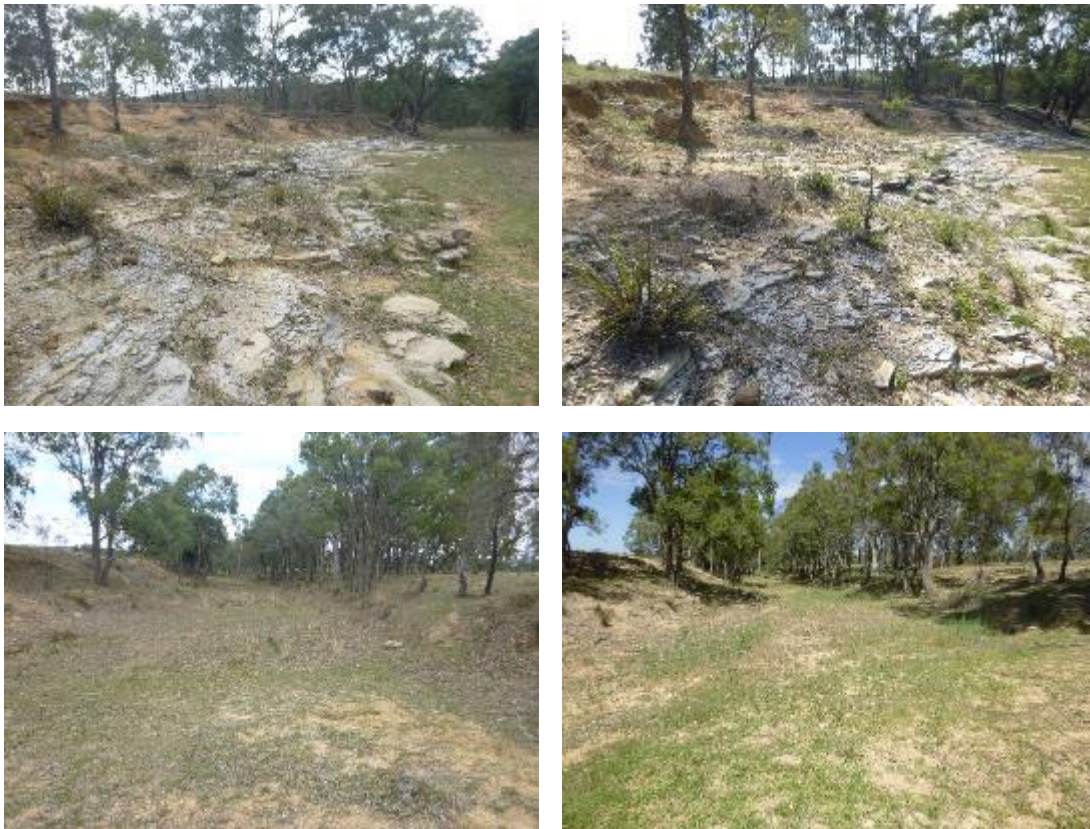
Figure B- 3: WcK3 site photos clockwise from left: 2017 upstream, 2018 upstream. 2018 downstream, 2017 downstream

The western section of Wilpinjong Creek (incorporating sites WCK1 to WCK8) contains good areas of natural regeneration with overall moderate to good riparian vegetation and habitat present. At the time of survey, there was abundant birdlife occupying the canopy and shrub layer, including the threatened species Dusky Woodswallow and Brown Treecreeper (eastern subspecies) (**Figure 3-2**). The influence of riparian vegetation on channel stability is well demonstrated in this section of Wilpinjong Creek, with well vegetated sites recording stable BEHI scores, by comparison two cleared sections around sites WCK3 and WCK4 showed significant lateral erosion and associated unstable BEHI scores.

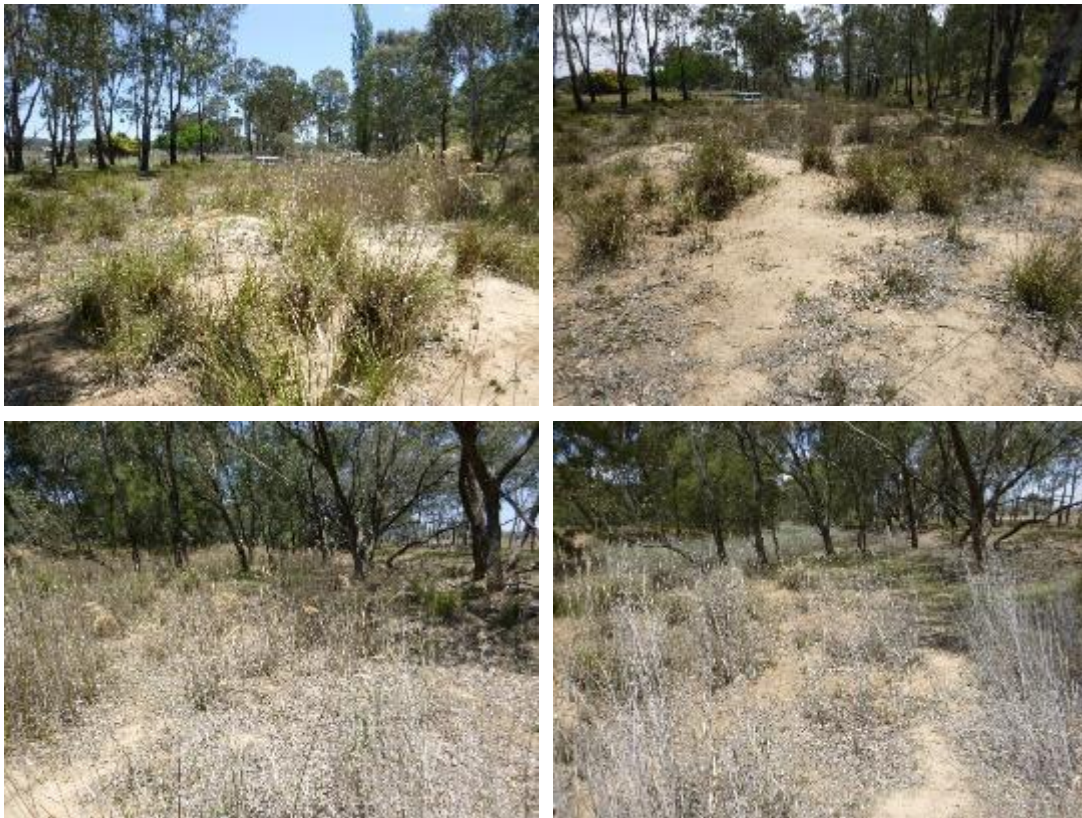
Figure B- 11: WcK11 site photos clockwise from top left: 2017 upstream, 2018 upstream. 2018 downstream, 2017 downstream

Site	Upstream	Downstream
WCK11	<ul style="list-style-type: none"> - Increased Wombat activity on bench of right bank compared to 2017 - Generally good vegetation cover in channel bed - Good litter cover in channel bed 	<ul style="list-style-type: none"> - Reasonably well-vegetated - Wombat burrows on right bank bench
WCK12	<ul style="list-style-type: none"> - Good vegetation cover on banks - Some minor <i>Casuarina cunninghamiana</i> (River Sheoak) regrowth on left bank - Wombat holes on left-hand bank - Blackberry noted along left-hand bank 	<ul style="list-style-type: none"> - Good vegetation cover on right bank, moderate vegetation cover on left bank - LWD, litter and wombat burrows on right-hand bank bench
WCK13	<ul style="list-style-type: none"> - Wombat burrows noted on left bank - Some bare exposed areas on left bank in steep sections - Blackberry present 	<ul style="list-style-type: none"> - Some undercutting on left bank downstream of reach - Left bank steep and bare - Sand and gravel in channel bed - Pig digging evident on left bank

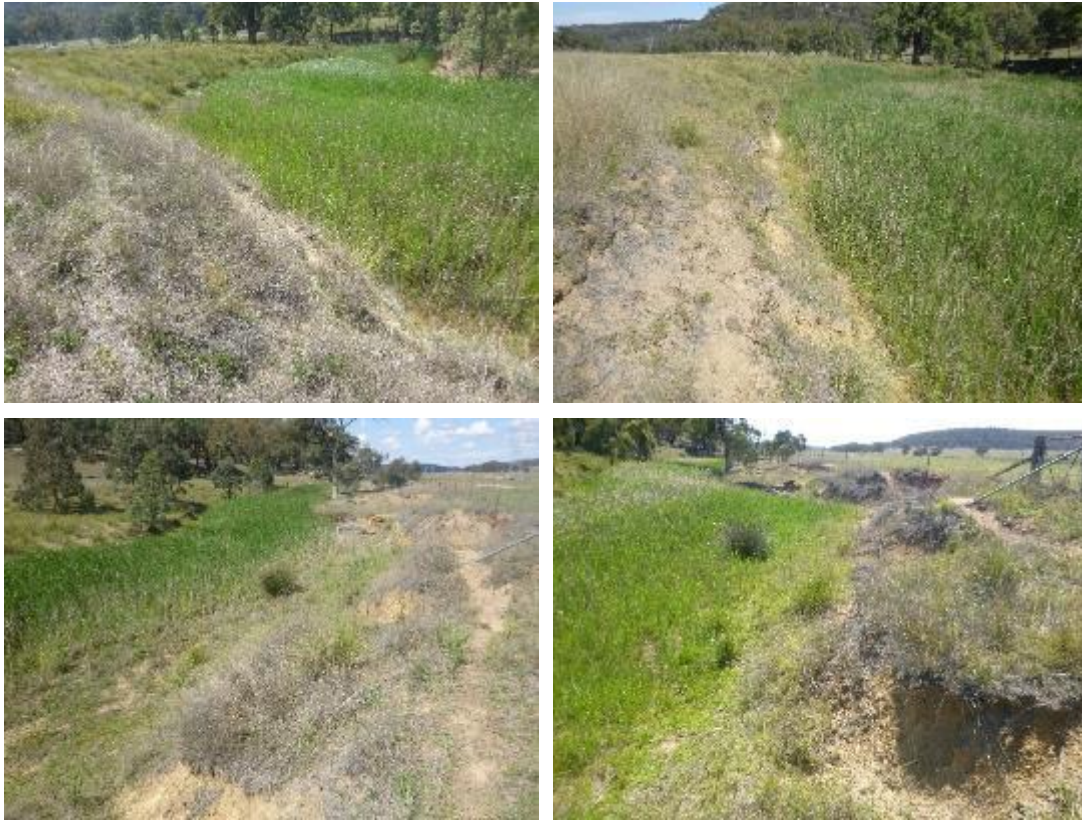
Figure B- 34: WcK34 site photos clockwise from top left: 2017 upstream, 2018 upstream. 2018 downstream, 2017 downstream

Site	Upstream	Downstream
WCK34	<ul style="list-style-type: none"> - In channel vegetation cover remains high - Right bank stable but some wombat burrows - Active erosion on face of left bank and right bank 	<ul style="list-style-type: none"> - Right-hand bank actively eroding and several bare animal tracks - Good vegetation cover on left bank - Blackberry at top of right bank
WCK35	<ul style="list-style-type: none"> - Instream vegetation cover remains high - Lower section of left bank remains stable and well vegetated, however some block failure is evident on top of left bank - Right bank active erosion and bare soil predominant 	<ul style="list-style-type: none"> - Right-hand bank has improved in vegetation cover - Regeneration downslope of reach on left bank
WCK36	<ul style="list-style-type: none"> - Right bank largely consistent, signs of grazing remain evident - Some bare dirt from stock tracks and erosion - Left bank remains steeply sloped and concave - Top of left bank still steep, showing signs of erosion - Good grass cover in channel and lower banks 	<ul style="list-style-type: none"> - Slumping still occurring on right bank - Some undercutting and exposed bare soil at downstream end of left bank - Good grass cover in channel and lower banks

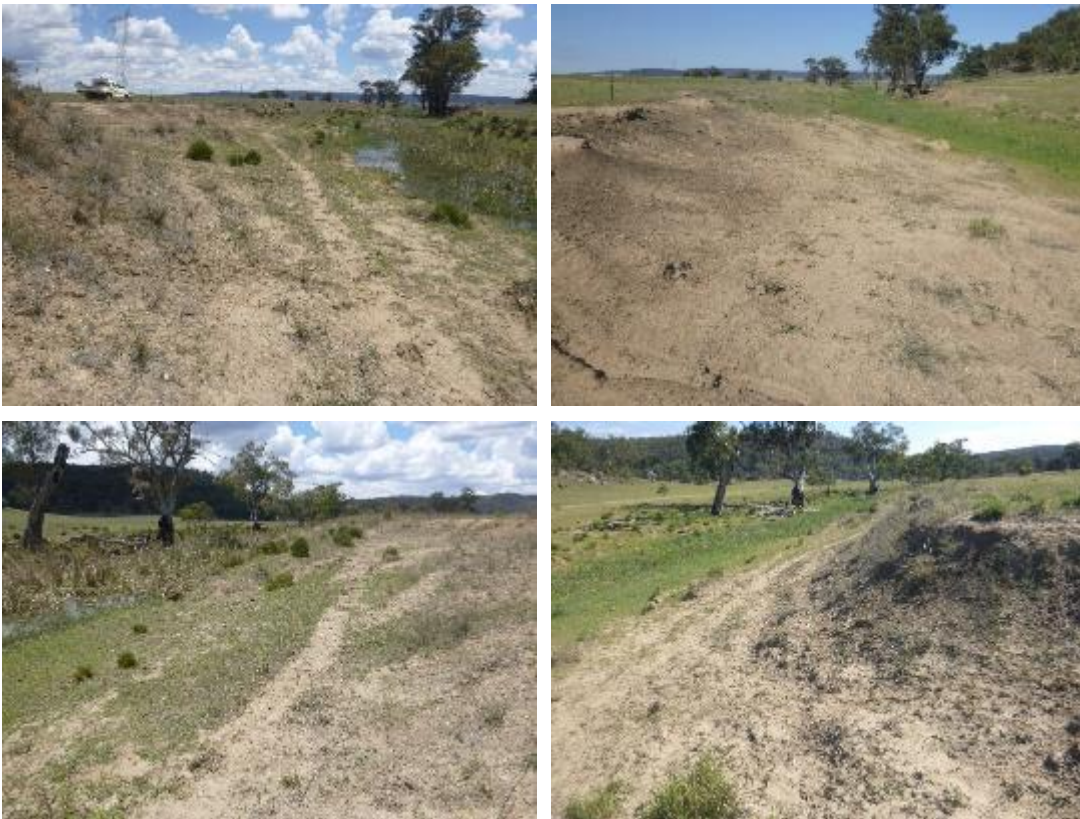
Figure B- 37: WcK37 site photos clockwise from top left: 2017 upstream, 2018 upstream. 2018 downstream, 2017 downstream

WCK37	<ul style="list-style-type: none"> - Left bank remains well vegetated (grazed) with some lateral erosion - Some Wombat burrows in left bank - Right bank bare, with very little vegetation cover - Stock tracks causing bare areas and erosion on right bank 	<ul style="list-style-type: none"> - Wombat burrows on left-hand bank - Right bank groundcover appears to have deteriorated with increased bare soil compared to 2017 - Stock tracks evident on right-hand bank - Moderate vegetation cover on left bank, with some lateral erosion
WCK38	<ul style="list-style-type: none"> - Instream vegetation remains similar, continues to be grazed by cattle - Wombat burrows on left bank - Stock tracks causing localised erosion on both banks - Right bank has reasonable vegetation cover though grazed - Left bank active erosion, is steep and bare 	<ul style="list-style-type: none"> - Stock access causing localised erosion - Good vegetation cover in channel and on banks, however it is being actively grazed

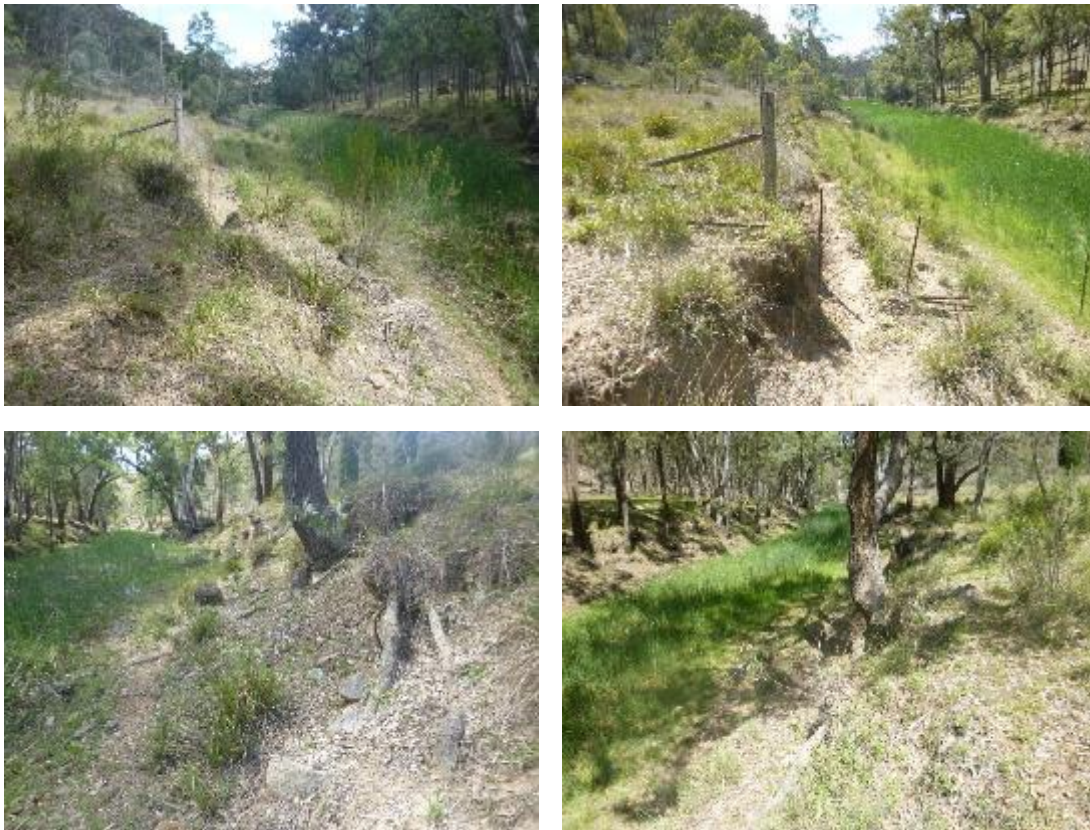
Figure B- 47: WcK47 site photos clockwise from top left: 2017 upstream, 2018 upstream. 2018 downstream, 2017 downstream

WCK47	<ul style="list-style-type: none"> - Instream vegetation cover remains good, though some impact of grazing noted below fence - Steep erosion around fence on right bank - Right bank bare where animal tracks are 	<ul style="list-style-type: none"> - Stock causing localised erosion on banks - Good vegetation cover in channel - Good level of debris and litter in stream and on lower banks
WCK48	<ul style="list-style-type: none"> - Good vegetation cover in channel - Some steep erosion points and bare soil on left bank - Right bank stabilised by rock cover - Good leaf litter and native and exotic grasses and herbs vegetation cover on right bank 	<ul style="list-style-type: none"> - Stock and macropod access on left bank instigating lateral erosion - Abundant exposed <i>Angophora floribunda</i> roots on left bank - Good debris in channel
WCK49	<ul style="list-style-type: none"> - Good cover of grasses on channel and on right bank - Left bank showing signs of stock tracks and localised erosion - Vegetation has been heavily grazed 	<ul style="list-style-type: none"> - Vegetation cover good in channel and right-hand bank - Left bank steep but presently stable - Localised erosion caused by stock access - Wombat burrows on right bank
