**WILPINJONG COAL PTY LTD**

**Environment Protection Licence (EPL) 12425**

**LICENCE MONITORING DATA  
MONTHLY SUMMARY REPORT**

**1 February 2023 to 28 February 2023**

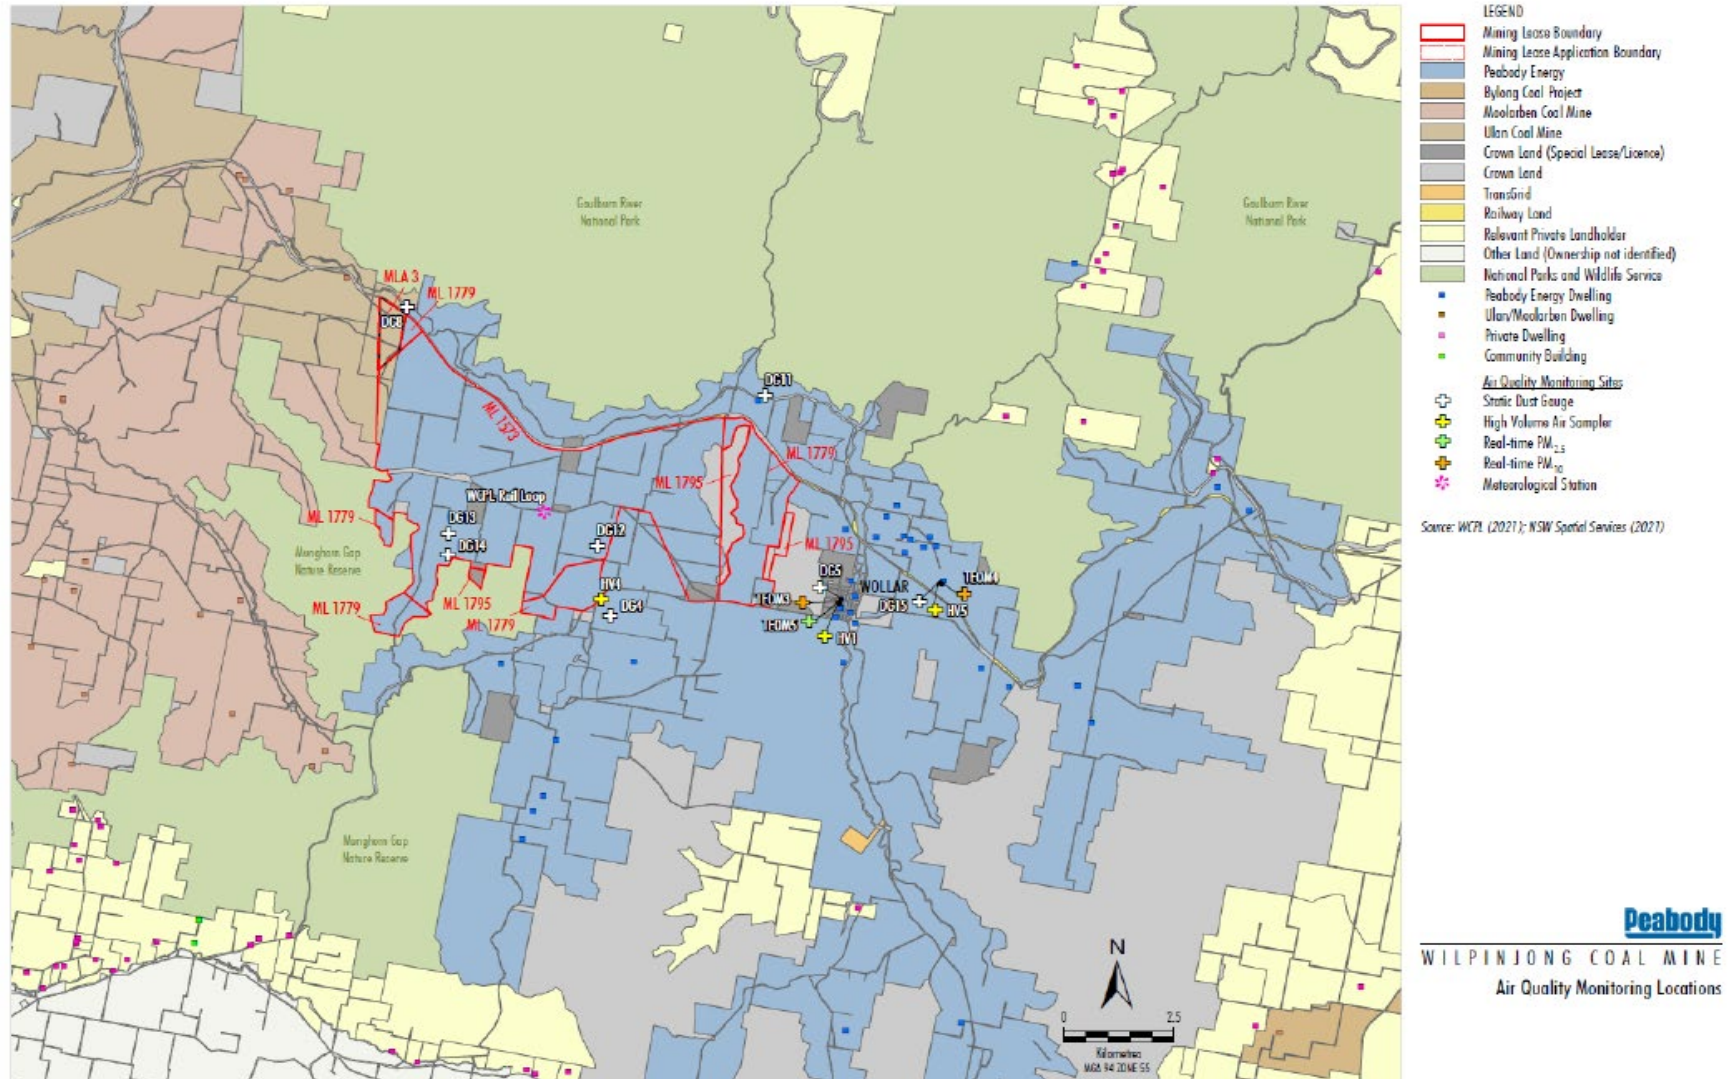
Figure 6 – Air (Dust) Monitoring Locations

The location of the above monitoring equipment in relation to Wilpinjong Coal Mine is shown in **Figures 6** and **8**.

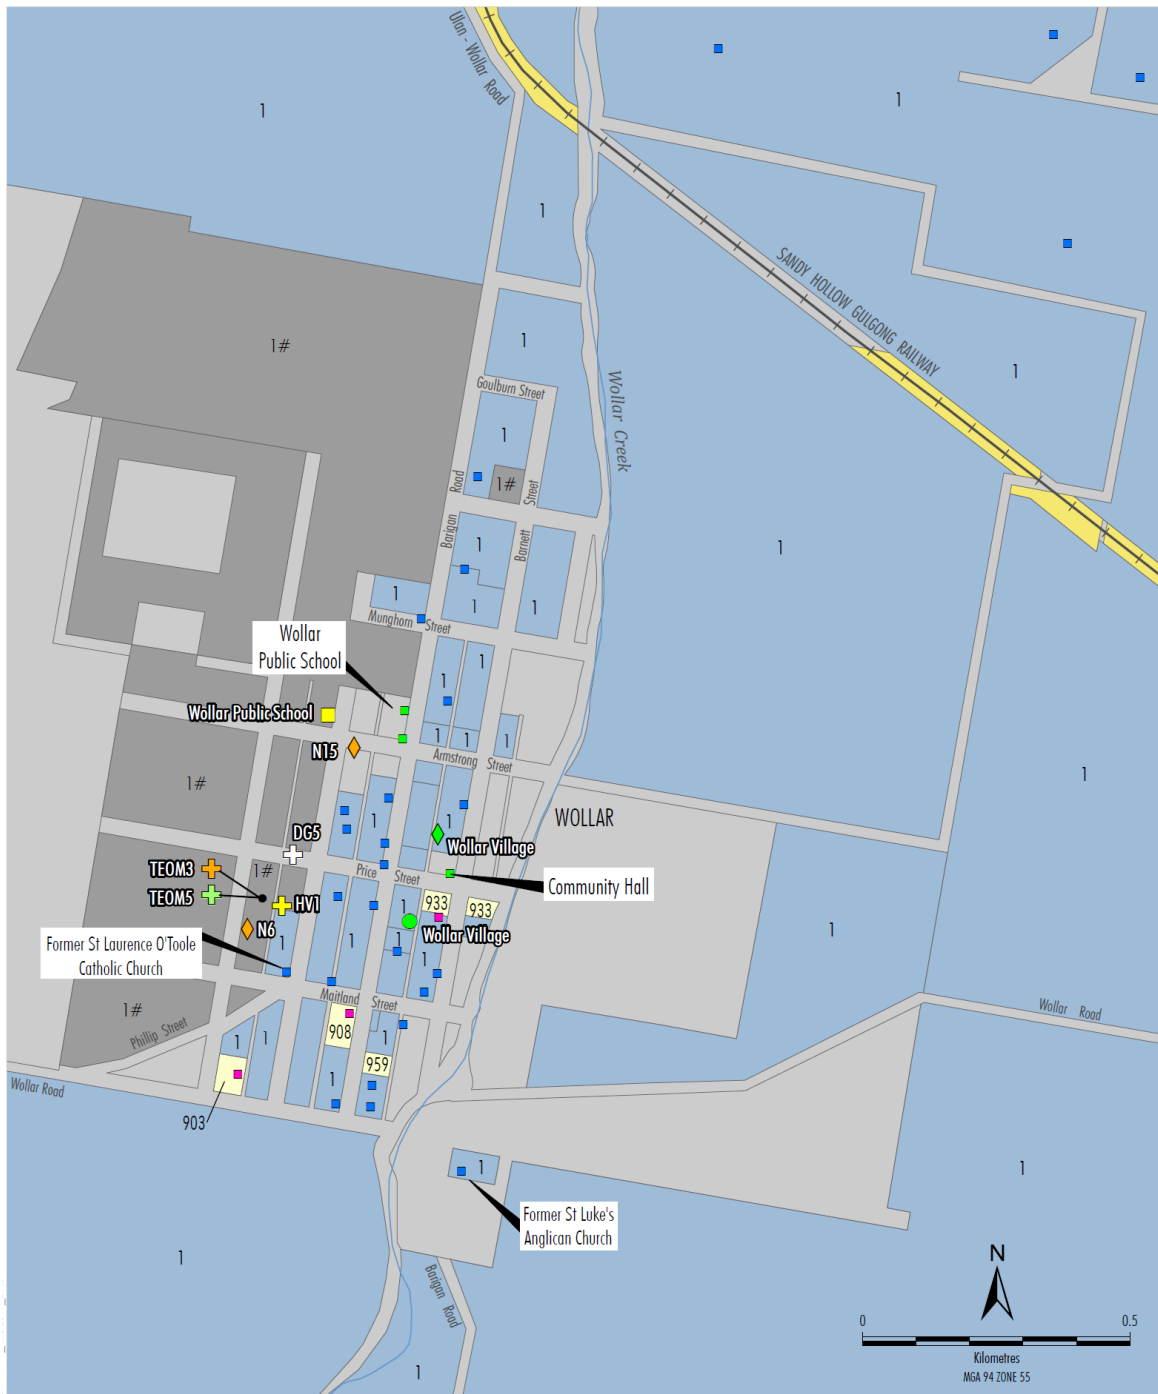
Figure 8 – Wollar Village Environmental Monitoring Sites

**Peabody**  
WILPINJONG COAL MINE  
Wollar Environmental Monitoring Sites
