WILPINJONG COAL PTY LTD Environment Protection Licence (EPL) 12425

LICENCE MONITORING DATA MONTHLY SUMMARY REPORT

1 June 2024 to 30 June 2024

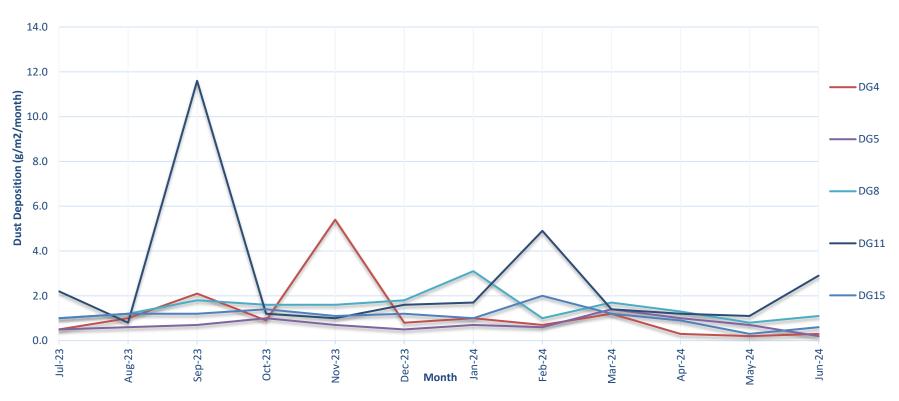
Figure 1a. DG Results - 12 Month Trend

^{1.} Limit of 4 g/m2/month (annual average) applies to DG5 (Wollar Village) - refer Figure 1b.

^{2.} During the sampling period ending 26th of September 2023, DG_11 results showed 30% ash, 5% fine dark particles annd 65% organic matter. A range of small fires present in the area throughout the month. Insects, bird droppings, grazing activity in the area. Special note: Ball of hair recorded in sample and a wasp nest on the bottle.

^{3.} An invalid result was taken at DG_11 during the February 24 monitoring period due to the funnel not being situated correctly in the bottle.

^{4.} During the June 24 sampling period, DG12 recorded a result of 4.2 g/m2/month. 50% of this result was attributed to insects.

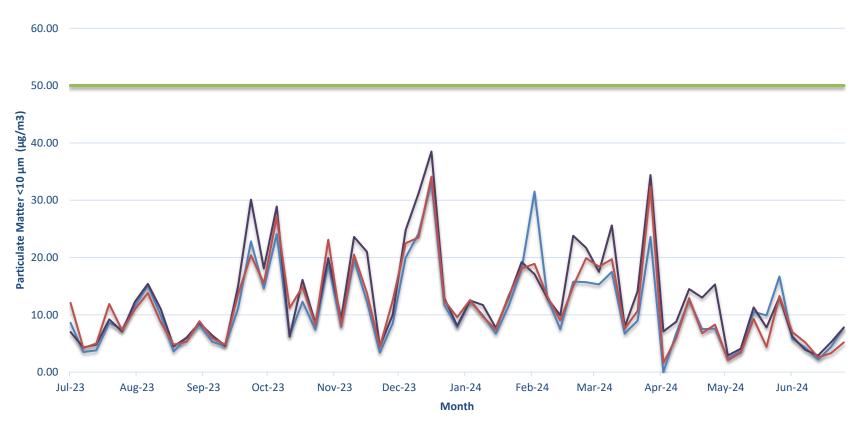
Figure 2. HV (PM10) Results - 12 Month Trend

^{1.} Limit doesn't apply for extraordinary events such as bushfires, prescribed burning, or dust storms.

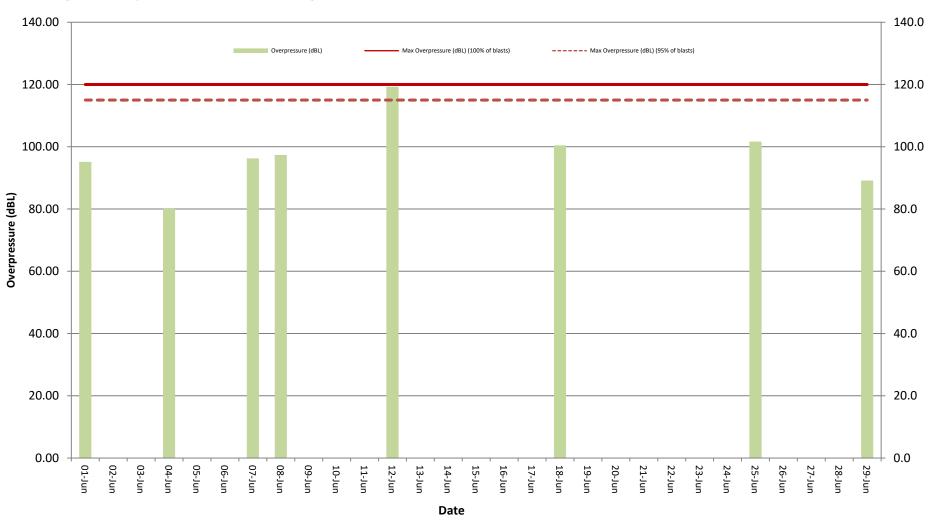
Figure 7. Overpressure (dBL) recorded during Month

Location	Month Number of Blasts		Minimum overpressure (dB(L))	Maximum overpressure (dB(L))	Mean overpressure (dB(L))	EPL overpressure Limits (dB(L))	Exceedance (yes/no)
Approx. 50m west of the Wollar Public School	June	8	79.9	119.1	97.3	115dB (95% blasts) 120dB (100% blasts)	no

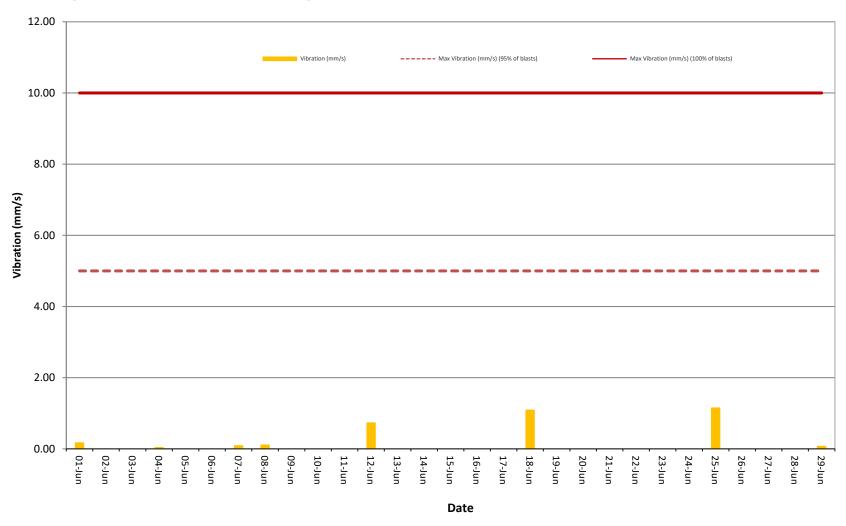
Figure 8. Vibration (mm/s) recorded during Month

Location	Month	Number of Blasts	Minimum vibration (mm/sec)	Maximum vibration (mm/sec)	Mean vibration (mm/sec)	EPL vibration Limits (mm/sec)	Exceedance (yes/no)
Approx. 50m west of the Wollar Public School	June	8	0.04	1.15	0.43	5 mm/s (95% blasts) 10 mm/s (100% blasts)	no

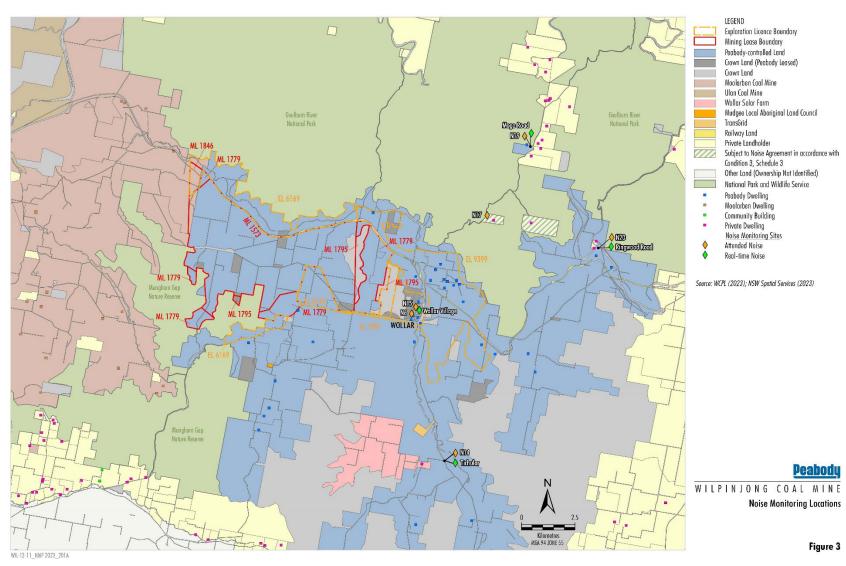
Figure 7 – Attended Noise Monitoring Locations

Attended environmental noise monitoring described in this report was done during the night period of 18 June 2024 at six monitoring locations.

Noise levels from site complied with relevant limits at all monitoring locations during the June 2024 survey.
