# **WAMBO SURFACE WATER MANAGEMENT PLAN**

Document No. WA-ENV-MNP-509.2  
November 2023

<b>Document No.</b>	WA-ENV-MNP-509.2
<b>Title</b>	Wambo Surface Water Management Plan
<b>General Description</b>	Surface Water Management at Wambo Coal Mine and Coal Handling Facilities
<b>Document Owner</b>	WCPL Environment & Community Manager

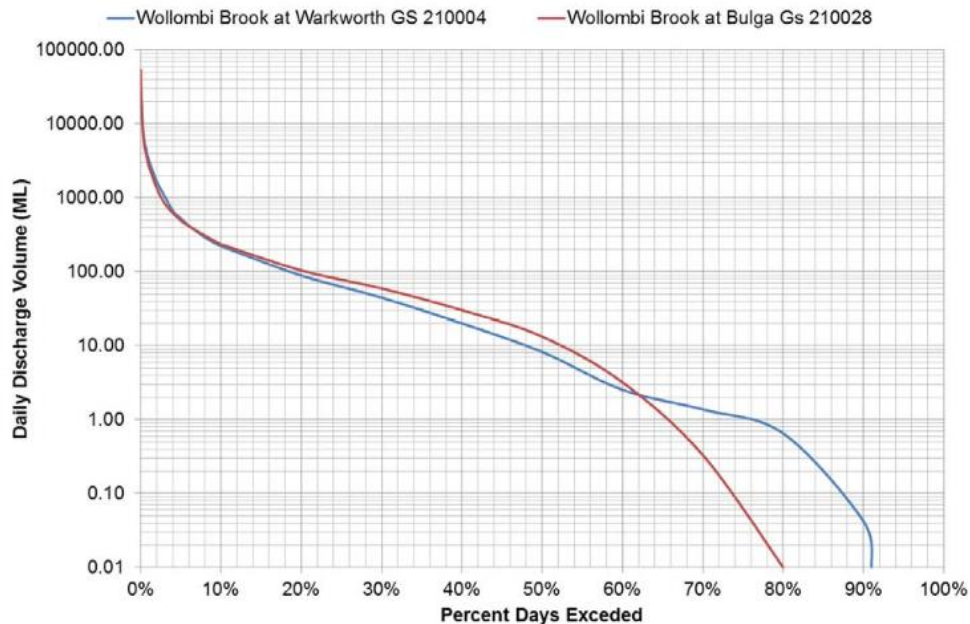
**Figure 6: Flow Duration Curves Wollombi Brook Upstream and Downstream of the Mine**

**Figure 6** shows the flow duration curves for Wollombi Brook at the DPIE Water gauging stations at Warkworth and Bulga (GS 210004 and GS 210028) which have been derived from flow recorded between 2003 and 2014. It is apparent that the distribution of flows in Wollombi Brook upstream and downstream of Wambo has generally been similar but with an increased frequency of low flows at the downstream station.

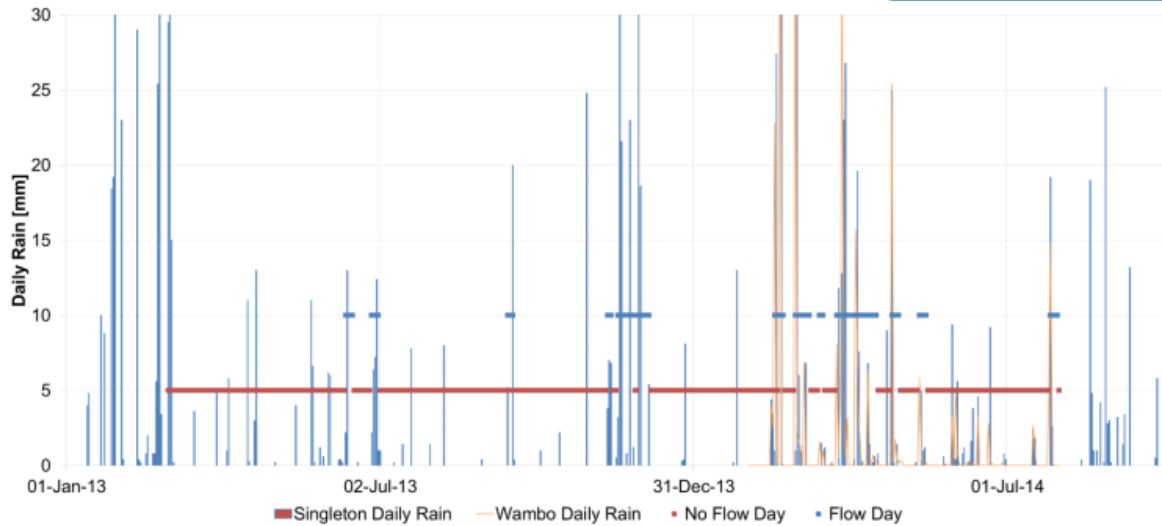
Figure 7: Recorded Daily Rainfall and Flow/No Flow Days – North Wambo Creek at FM2

The available flow monitoring data for *North Wambo Creek* show that these creeks are all ephemeral and typically only flow in response to intense rainfall. This can be seen in **Figure 7** and **Figure 8**, which show monitored (non-zero) daily flow data and concurrent daily rainfall measured at the Wambo climate station.

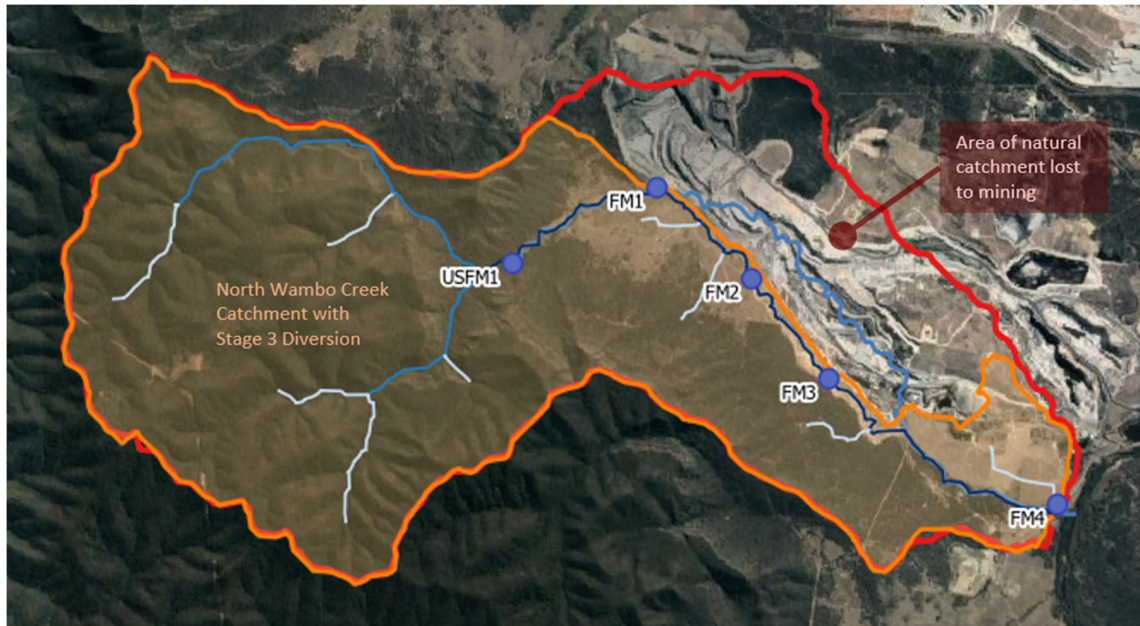
**Figure 4: North Wambo Creek Surface Flow Monitoring Locations and Reduction in Catchment Area post Stage 3 Diversion.**

A number of reports and data files were provided to Alluvium for this assessment. This included annual flow monitoring reports and this Plan. In addition, surface flow monitoring data was provided in spreadsheets for flow stations along the North Wambo Creek and within the diversion. Five flow monitoring stations were established between 2008 and 2017 (refer **Table 4**). The location of each flow monitoring location is shown in **Figure 4**.

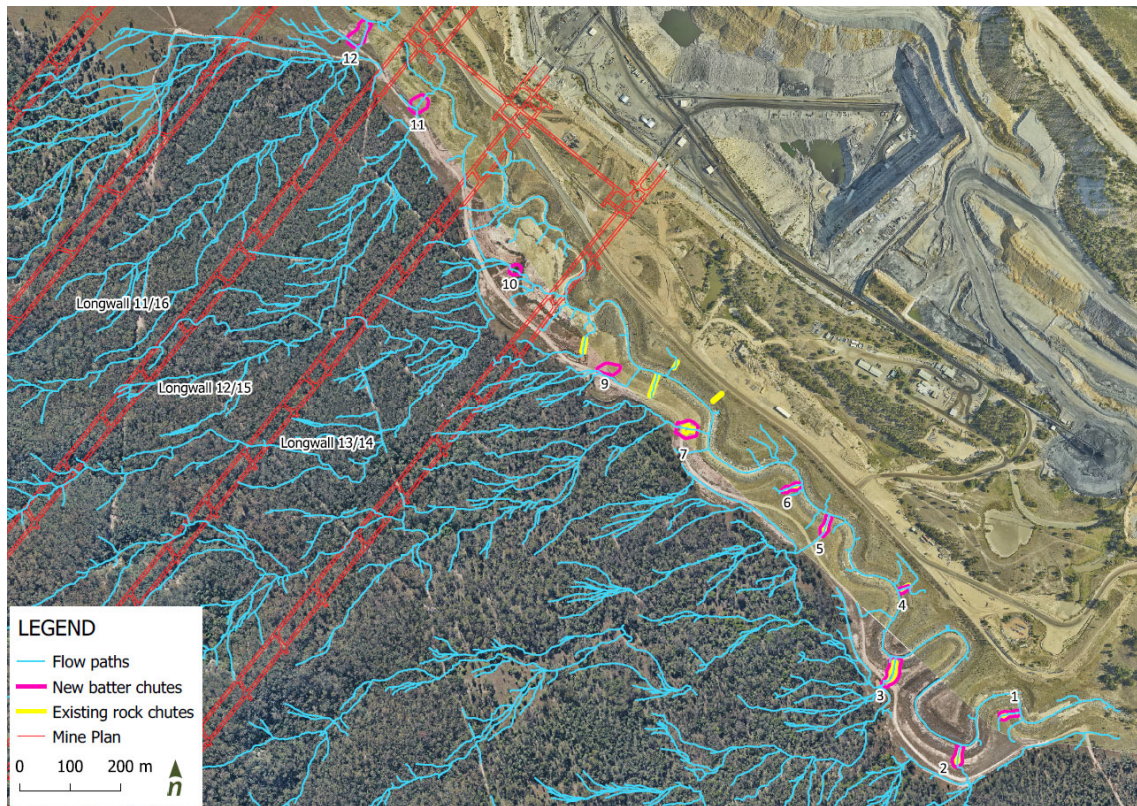
Figure 4. NWCD overland flow path mapping using CatchSim

Assessment of the existing batter chutes has been completed using a combination of onsite inspection of the chutes and flow path mapping using the latest (post LW11-LW16 subsidence) survey data. As part of the assessment, the current issues, threats and risks of each batter chute has been identified as well as a summary of the management action and an order of priority for construction. New chutes are the highest priority then the repair of existing chutes based on area of catchment and those with the largest catchments to be treated first. Management actions are described in detail in section 2.2.

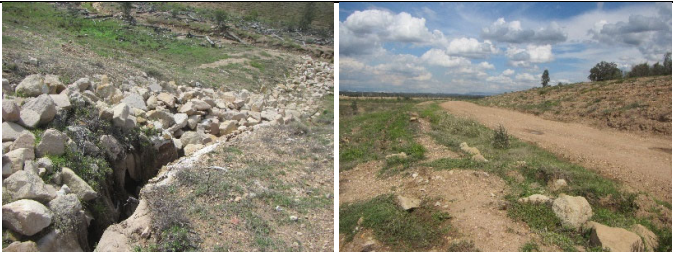
3 (36ha)	10

<p>Undermining of chute due to incorrect construction/materials.</p> <p>Rock chute sits proud of surrounding surface, preventing flows entering chute.</p> <p>Poorly graded and shaped rock mix used.</p> <p>Geotextile layer under rock causing piping plane failure.</p> <p>Ponding along top of bank causing Tunnel erosion.</p> <p>Road along top of bank with drain alongside causes ponding along top of bank – causing tunnelling.</p> <p>Catchsim flow path modelling shows that flowpaths have changed due to subsidence – rock chute in incorrect place.</p>	<p>Replace batter chute with properly designed new chute.</p> <p>Include granular filter layer.</p> <p>Use correctly graded rock mix.</p> <p>Extend rock beaching upstream to pond – acts as rock armoured spillway.</p> <p>Reconfigure area upstream of chute to direct flows down bund whilst preventing water from ponding within 10m of top of bank. Realign road and fill over existing road so that top of bank ties in with nearby raised bund of eastern side of existing road.</p> <p>Realign chute according to new flow paths.</p>

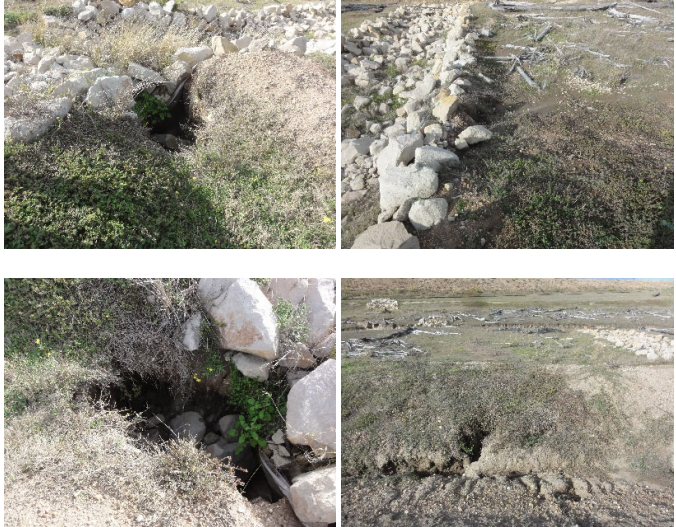
bank.
9 (5.4ha)	6

<p>Undermining of chute due to incorrect construction/materials.</p> <p>Rock chute sits proud of surrounding surface, preventing flows entering chute.</p> <p>Poorly graded and shaped rock mix used.</p> <p>Geotextile layer under rock causing piping plane failure.</p> <p>Ponding along top of bank causing Tunnel erosion.</p>	<p>Reconstruct batter chute with:</p> <ul style="list-style-type: none"> <li>• Lower crest</li> <li>• granular filter layer instead of geofabric</li> <li>• correctly graded rock mix.</li> </ul> <p>Reconfigure area upstream of chute to direct flows down bund whilst preventing water from ponding within 10m of top of bank.</p>
10 (1ha)	1

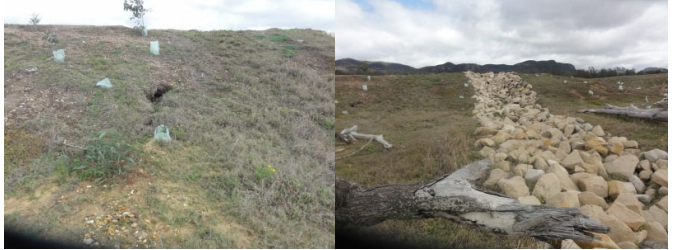
<p>Undermining of chute due to incorrect construction/materials.</p> <p>Rock chute sits proud of surrounding surface, preventing flows entering chute.</p> <p>Poorly graded and shaped rock mix used.</p> <p>Geotextile layer under rock causing piping plane failure.</p> <p>Ponding along top of bank causing Tunnel erosion.</p>	<p>Reconstruct batter chute with:</p> <ul style="list-style-type: none"> <li>• Lower crest</li> <li>• granular filter layer instead of geofabric</li> <li>• correctly graded rock mix.</li> </ul> <p>Reconfigure area upstream of chute to direct flows down bund whilst preventing water from ponding within 10m of top of bank.</p>

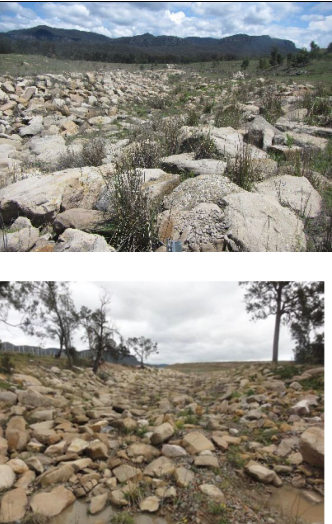
04	Diversion - Stage 3	Rock chute tie in to downstream.

Durability of sandstone, long term increase in grade and erosive potential in downstream end of diversion, partial mitigation due to the downstream extent of diversion being largely in situ sandstone.	Include in ongoing monitoring program - Annual inspections to monitor any significant changes in stability.
05	Diversion - Stage 3	Rock chute.

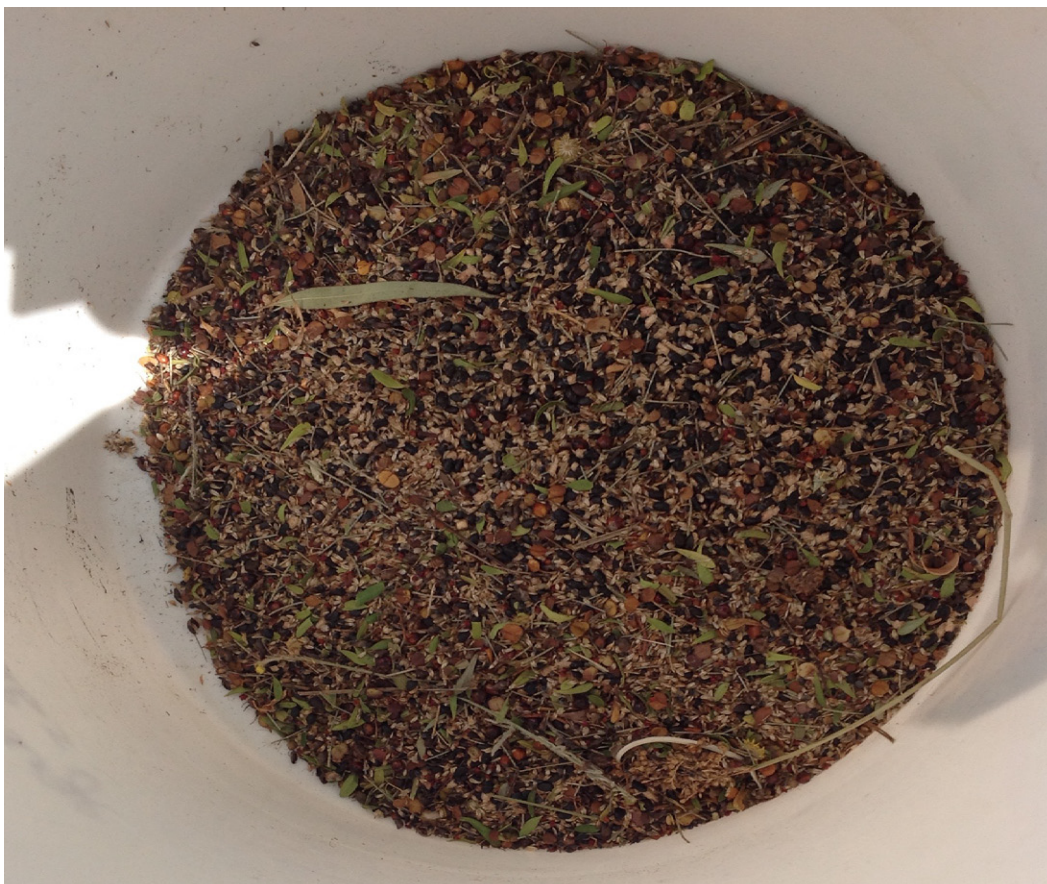
Native seed blended for broadcasting

It may not be possible to collect all the species on the revegetation list but as many species as possible from each of the types of vegetation should be sourced. Final seed mixes should meet or exceed diversity values as compared to target vegetation benchmark values.

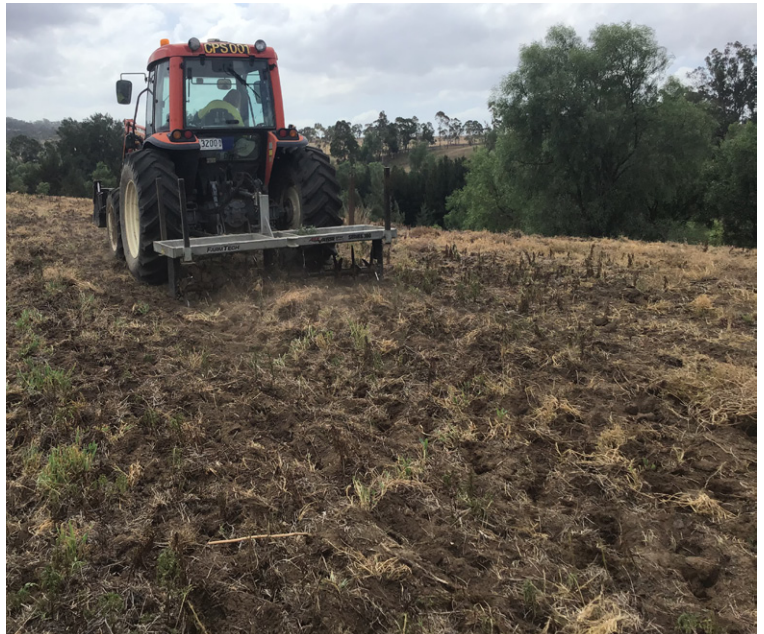
Aerator preparing ground for sowing, Jerry's Plains NSW

Various methods exist for sowing native seed – e.g. broadcasting, drilling, hydroseeding. Given the size and topography of the site a combination of broadcasting and hydroseeding are considered the most appropriate. The majority of the site can be sown using broadcasting techniques but in some steep areas prone to erosion hydroseeding could be used, particularly in conjunction with hydromulch applications. These methods may be required due to lack of access for conventional seedbed preparation and the need for added stability in these zones.

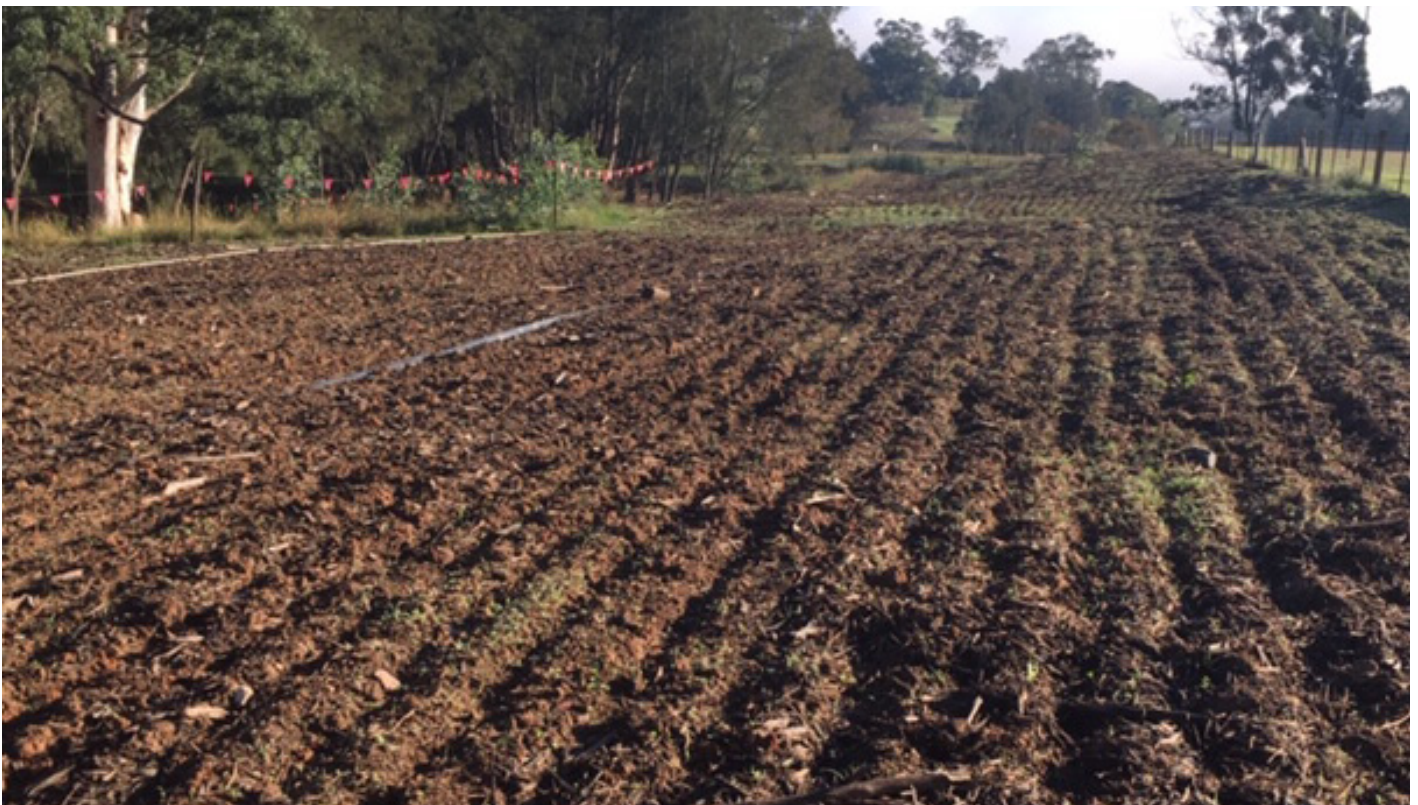
Ground prepared for sowing, Camden Lakeside Golf Course NSW
