WILPINJONG COAL PTY LTD

Environment Protection Licence (EPL) 12425

**LICENCE MONITORING DATA
MONTHLY SUMMARY REPORT**

1 July 2020 to 31 July 2020

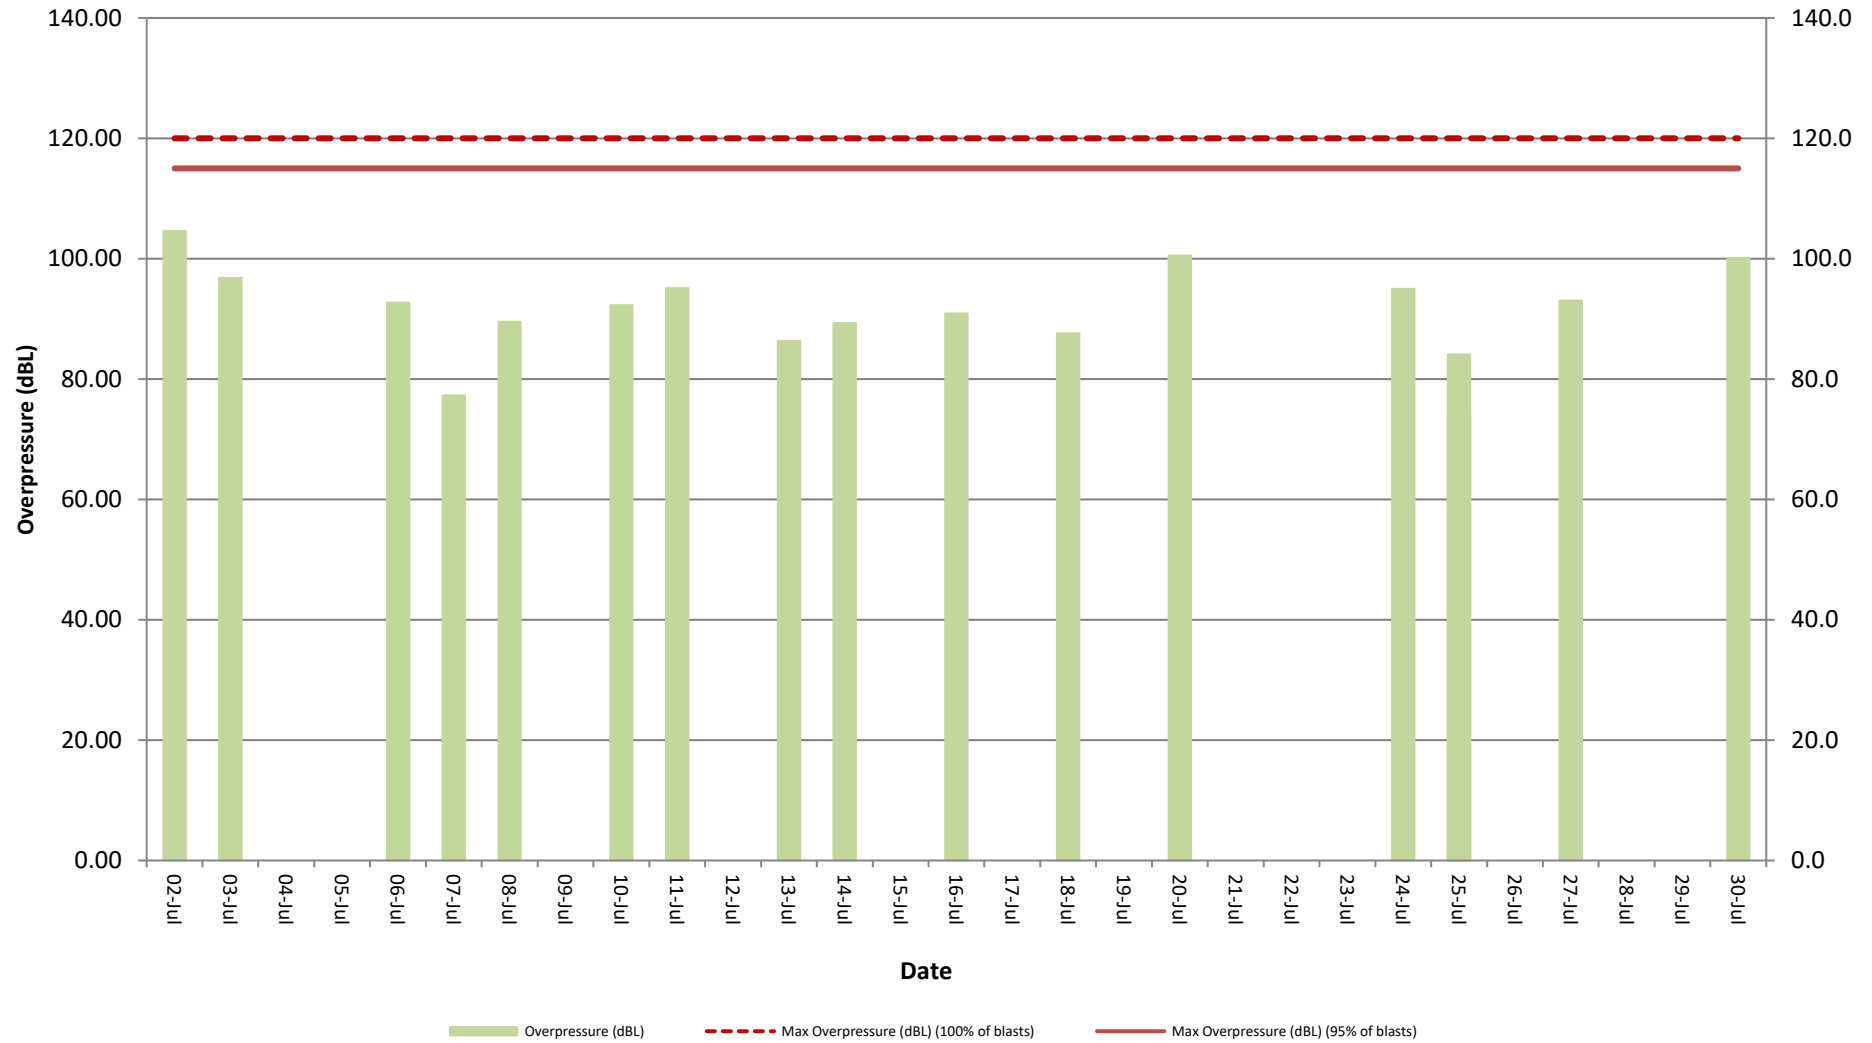
Figure 7. Overpressure (dBL) recorded during Month

Monitoring is carried out near sensitive locations during blasting activities to determine the vibration in the air (overpressure) and earth (ground vibration). A summary of the results of this monitoring, and the limits specified in the EPL, are shown in **Tables 3** and **4**. **Figures 7 & 8** shows the actual overpressure and vibration levels recorded during the month.

Location	Month	Number of Blasts	Minimum overpressure (dB(L))	Maximum overpressure (dB(L))	Mean overpressure (dB(L))	EPL overpressure Limits (dB(L))	Exceedance (yes/no)
Approx. 50m west of the Wollar Public School	July	17	74.1	104.6	91.1	115dB (95% blasts) 120 dB (100% blasts)	no
