WILPINJONG COAL PTY LTD

Environment Protection Licence (EPL) 12425

**LICENCE MONITORING DATA
MONTHLY SUMMARY REPORT**

1 May 2020 to 31 May 2020

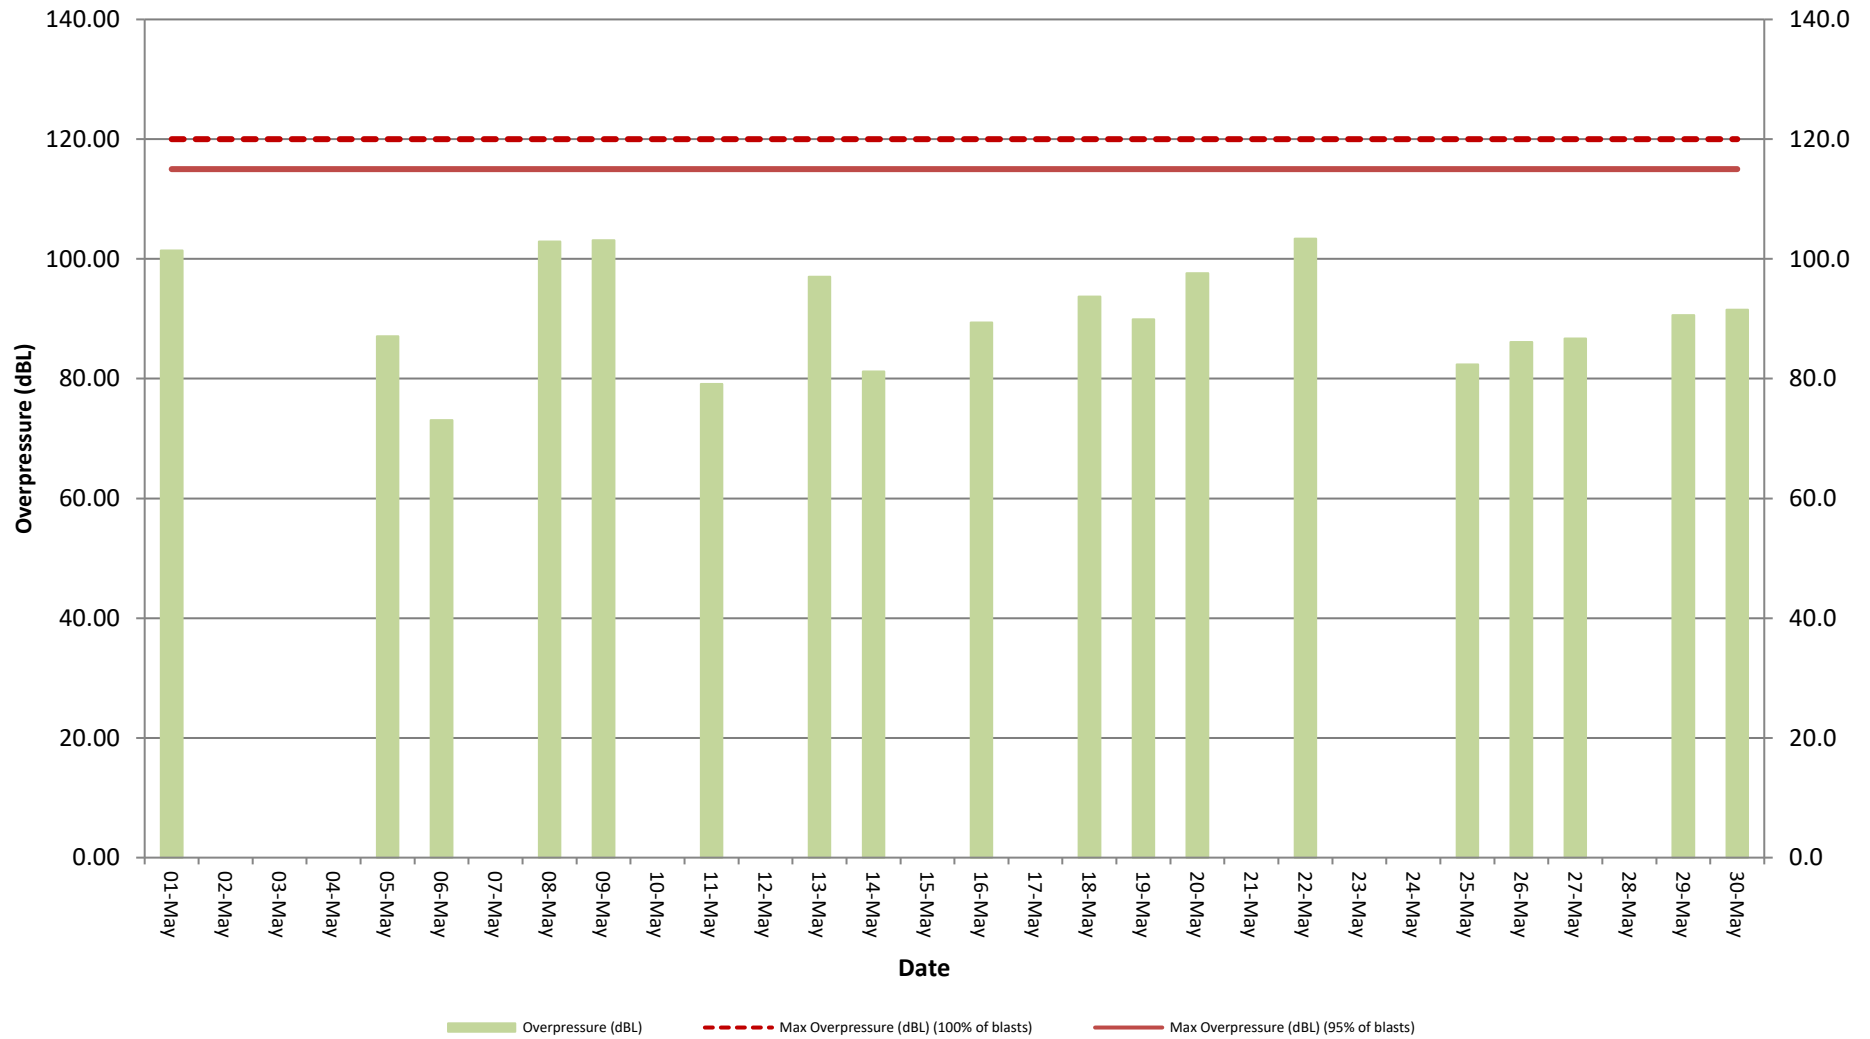
Figure 7. Overpressure (dBL) recorded during Month

Monitoring is carried out near sensitive locations during blasting activities to determine the vibration in the air (overpressure) and earth (ground vibration). A summary of the results of this monitoring, and the limits specified in the EPL, are shown in **Tables 3** and **4**. **Figures 7 & 8** shows the actual overpressure and vibration levels recorded during the month.

Location	Month	Number of Blasts	Minimum overpressure (dB(L))	Maximum overpressure (dB(L))	Mean overpressure (dB(L))	EPL overpressure Limits (dB(L))	Exceedance (yes/no)
Approx. 50m west of the Wollar Public School	May	18	73.1	103.4	90.9	115dB (95% blasts) 120 dB (100% blasts)	no
