**WILPINJONG COAL PTY LTD**

**Environment Protection Licence (EPL) 12425**

**LICENCE MONITORING DATA  
MONTHLY SUMMARY REPORT**

**1 November 2022 to 30 November 2022**

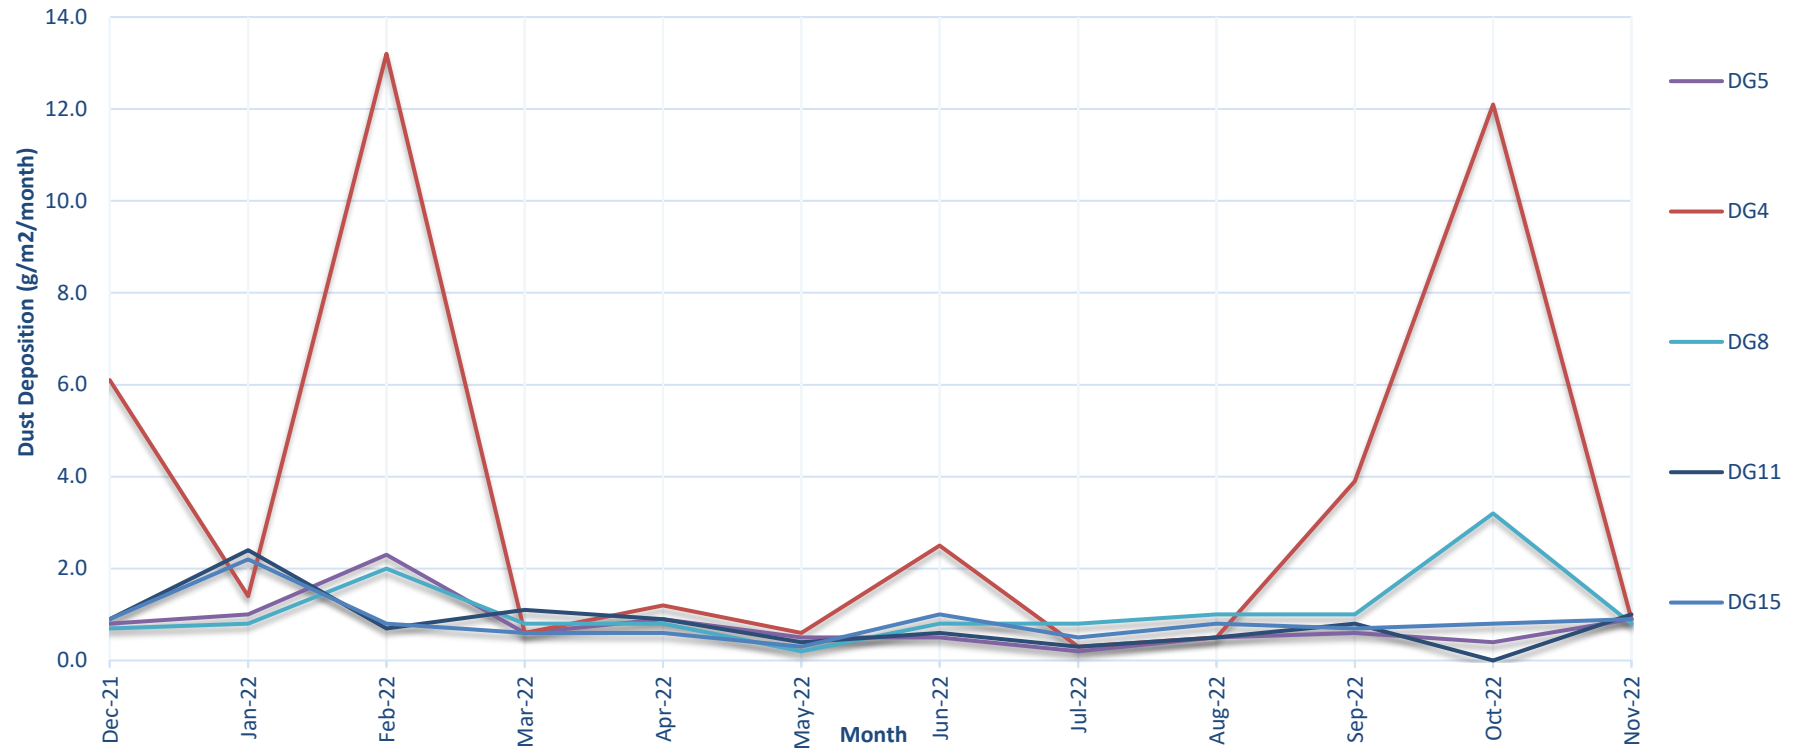
Figure 1a. DG Results - 12 Month Trend

1. Limit of 4 g/m<sup>2</sup>/month (annual average) applies to DG5 (Wollar Village) - refer Figure 1b.
2. In February 2022, DG4 recorded 5.3g/m<sup>2</sup> of total insoluble matter. Upon further inspection, only 5% if the composition was attributed to dark particles indicating that the result was not due to mining operations. The result predominantly consisted of organic matter (80%).
- 3 In December 2021, DG4 recorded 6.1g/m<sup>2</sup> of total insoluble matter. The sampler recorded insects and spider webs within the funnel most likely influencing the result.
4. In October 2022, DG4 recorded 12.1g/m<sup>2</sup> of total insoluble matter. The sampler recorded 75% organic material indicating that the influence of mining operations contributed less than the limit of 4g/m<sup>2</sup> during the month.

A summary of the monitoring results for the month is provided in **Table 1** and the yearly trends are also shown in **Figures 1** to **3**.

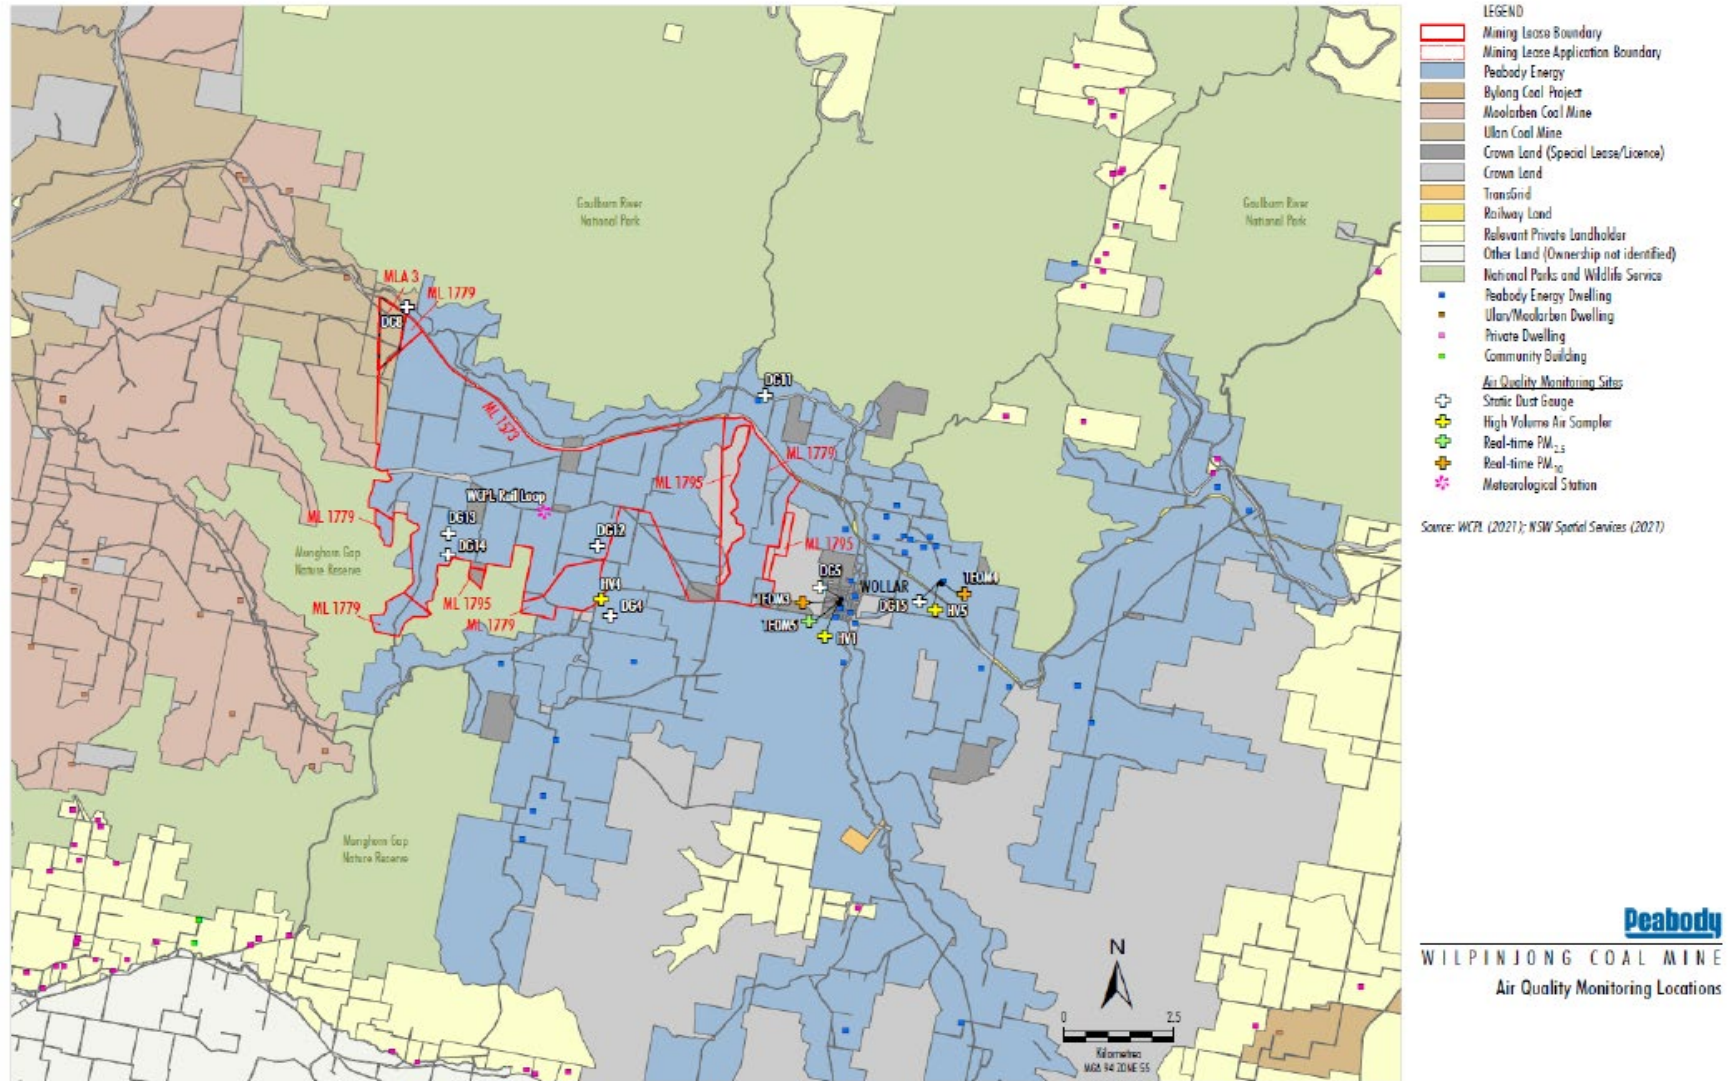
Figure 6 – Air (Dust) Monitoring Locations

The location of the above monitoring equipment in relation to Wilpinjong Coal Mine is shown in **Figures 6** and **8**.

Continuous weather monitoring occurs onsite at the location shown on Figures 5 and 6 (**Meteorological Station**). The Meteorological Station continuously monitors for: rainfall; relative humidity; temperature (i.e. at 2m, 10m & 60m), barometric pressure, wind speed, wind direction and temperature lapse rate.

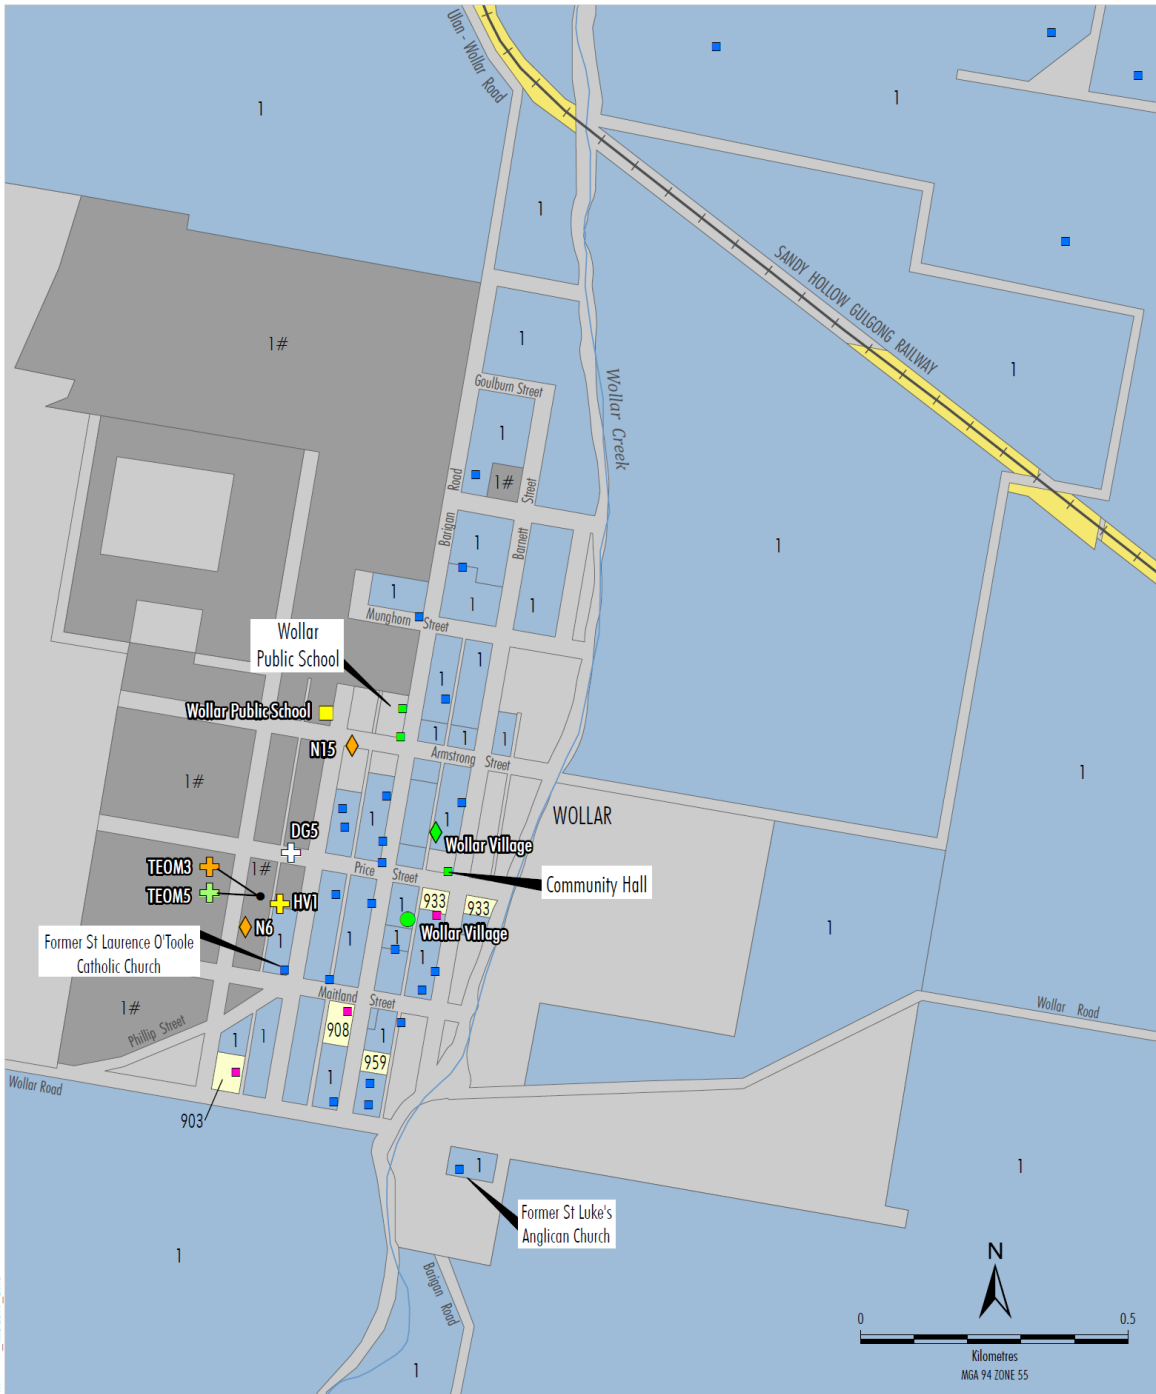
**Figure 8 – Wollar Village Environmental Monitoring Sites**

**Peabody**  
WILPINJONG COAL MINE  
Wollar Environmental Monitoring Sites
