METROPOLITAN COAL LONGWALLS 311-316

HERITAGE MANAGEMENT PLAN

N	Metropolitan Coal – Heritage Management Pl	an
Revision No. HMP-R01-C		Page 1
Document ID: Heritage Management Plan

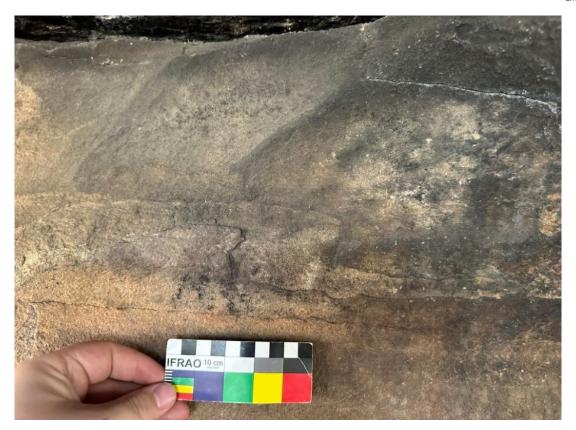
Plate 18: Panel #4, motif #12, showing active weathering - Woronora Reservoir Northern Trail 3.

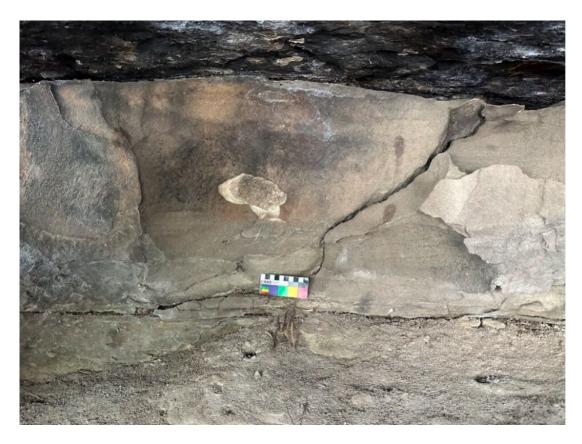
Plate 23: Root jacking (monitoring point) in the centre of Panel #6 – Woronora Reservoir Northern Trail 3.

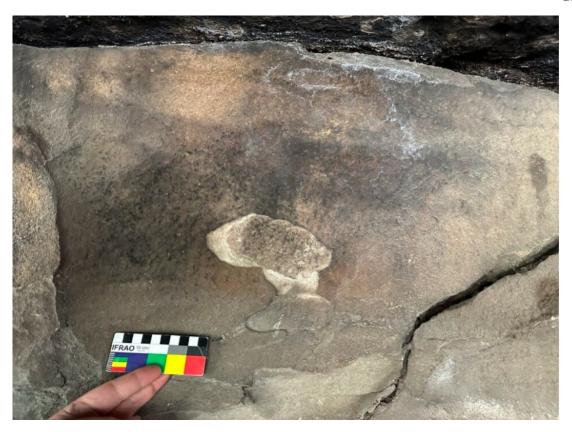
Plate 24: Close up of monitoring point at Panel #6 – Woronora Reservoir Northern Trail 3.

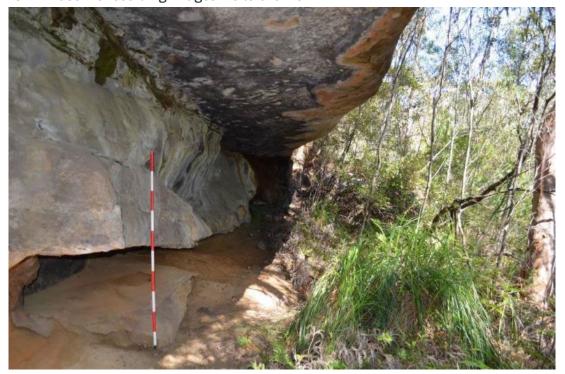
Plate 34: Interior context shot of Woronora Reservoir Northern Trail 5, facing west.

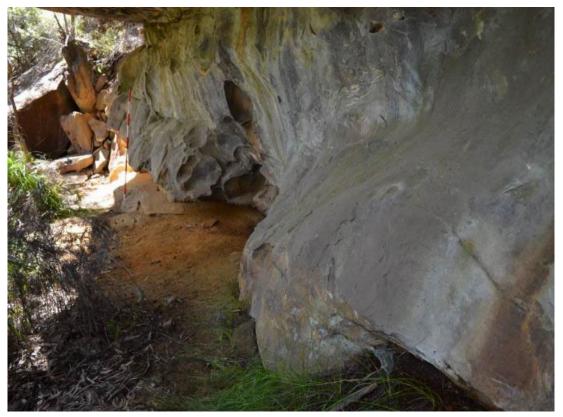
Plate 35: Interior context shot of Woronora Reservoir Northern Trail 5, facing east.

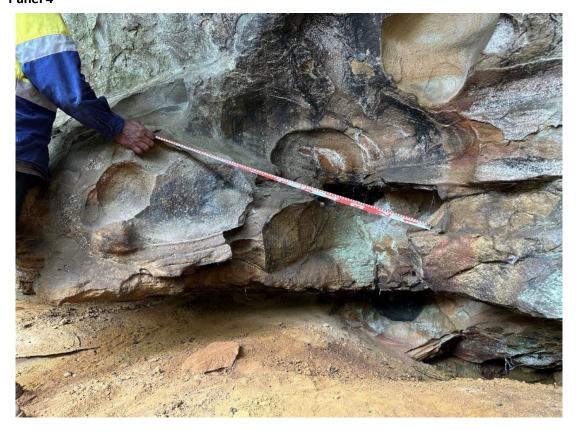
Plate 45: Panel #4 overview, consisting of several small, cavernous holes with art – Woronora Reservoir Northern Trail 5.

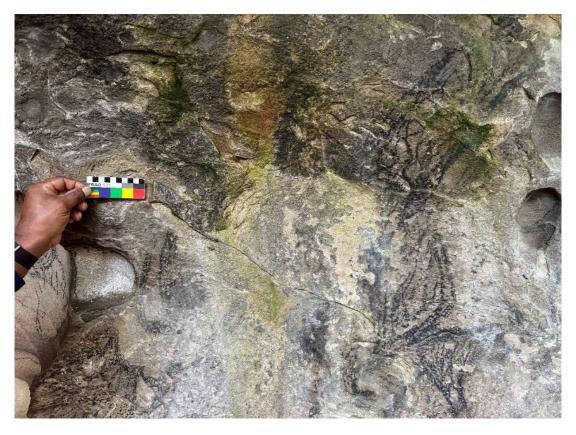
Plate 63: Panel #6, motif #29, showing water wash – Woronora Reservoir Northern Trail 5

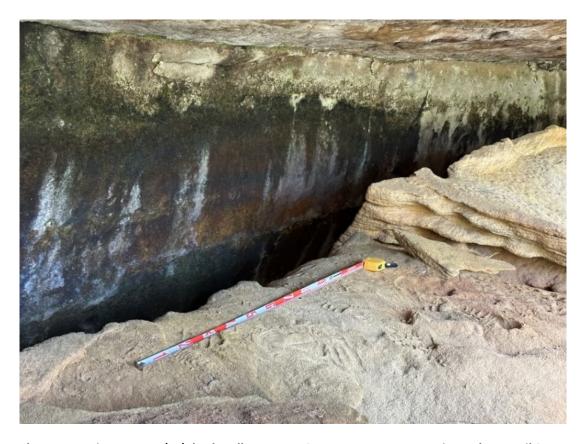
Plate 111: Active seepage (#1), back wall at 5.5 m – 9 m – Woronora Reservoir Northern Trail 9

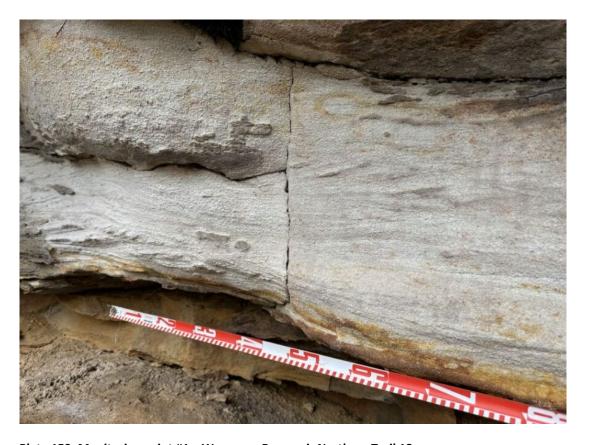
Plate 159: Monitoring point #1 – Woronora Reservoir Northern Trail 18

Monitoring Points				
Number	Location in shelter	Notes			
#1	Back wall	Vertical crack at back wall, at 1.952 m – active weathering (cavernous).			
#2	Start of Panel #2	Vertical crack at the start of Panel #2, at 5.261 m.			
#3	Centre of Panel #2	Vertical crack at the centre of Panel #2, at 6.501 m. The crack at the top of the panel travels to 40 cm short of the floor.

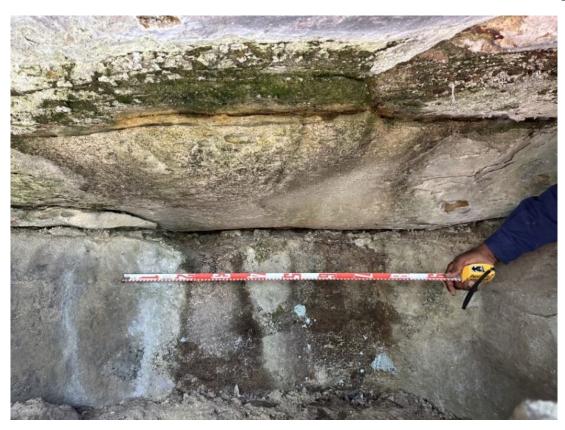
Plate 178: Monitoring point #1 – Northern Trail 19

Monitoring Points				
Number	Location in shelter	Notes			
#1	At 0 m	Water wash.			
#2	At 1.5m	Vertical crack.			
#3	Floor to shelf at 2 m	Vertical crack.			
#4	At 2 m	Active cavernous weathering.			
#5	At 4 m	Vertical jault/crack.			
#6	At 5.5 m	Large vertical crack – block fall and separation.			
#7	At 6 m	Active water wash.

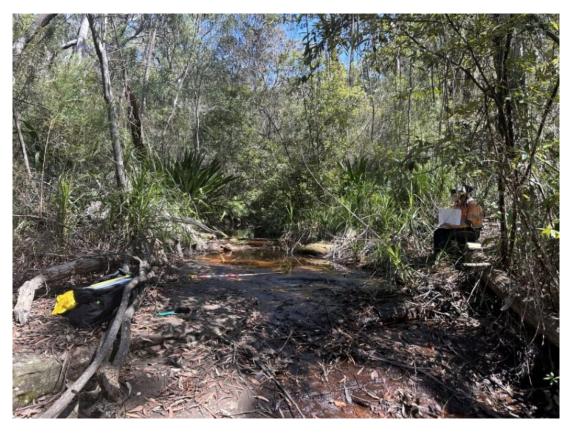
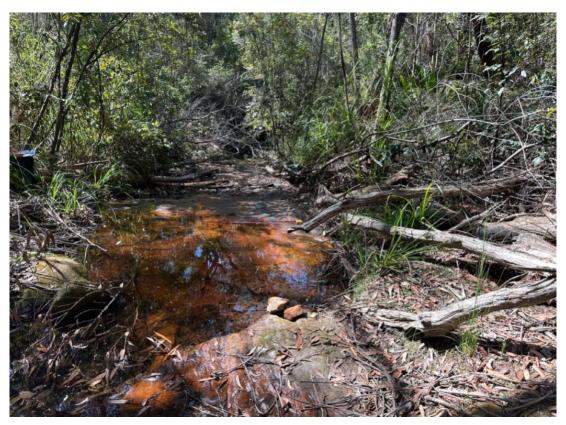
This site is located on a sandstone platform near an unnamed creek line. Six grinding grooves were relocated from the original 10 previously recorded in 1976, and some possible ground dishes were also located. The site is in a stable condition.

Condition	Visible – is susceptible to flows in creek line.	o organic (chemical) v	veathering from cove	ring and uncovering	g during different	
Orientation	See detailed recording t	able.

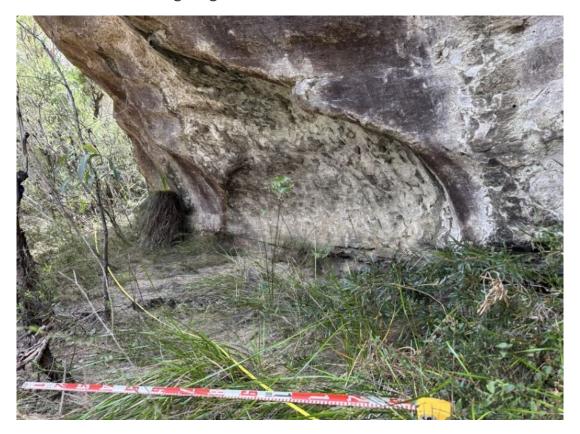
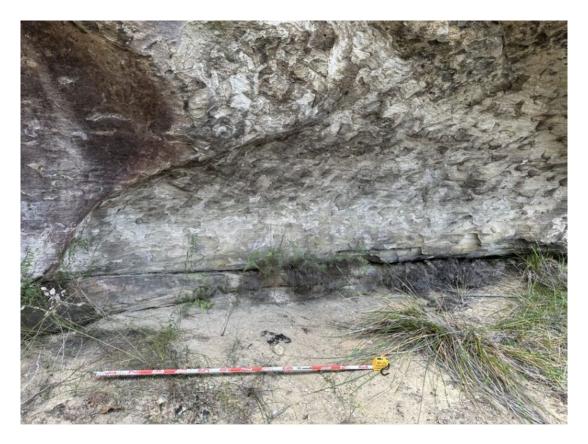
Damage/threats						
Water wash	Yes – not active	Graffiti	No	Macro vegetals	Yes	
Animals	Small	Salt/granular loss	Yes	Fissuring	Yes	
Insects	Small	Spalling/exfoliation	Yes – back wall	Other	N/A	
Fire	Yes – ash and smoke present	Block fall	Yes - ancient

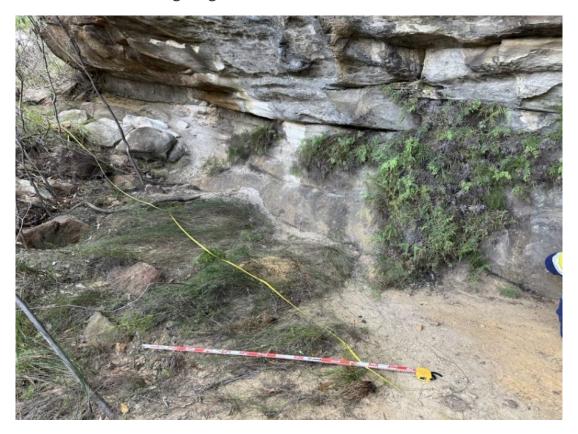
This shelter has been affected by block fall, and cavernous and chemical weathering. It is located at 268 m elevation, under a ridgeline and north of a large swamp. Three art panels and eight motifs were located. The art located at this shelter has been affected by weathering and spalling, particularly the red ochre stencils. More than 20 artefacts were located within the inner dripline area.

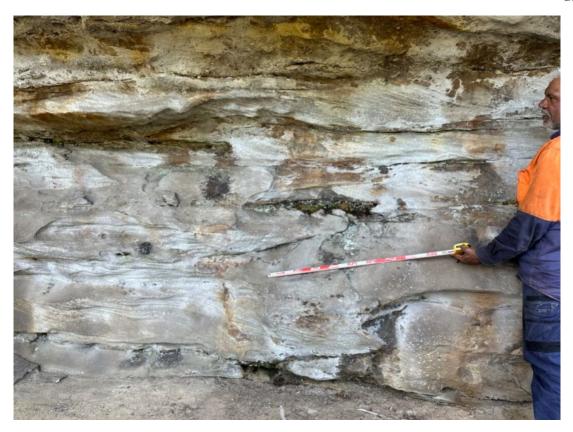
Plate 294: Monitoring point #3 – Northern Trail 76.

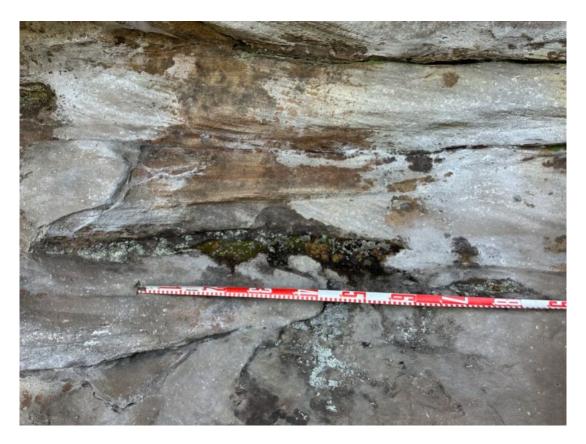
Plate 295: Monitoring point #3 – Northern Trail 76.

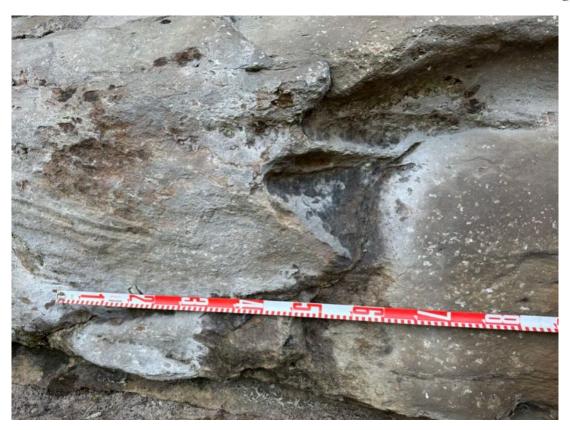
Plate 296: Monitoring point #3 – Northern Trail 76.

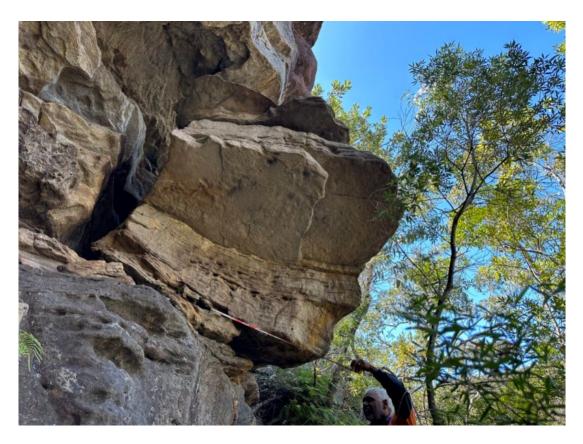
Plate 297: Monitoring point #4, large boulder overhanging 4 m N of shelter – Northern Trail 76.

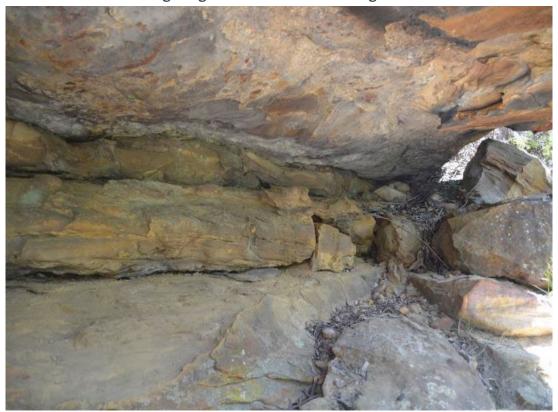
Monitoring Points				
Number	Location in shelter	Notes			
1	Runs from SW corner of shelter.	Faultline/crack			
2	Runs from back wall, up ceiling in NE direction.	Start of crack/wear point.			
3	Ceiling	Portion of ceiling lifted – ready to break off.			
4	Back of shelter	Natural fissure.

Plate 300: Northern Trail 80 monitoring Point # 1, SW corner of shelter.

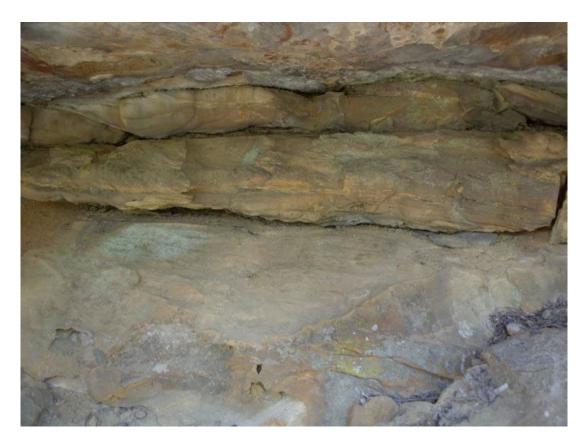
Plate 301: Northern Trail 80 overview of monitoring Points # 2-4, backwall and ceiling.

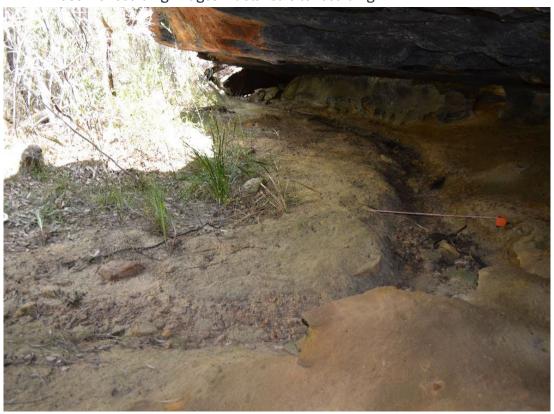
Plate 304: Detail of waterflow through shelter where artefacts located at Northern Trail 81, facing south.

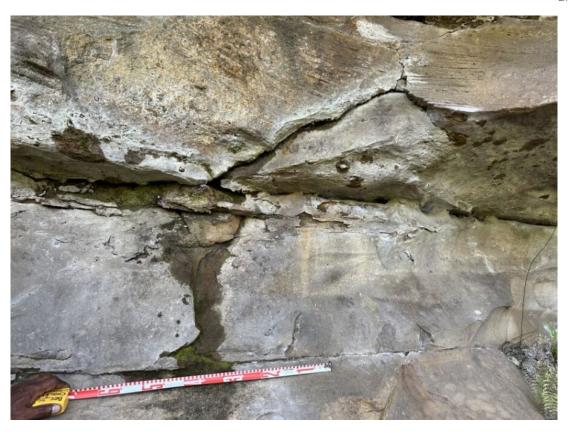
Plate 307: Monitoring point #1, seepage – Northern Trail 85.

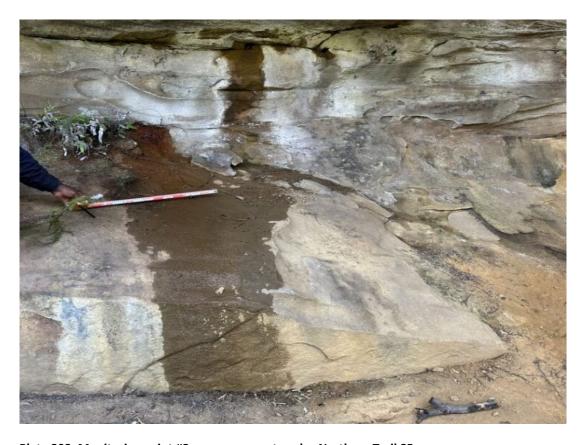
Plate 308: Monitoring point #2, seepage on artwork – Northern Trail 85.

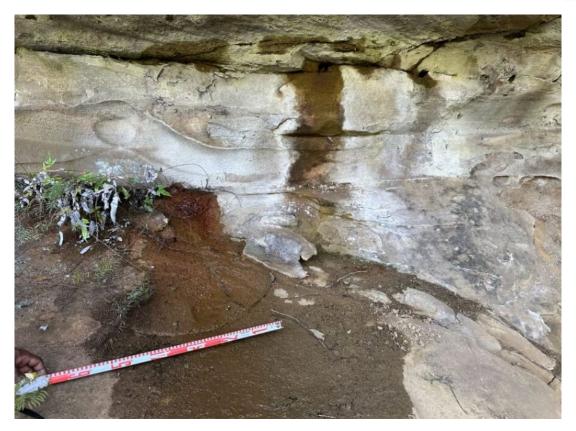
Plate 309: Monitoring point #2, seepage on art work – Northern Trail 85.

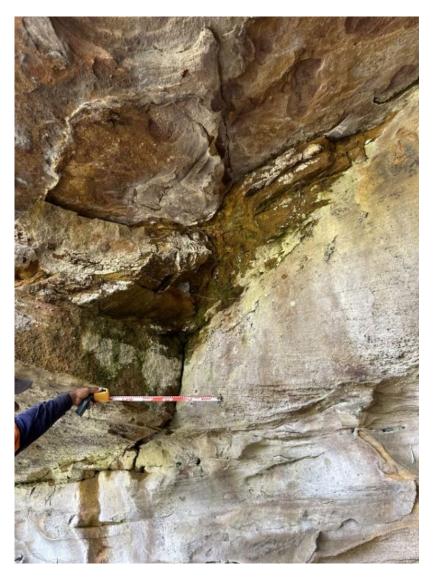
Plate 310: Monitoring point #2, seepage on art work – Northern Trail 85.

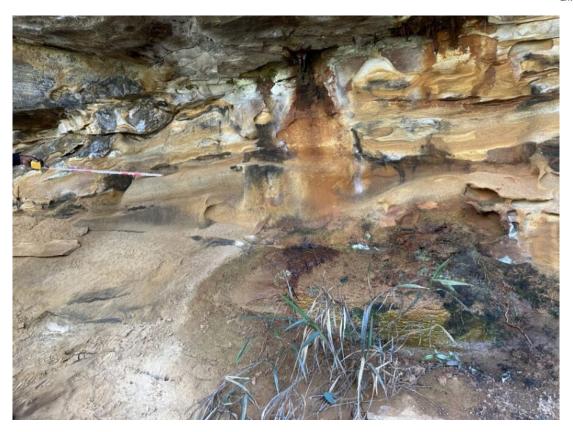
Plate 311: Monitoring point #3, active erosion and seepage – Northern Trail 85.

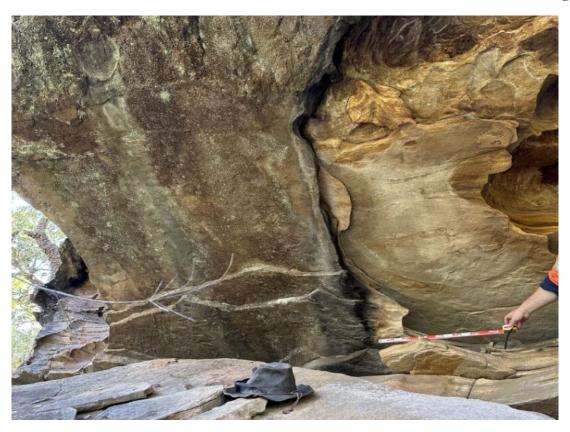
Plate 349: Recent water wash – Northeast Woronora 12.

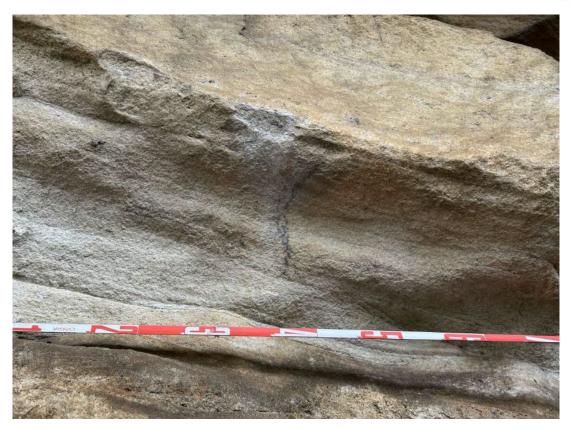
Plate 361: Monitoring Point #6 (chipping to the upper left of art) – Northeast Woronora 15

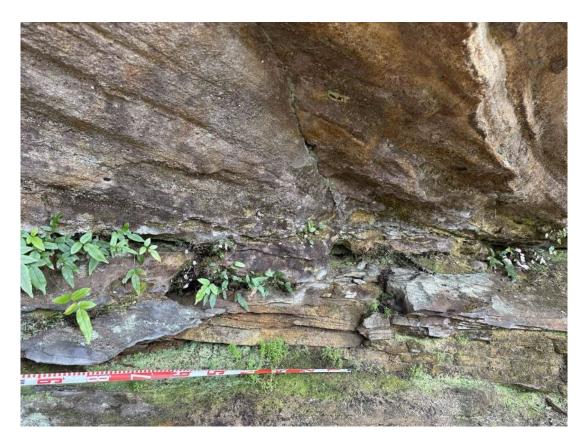
Plate 366: Monitoring point #2, NW aspect – Northeast Woronora 16.

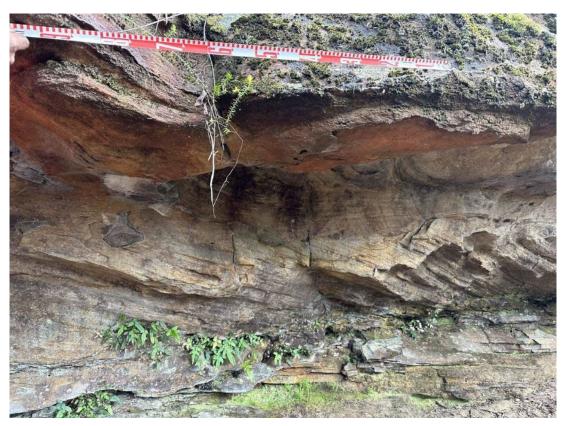
Plate 367: Monitoring point #2 showing exterior rock surface, NW aspect – Northeast Woronora 16.

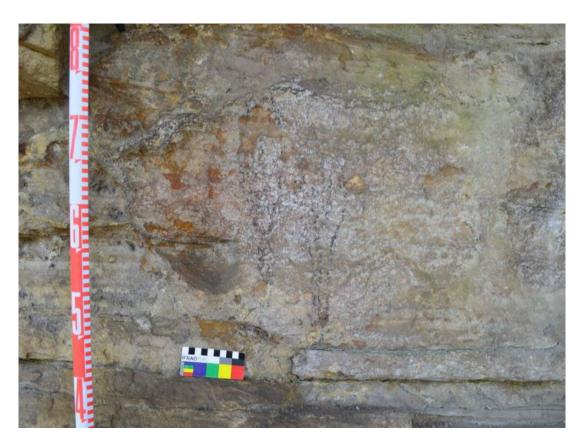
Plate 384: Motif #1, charcoal outline and infil on back wall – Northeast Woronora 20.

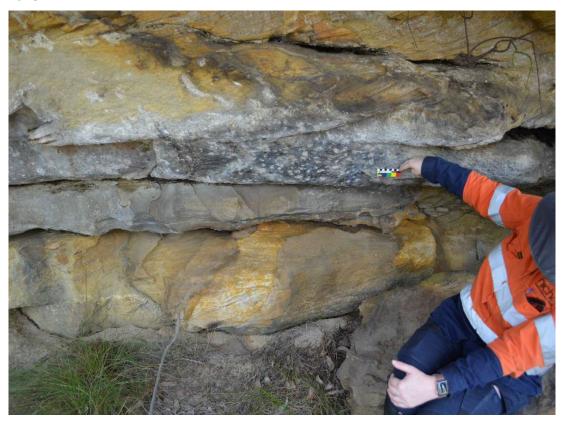
Plate 393: Northeast Woronora 21 overview of Panel #1.

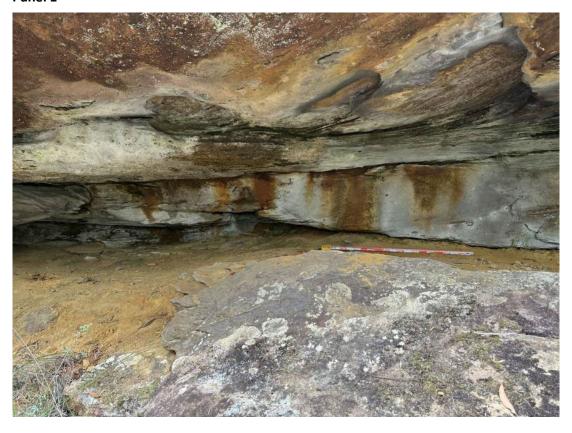
Plate 401: Back wall mineral / water leeching over art panel – Northeast Woronora 23.

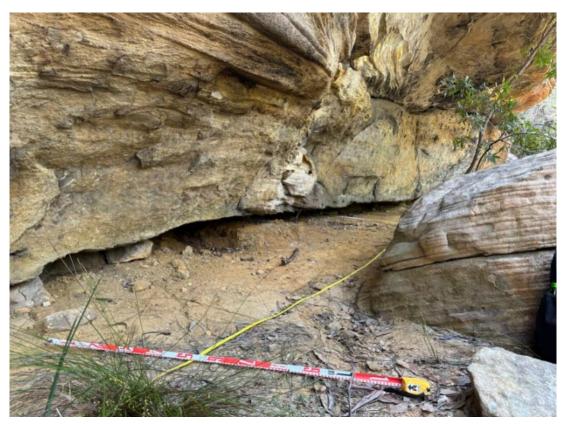
Plate 406: Shelter overview, S aspect – Northern Trail 77; Woronora Catchment Area.

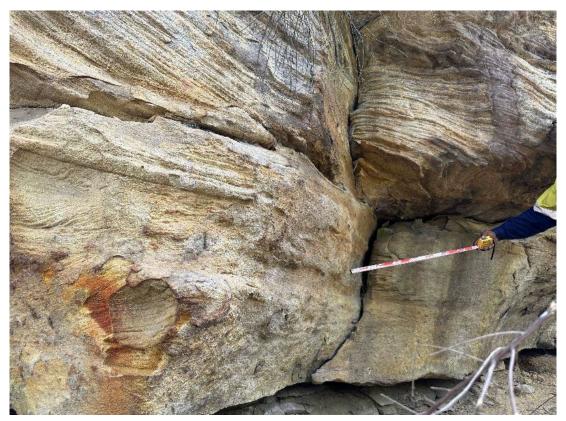
Monitoring Poin	ts
Number	Location in shelter	Notes
1	From 2.10 m – 2.6 m	Vertical separation – floor to roof.
2	At 3.7 m	Mid wall starts at horizontal separation plane.
3	Starts at 6.70 m – 5.80 m	Vertical and horizontal crack / separation – floor to roof and horizontal separation plan.
4	Joins point #3 at $6.70m$ – starts at $7.30m$ (floor) and connects to roof at $7.20m$.	
5	At 9 m	Vertical crack – starts at floor – runs 40 mm short of roof separation.

Plate 407: Monitoring point #1, vertical separation from floor to roof – Northern Trail 77; Woronora Catchment Area.

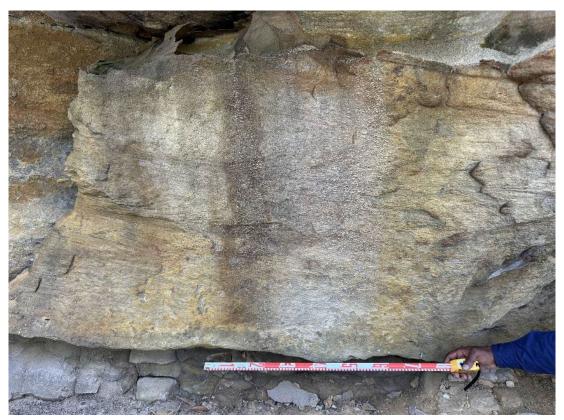
Plate 408: Monitoring point #2, water wash – Northern Trail 77; Woronora Catchment Area.

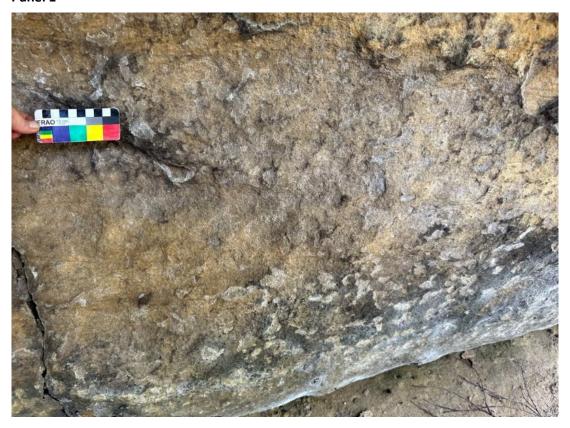
Plate 412: Possible art panel, no longer visible – Northern Trail 77; Woronora Catchment Area.

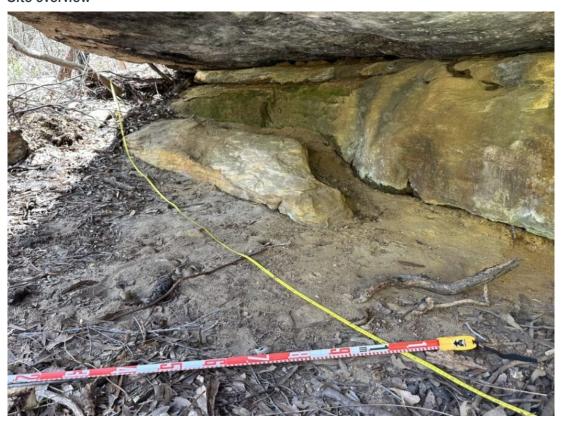
This ridgeline shelter is formed out of sandstone and has been affected by cavernous weathering and block fall. It is located 10 m SE of stored water at creek inlet, under the first ridge in this area. There were no monitoring points to be recorded. The partial art located at this shelter has been affected by chemical weathering.

Plate 415: Shelter overview, E aspect – Northern Trail Rock Shelter 01.

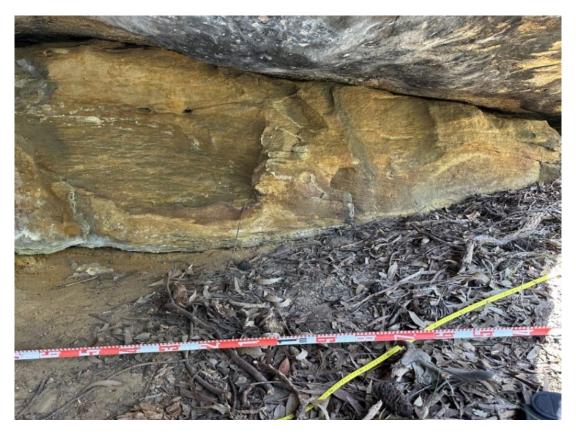
Plate 417: Back wall of shelter – Northern Trail Rock Shelter 01.

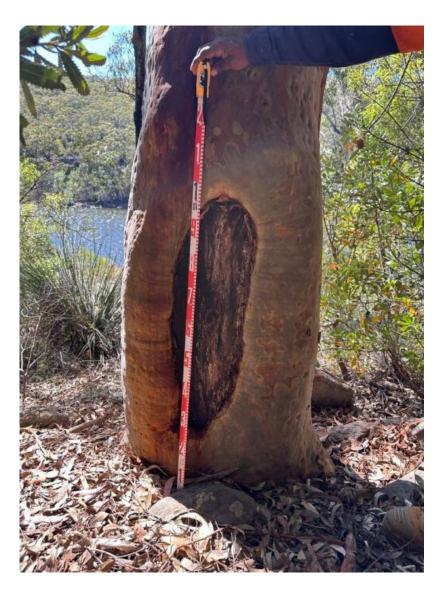
This site contains one potential scarred tree, with a 78 cm x 28 cm scar. It is located on a hillside, between stored water and the first ridgeline ledge and 720 m south of Honeysuckle Creek.

Plate 421: Potential scarred tree – scar.

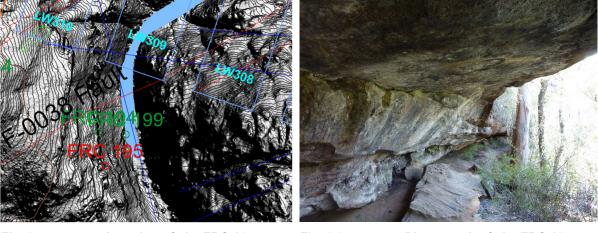
Fig. 2.5 Location of site FRC 195

FRC 195 is located on a north-east facing steep slope above the Waratah Rivulet and is approximately 220 m to the south of Longwall 309. The site is approximately mid slope within a series of ledges. The shelter has a stepped and sloping back wall. A weathered band infilled with clayey sand is observed near the base of the back wall. Active seepage is evident at step changes. Large fallen blocks are present within the shelter.

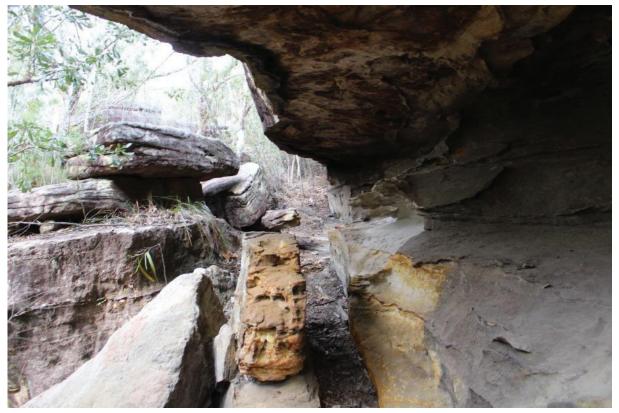
Plate 40: Overview of site FRC 191. View looking East.

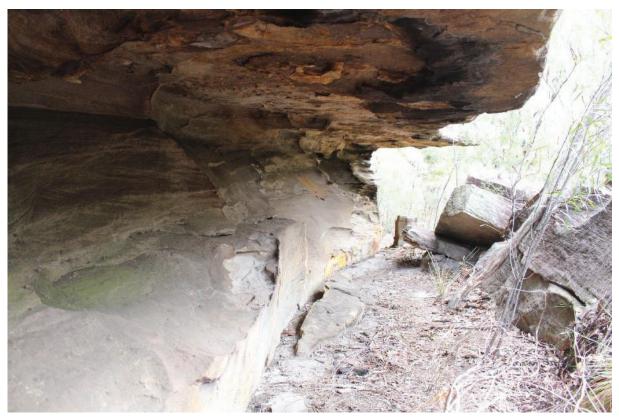
Plate 41: Overview of site FRC 191. View looking Southwest.

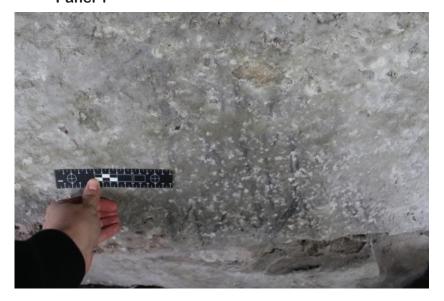
There has been heavy damage over Panel 1 due to water wash and exfoliation which has caused many of these motifs to fade and wear away. Only 70 motifs remain visible at the time of this baseline recording. Figure 26 and Figure 27 are a reproduction of the original Sefton site card drawings demonstrating the loss of motifs at the site due to natural processes.

Plate 118: Image of Panel 1, view west.

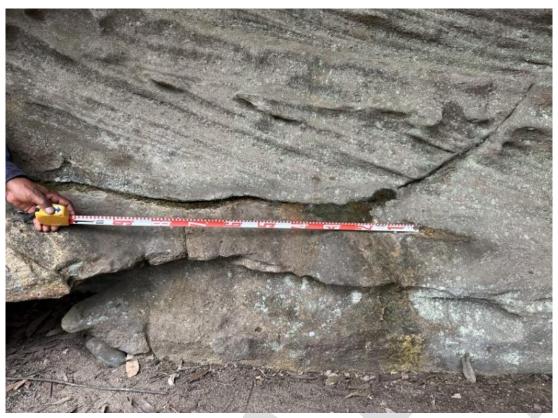
Monitoring Points				
Number	Location in shelter	Notes			
1	Near roof, follows roof, at 1.70 m.	Vertical crack			
2	At 4 m – 5 m.	Vertical to horizontal along rock ledge – crack and seepage on ledge where ground axe lies underneath in the hollow.			
3	From floor to half wall, at 5.90 m and 6.30 m.	Seepage, (water wash) and crack (vertical).			
4	At 14.30 m	Seepage – algae (active).			
5	At 22.50 m	Water wash – active.

Plate 274: Monitoring point #2 – Northern Trail 75. Note ground axe in situ on bottom left corner.

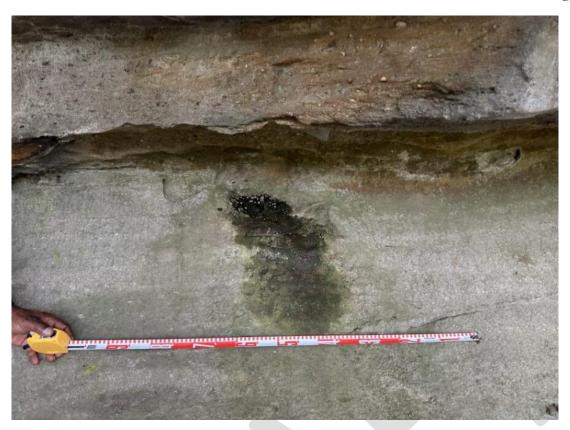
Plate 275: Monitoring point #3 – Northern Trail 75

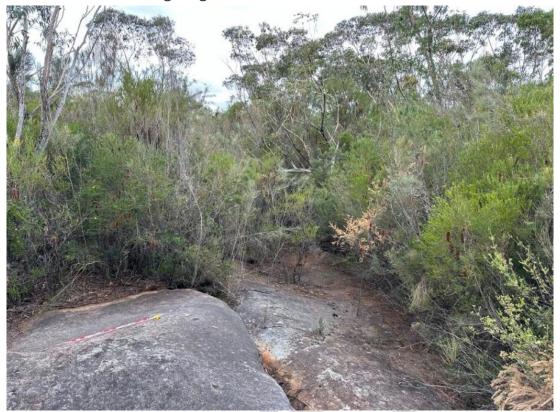
This site is situated upon a creek line landform, that moves into a stored water area. Features include two platforms with six petroglyphs and 52 grinding grooves. These are in a stable condition; however, some impacts are evident such as organic matter and environmental degradation and erosion.

Plate 93: Site overview - Woronora Reservoir Northern Trail 8

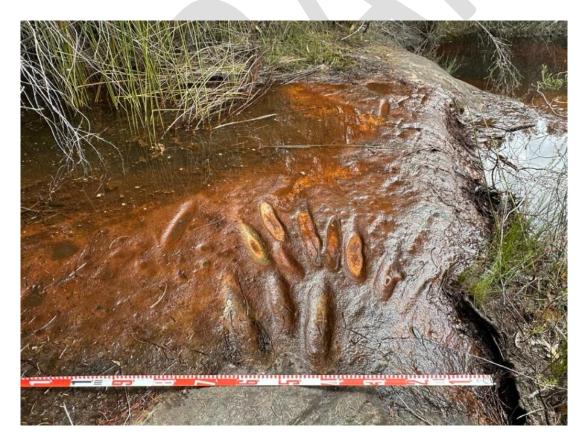
Plate 94: Overview of grinding grooves (Platform 1) – Woronora Reservoir Northern Trail 8

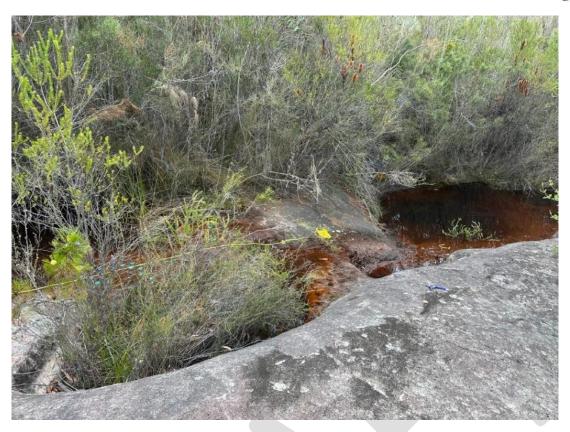
Plate 95: Platform 2 overview, facing south – Woronora Reservoir Northern Trail 8

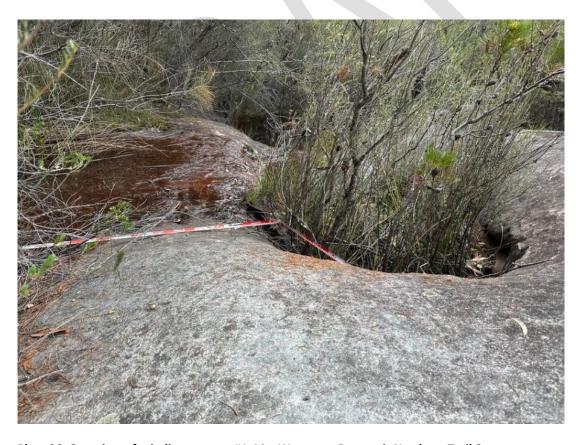
Plate 96: Overview of grinding grooves #1-14 – Woronora Reservoir Northern Trail 8.

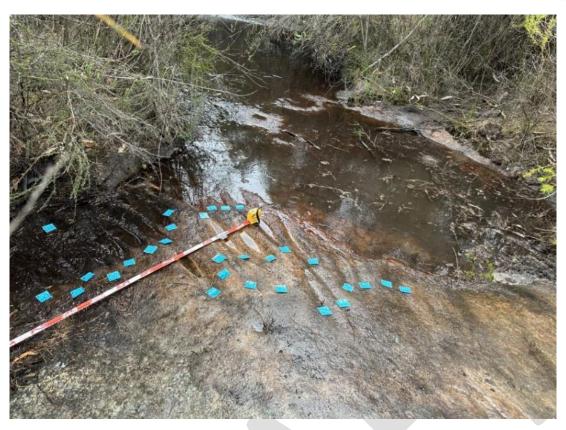
Plate 97: Example overview of grinding grooves – Woronora Reservoir Northern Trail 8

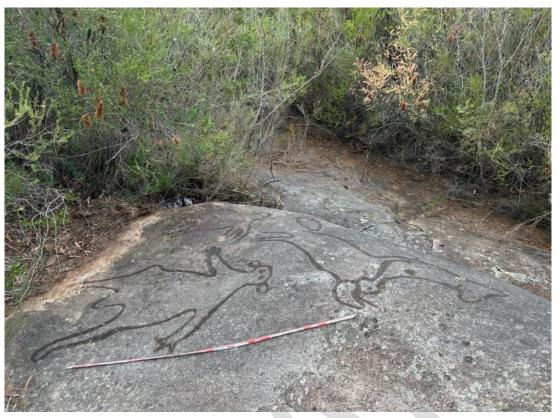
Plate 98: Petroglyphs #1, #2 and #3, facing N – Woronora Reservoir Northern Trail 8

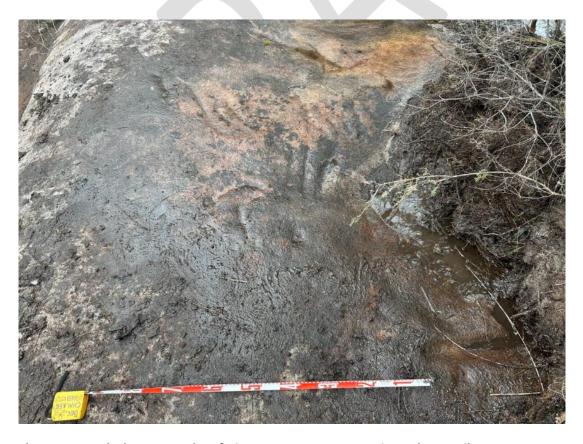
Plate 99: Petroglyphs #4, #5 and #6, facing N – Woronora Reservoir Northern Trail 8

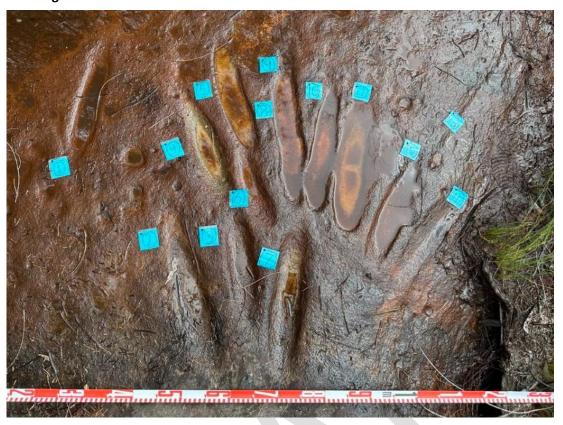
Plate 100: Grinding grooves #1-14 - Woronora Reservoir Northern Trail 8

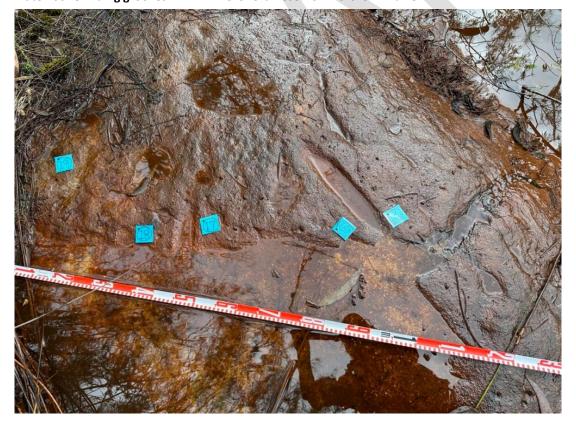
Plate 101: Grinding grooves #15-19 – Woronora Reservoir Northern Trail 8

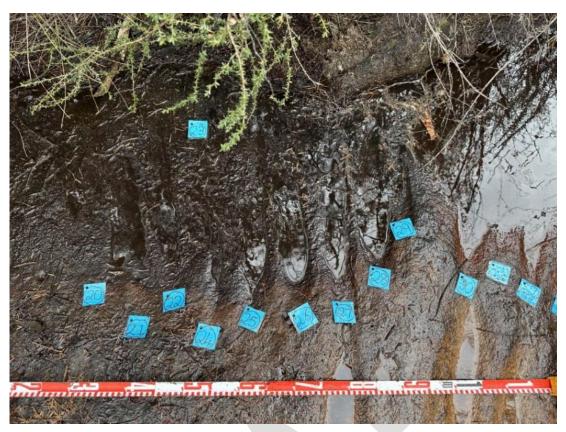
Plate 102: Grinding grooves #20-33 – Woronora Reservoir Northern Trail 8

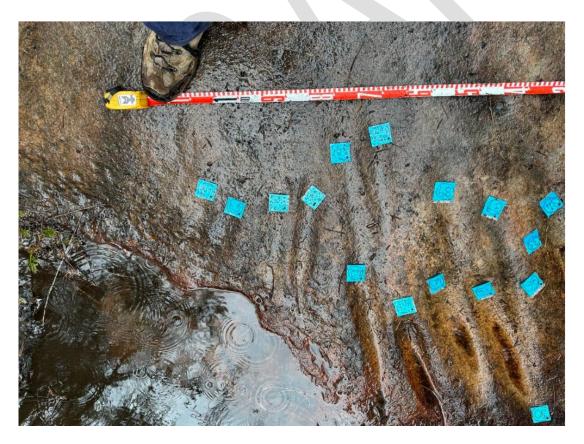
Plate 103: Grinding grooves #34-48 – Woronora Reservoir Northern Trail 8

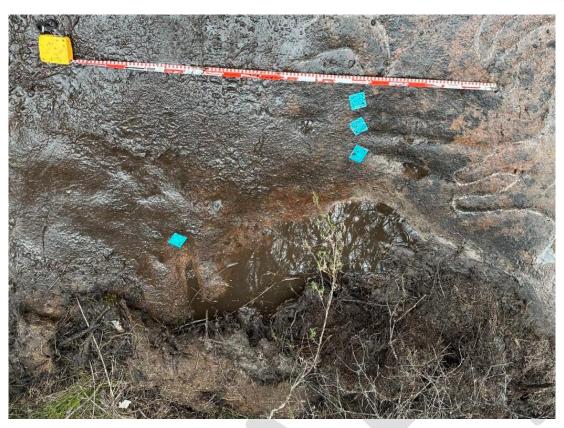
Plate 104: Grinding grooves #49-52 – Woronora Reservoir Northern Trail 8

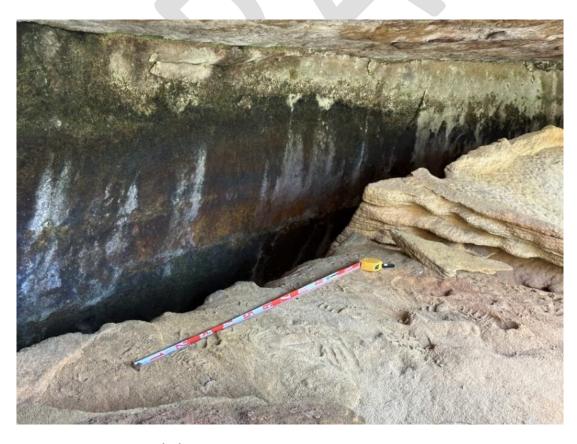
Plate 111: Active seepage (#1), back wall at 5.5 m - 9 m - Woronora Reservoir Northern Trail 9
